# RCWD BOARD OF MANAGERS WORKSHOP

**Date:** December 30, 2024  
**To:** RCWD Board of Managers  
**From:** Tom Schmidt, Drainage & Facilities Manager  
**Subject:** District Iron Enhanced Sand Filter Operations and Maintenance Update

# District Iron Enhanced Sand Filter (IESF) Operations and Maintenance Update

## RCWD Monitoring Report

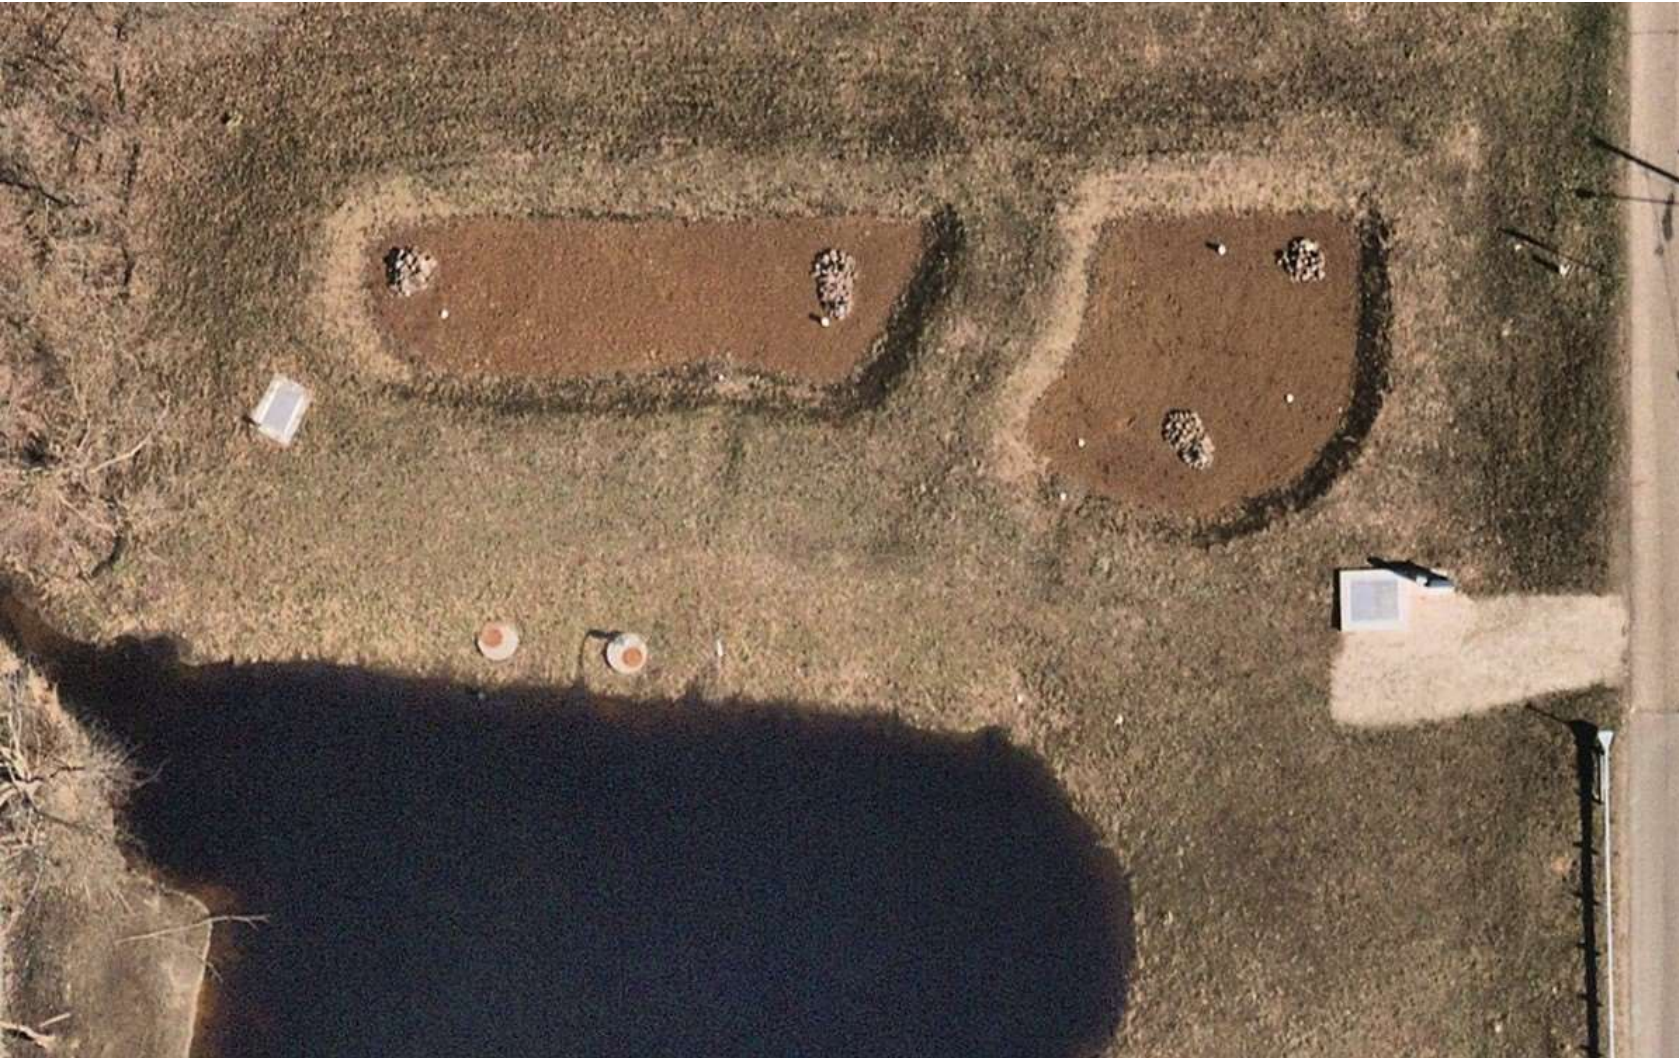
Bald Eagle IESF

Bald Eagle IESF- the Electronic Control Unit (ECU) failed and started on fire and is completely inoperable, we are retrofitting this site with the newer style ECU that is more reliable and less complex. BE IESF site should be 100% operational spring 2025

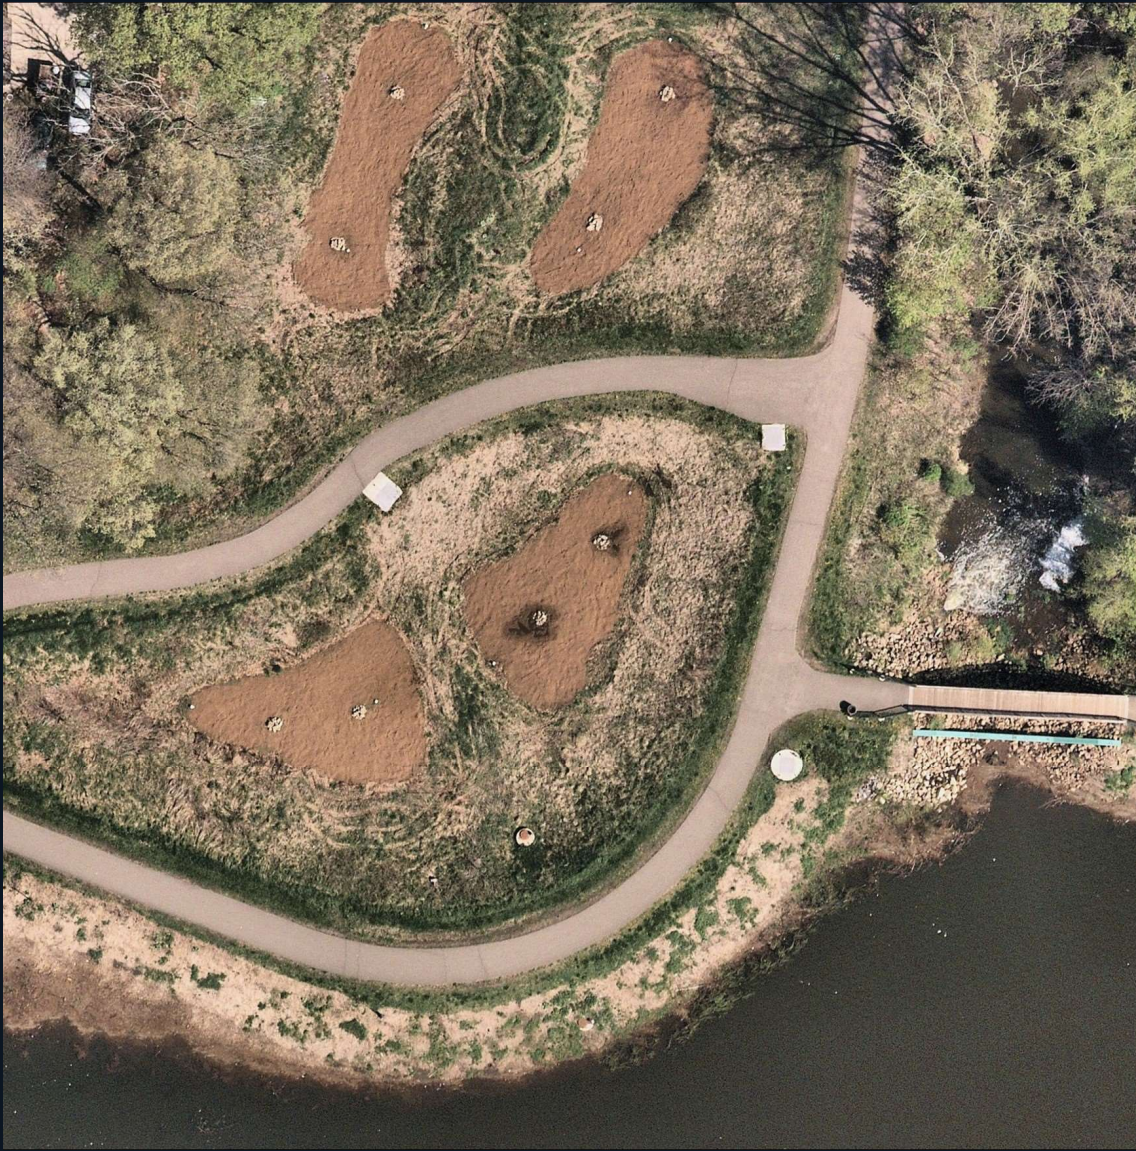
Easy fix problem at Hansen is the pump motor lead box sits directly on the manhole, during high water events water runs up pipe and through box depositing debris and corroding connections

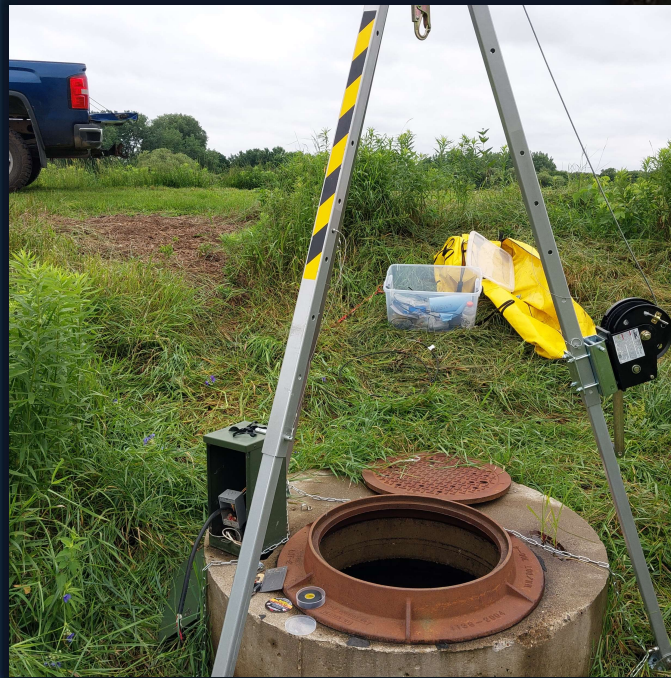
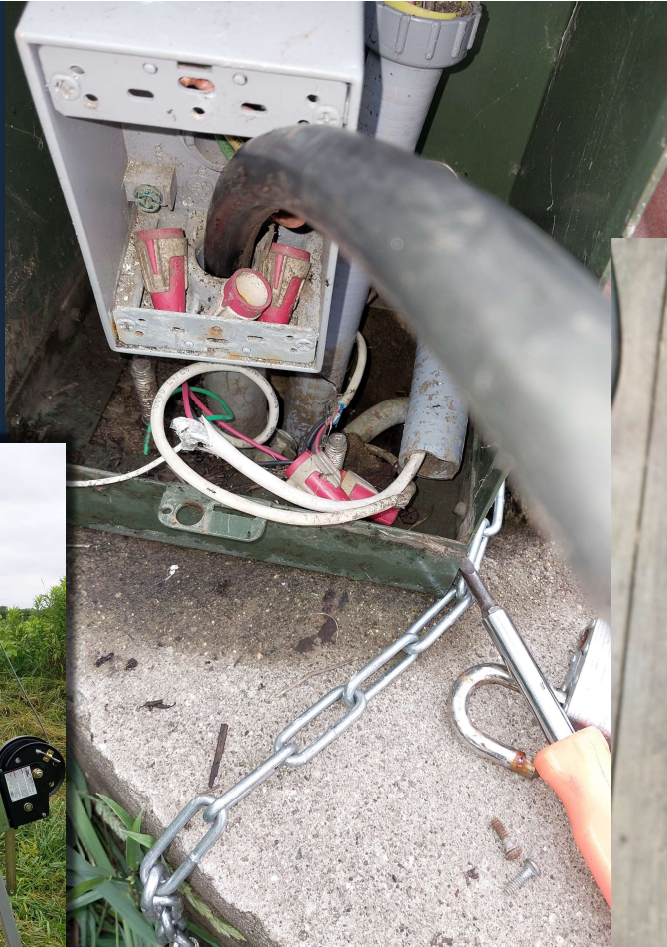
Motor lead cable damaged by muskrat and made pump inoperable, has been repaired

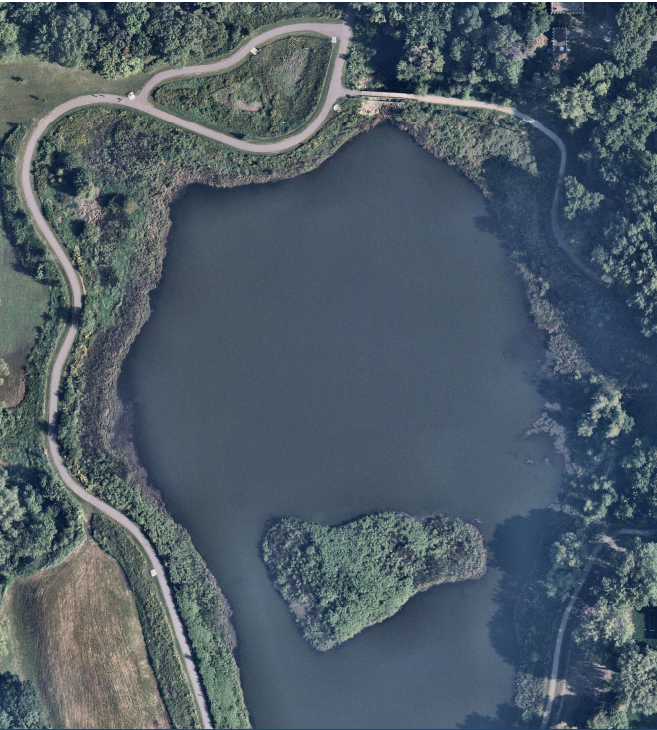
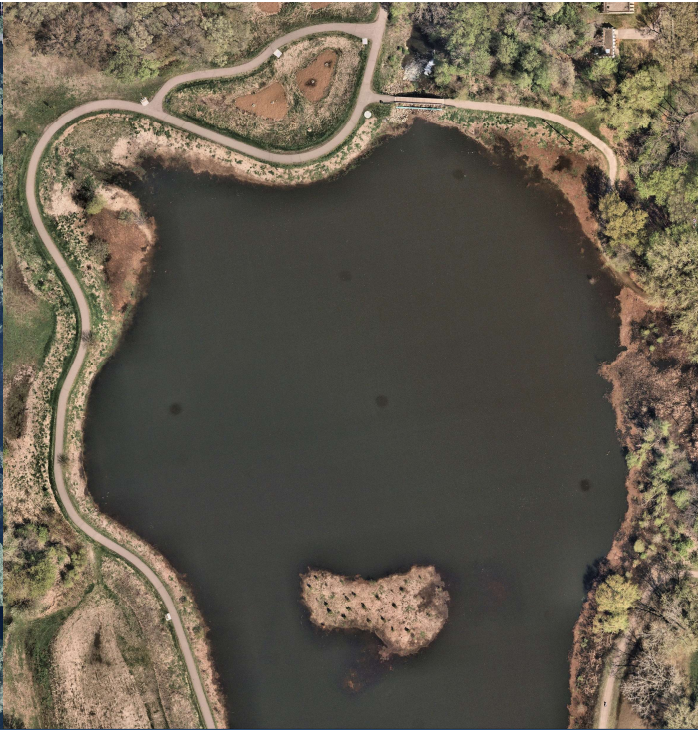
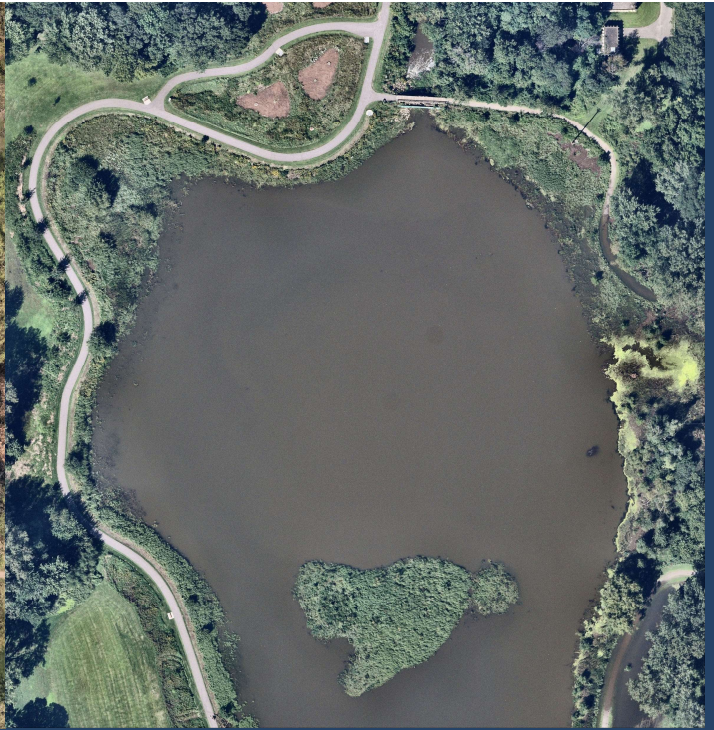
August 22<sup>nd</sup>, 2023

May 3<sup>rd</sup>, 2024

August 30<sup>th</sup>, 2024

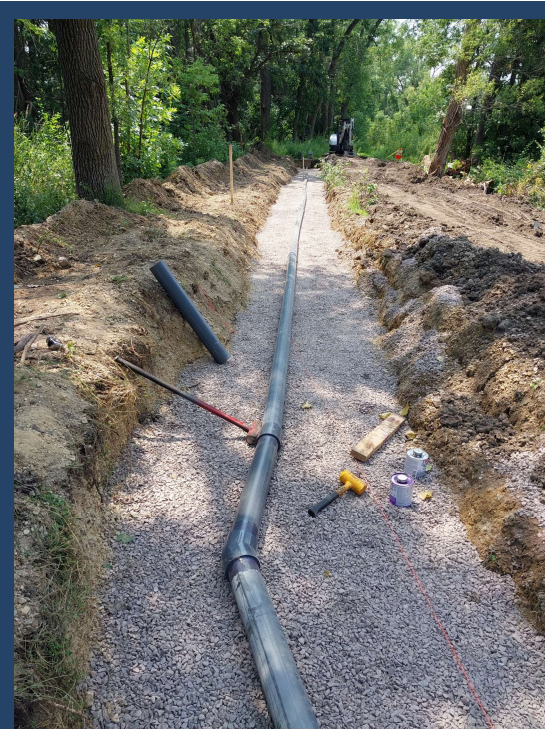
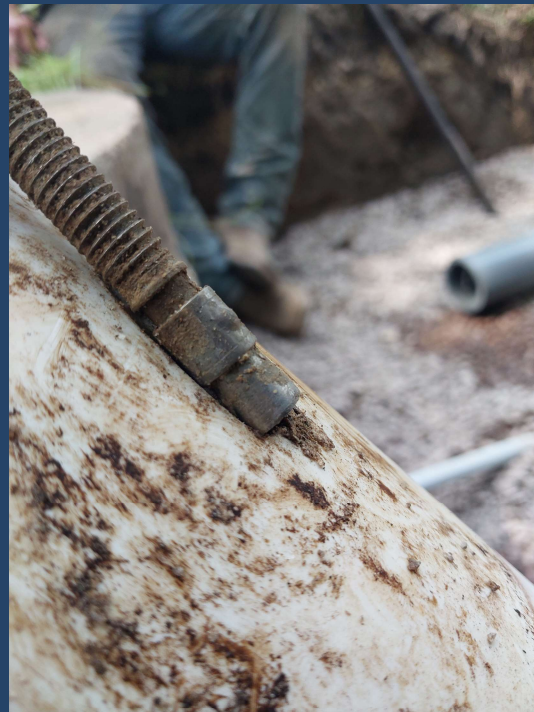
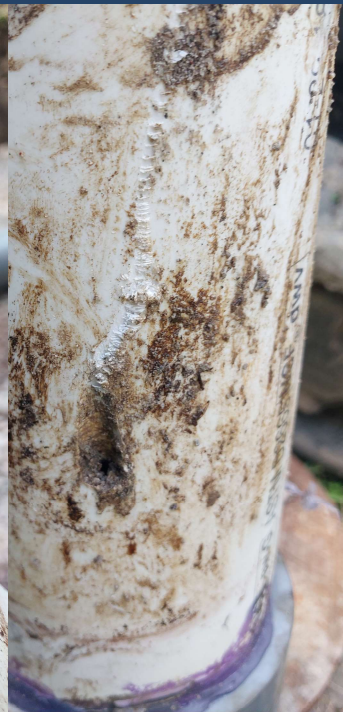
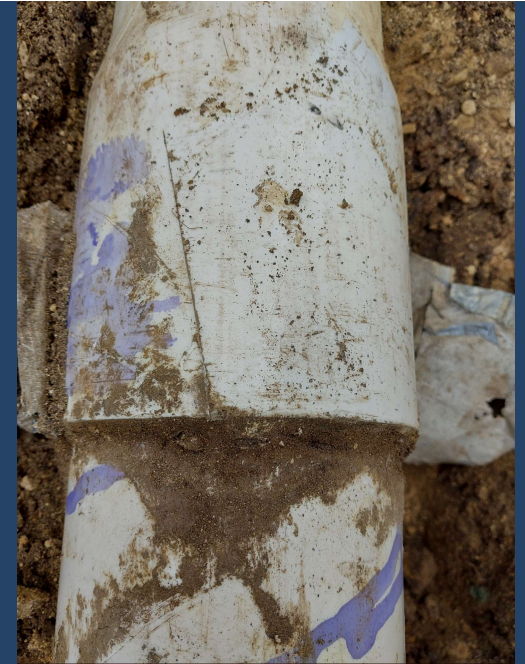
The city of Roseville plans on paving the trail adjacent to the pipe, so the decision was made to get as much of the pipe out from under the trail as possible

many breaks were discovered in the pipe that caused the system to lose pressure, the loss of flow stops the pump from running to prevent burning it out

Summer of 2024, Staff replaced the failed pipe that connected the lift station to the valve vault; it should be fully functioning next spring.

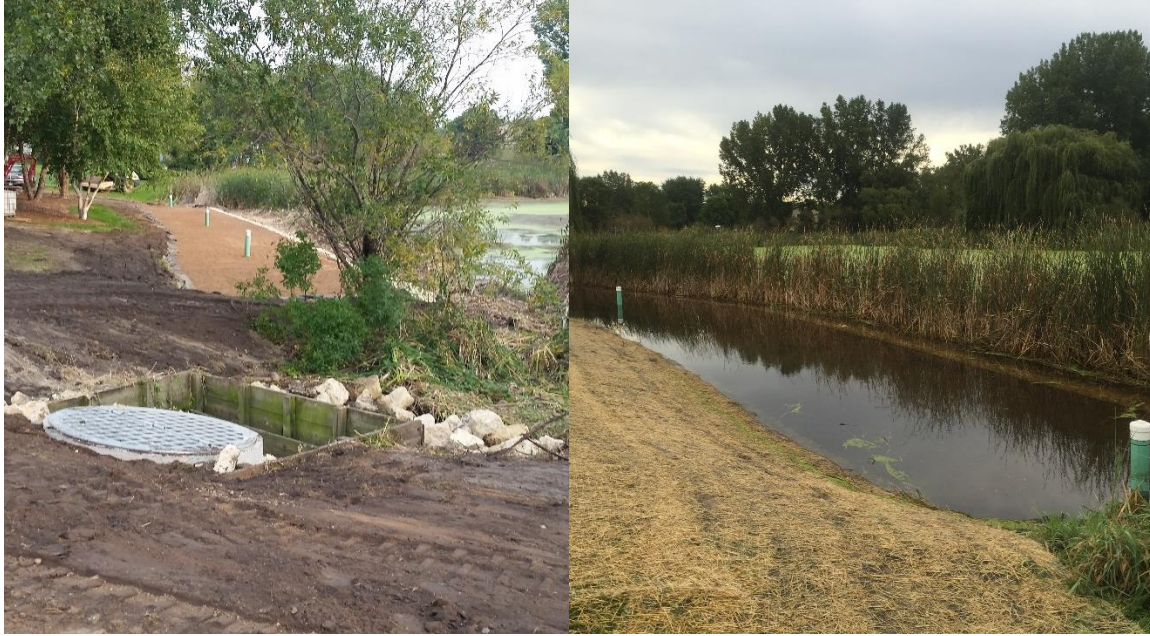
Figure 1. Photos of the Centennial Green IESF. Left: Outlet structure and filter bed during construction Right: Filter bed inundated; water would be flowing through filter and into outlet structure.

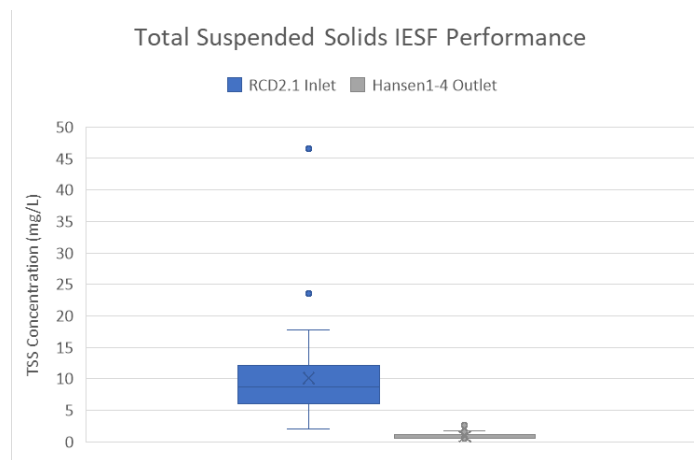
Figure 3 shows performance of the IESF in removing total suspended solids (TSS). Over all years and IESF beds, the system removed approximately 95% (median) of TSS.

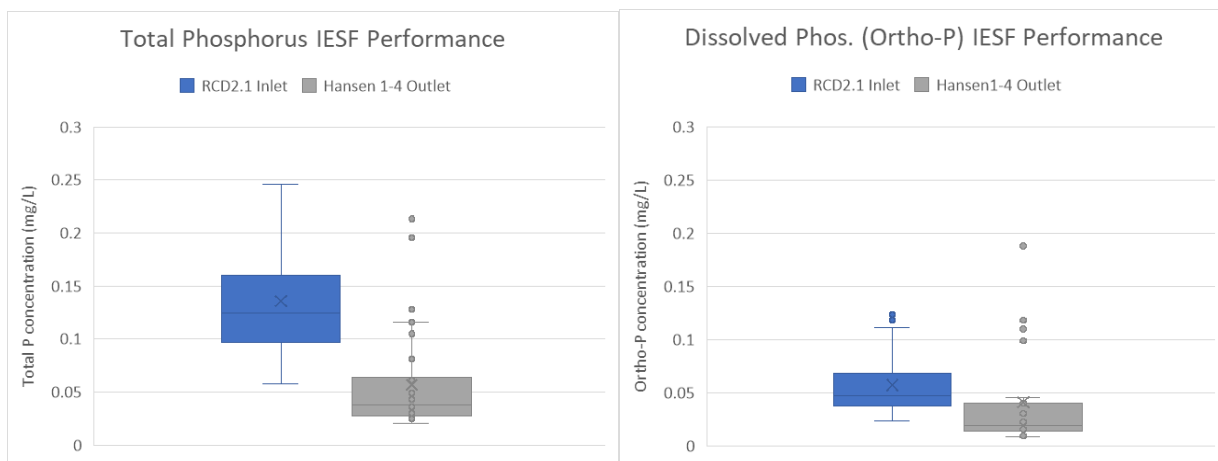
Figure 4 shows the IESF system performance for removal of total and dissolved phosphorus. Over all years and all filter beds, total phosphorus concentrations were reduced by approximately 70%, and dissolved phosphorus was reduced by about 60%. Several high statistical outliers are present in the IESF outlet datasets (shown by individual grey dots), raising question about periodic poor performance. Fortunately, the design of the IESF accommodated a deeper dive into performance of each IESF bed, since samples could be collected from the outlet of each individual bed.

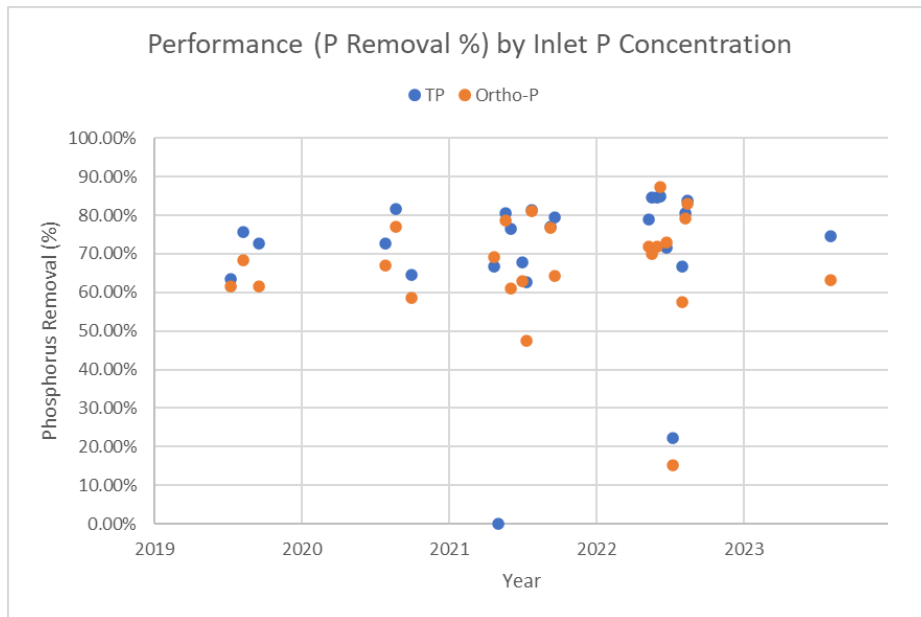
Figure 8. Reduction in phosphorus concentration (%) over time. Due to possible problems with filter media in IESF bed 1, data from bed 1 are omitted.

Figure 8 shows phosphorus removal performance over time. There is no apparent trend in phosphorus removal performance.

There is no apparent trend in IESF performance over time (Figure 8). This analysis could be used to identify the need for filter media testing, maintenance, and replacement, *if* there were a downward trend in performance over time. Due to the aforementioned filter media issues in IESF bed 1, those data are omitted from this analysis. Thus, data from beds 2-4 do not suggest replacement is necessary. However, given the problems with bed 1, system-wide filter media testing would be prudent.
