**RAMSEY COUNTY DITCH 1
DRAINAGE SYSTEM RECORD CORRECTION PUBLIC HEARING**

Technical Memorandum

Subject: Ramsey County Ditch 1 – Historical Review

Date: April 10, 2024

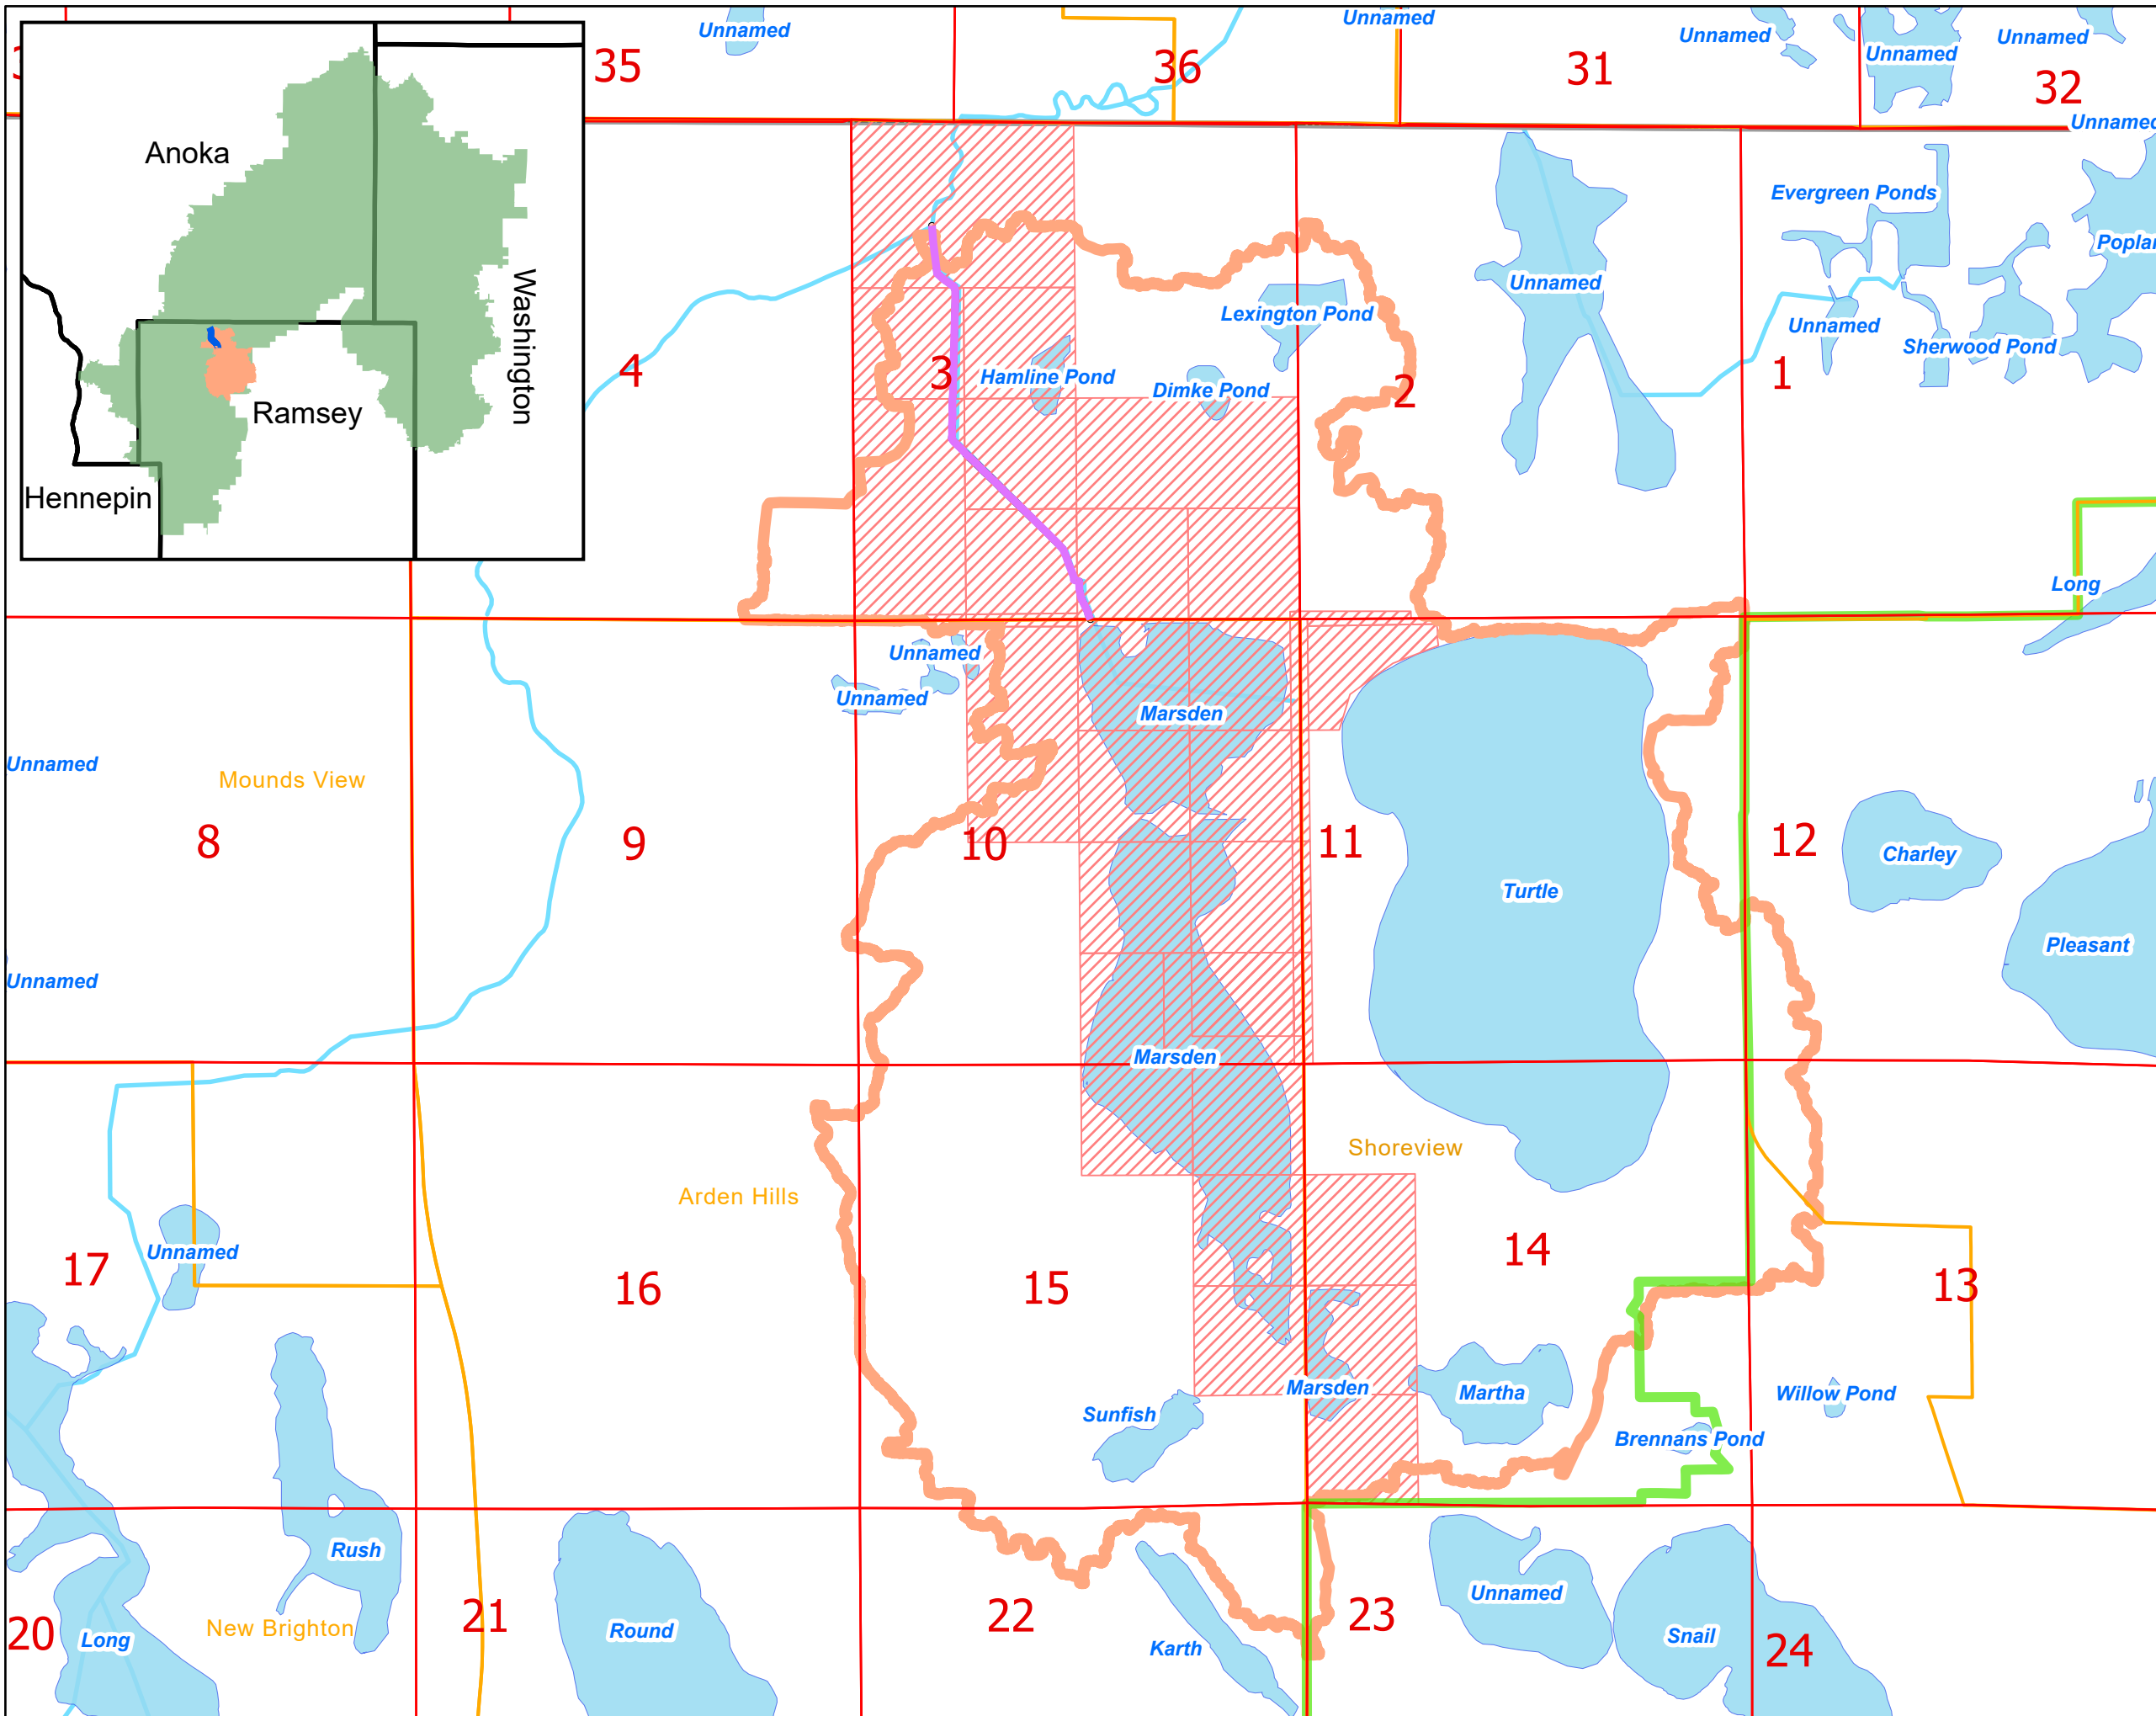
Figure 3: RCD 1 Benefiting Lands

RCD 1 Benefiting Lands*

*As defined in the 1914 Assessment for Repair

Repairs to the ditch in 1914 are documented through an auditor's tabular assessment statement, including costs that were assessed to benefitting acres presented visually in **Figure 3**. Charges were split up into equal installments for a 10-year pay back period.

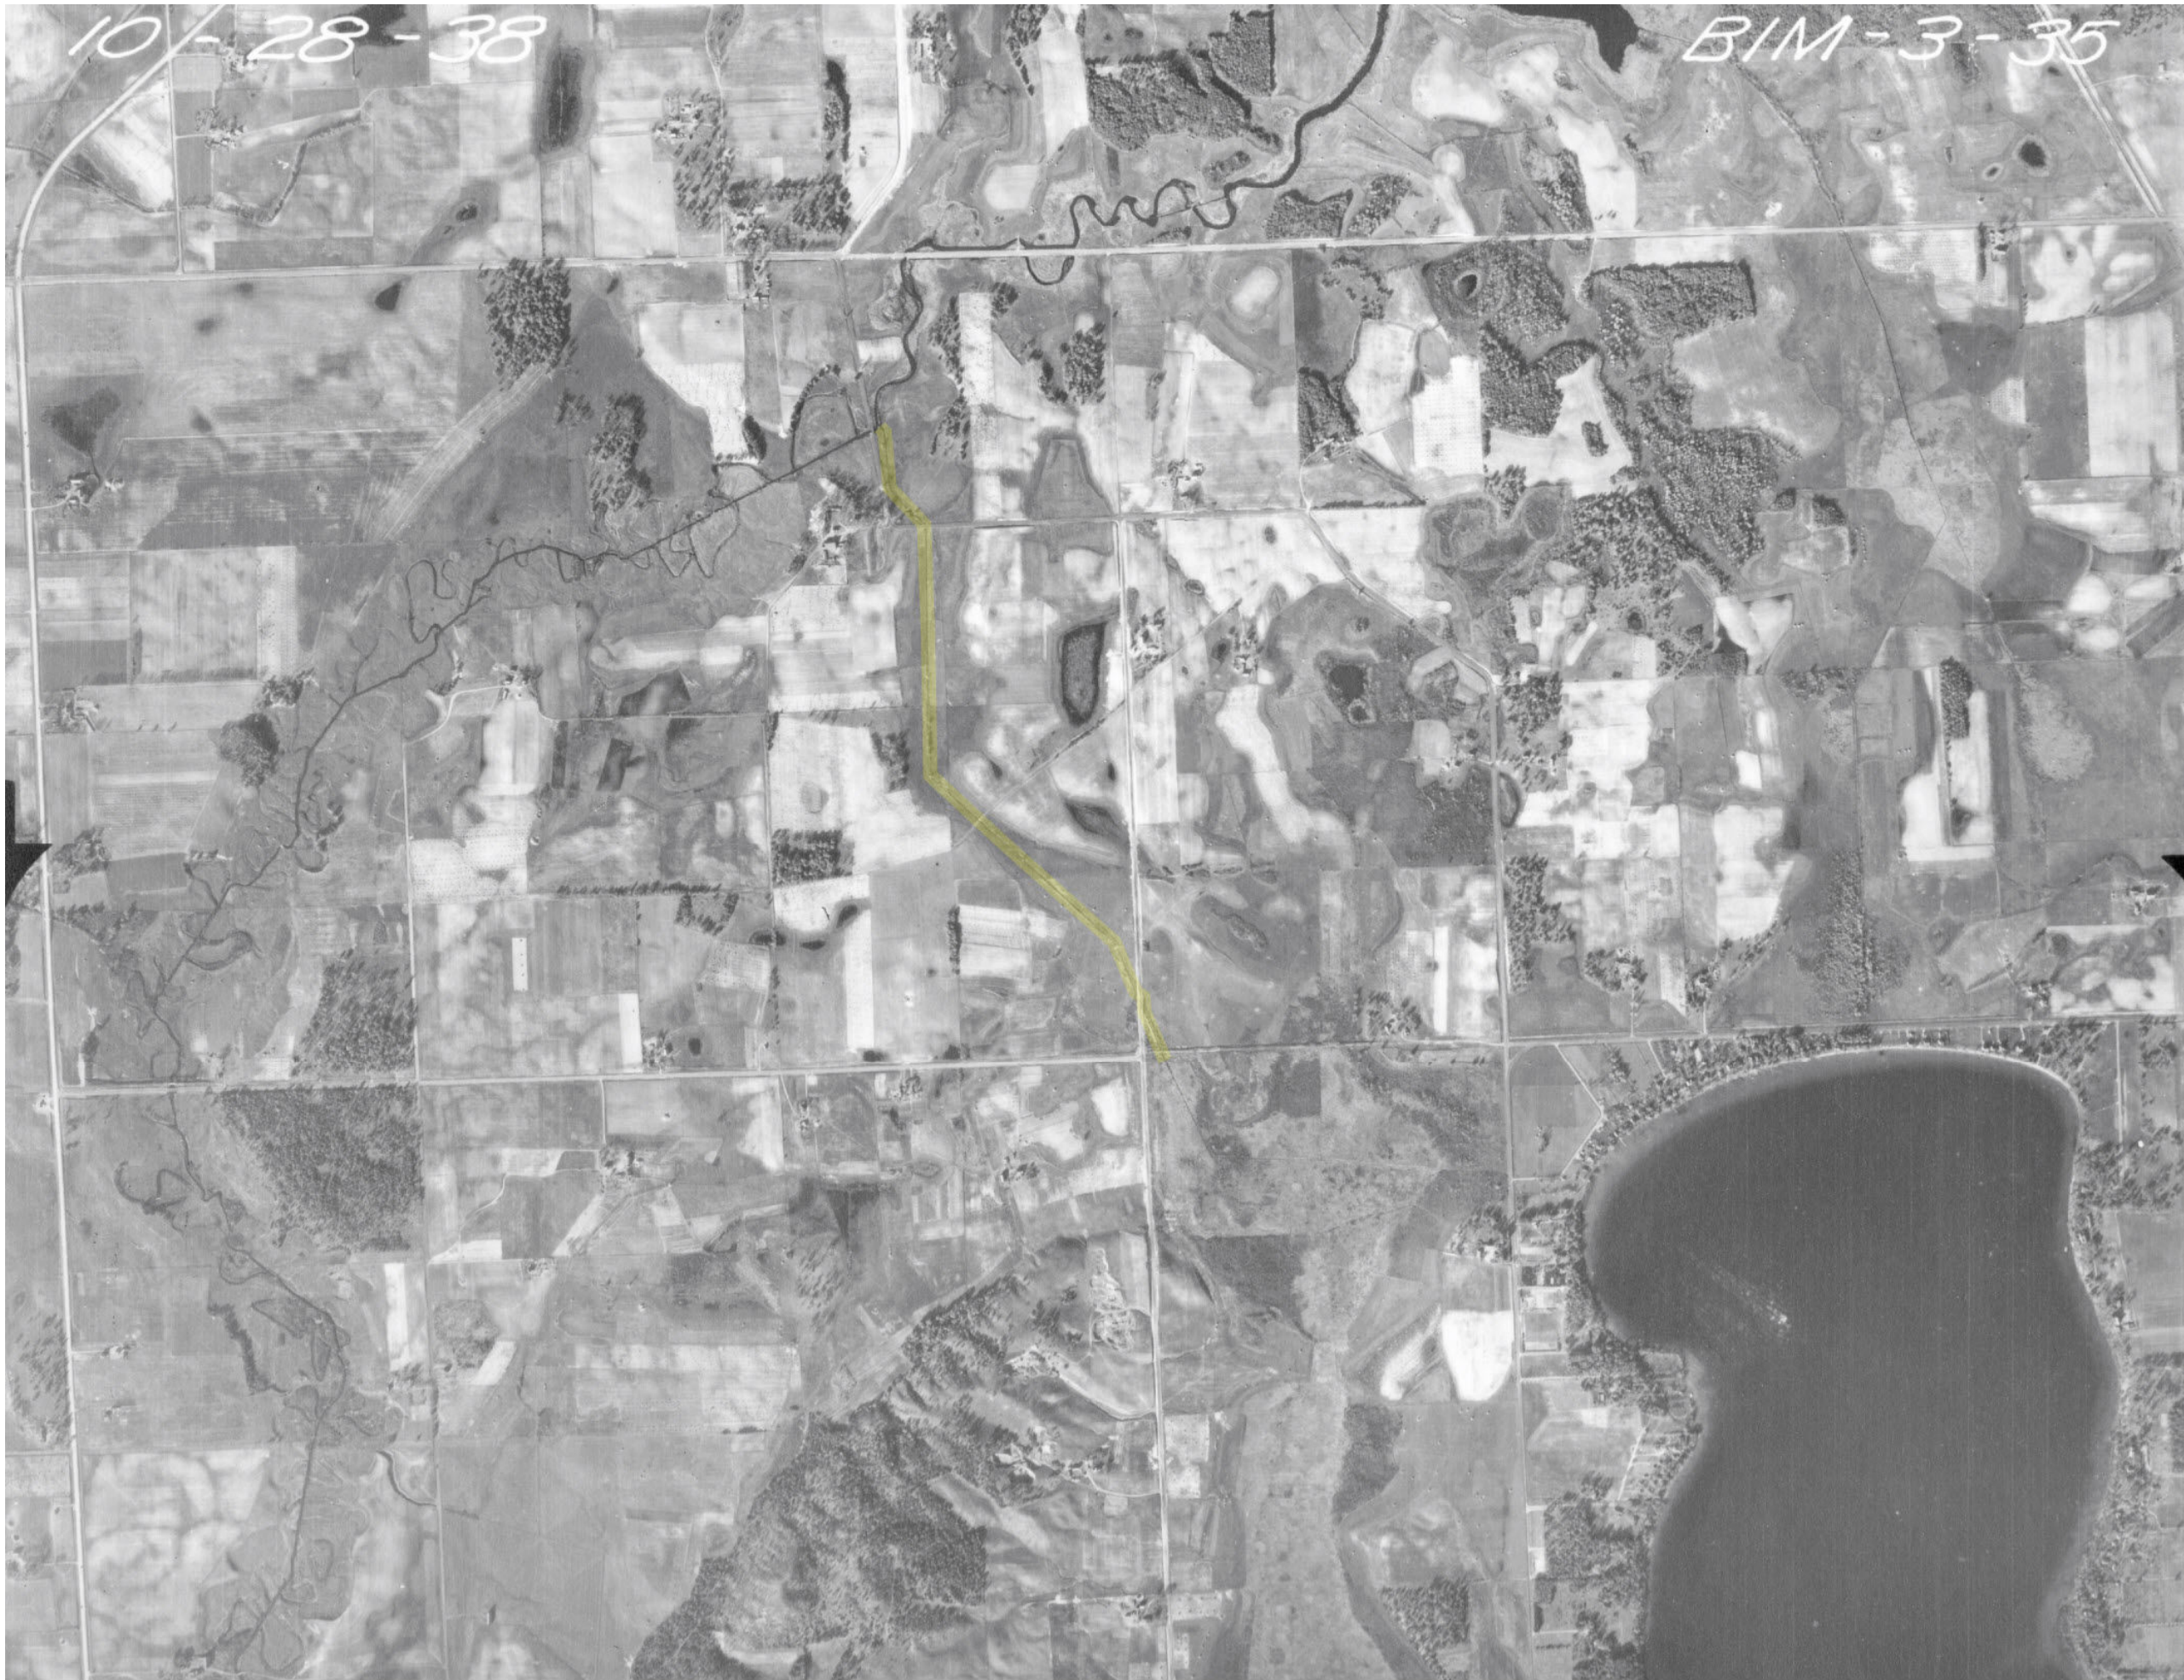
Figure 4: Historic Aerial 1938

Yellow Highlights
Added to Show RCD 1
Alignment

Historic aerial imagery is captured in 1938, 1940, 1953, 1957, 1960, and 1964 and is stored digitally at the University of Minnesota's web portal MHAPO <https://apps.lib.umn.edu/mhapo/>. These historic images help defined when and where the different roadways traversed adjacent to and across the ditch. They aid in the understanding of the landuse in the watershed, and the extents of development at different times in the history of RCD 1. **Figure 4** displays the landuse adjacent to the ditch in 1938.

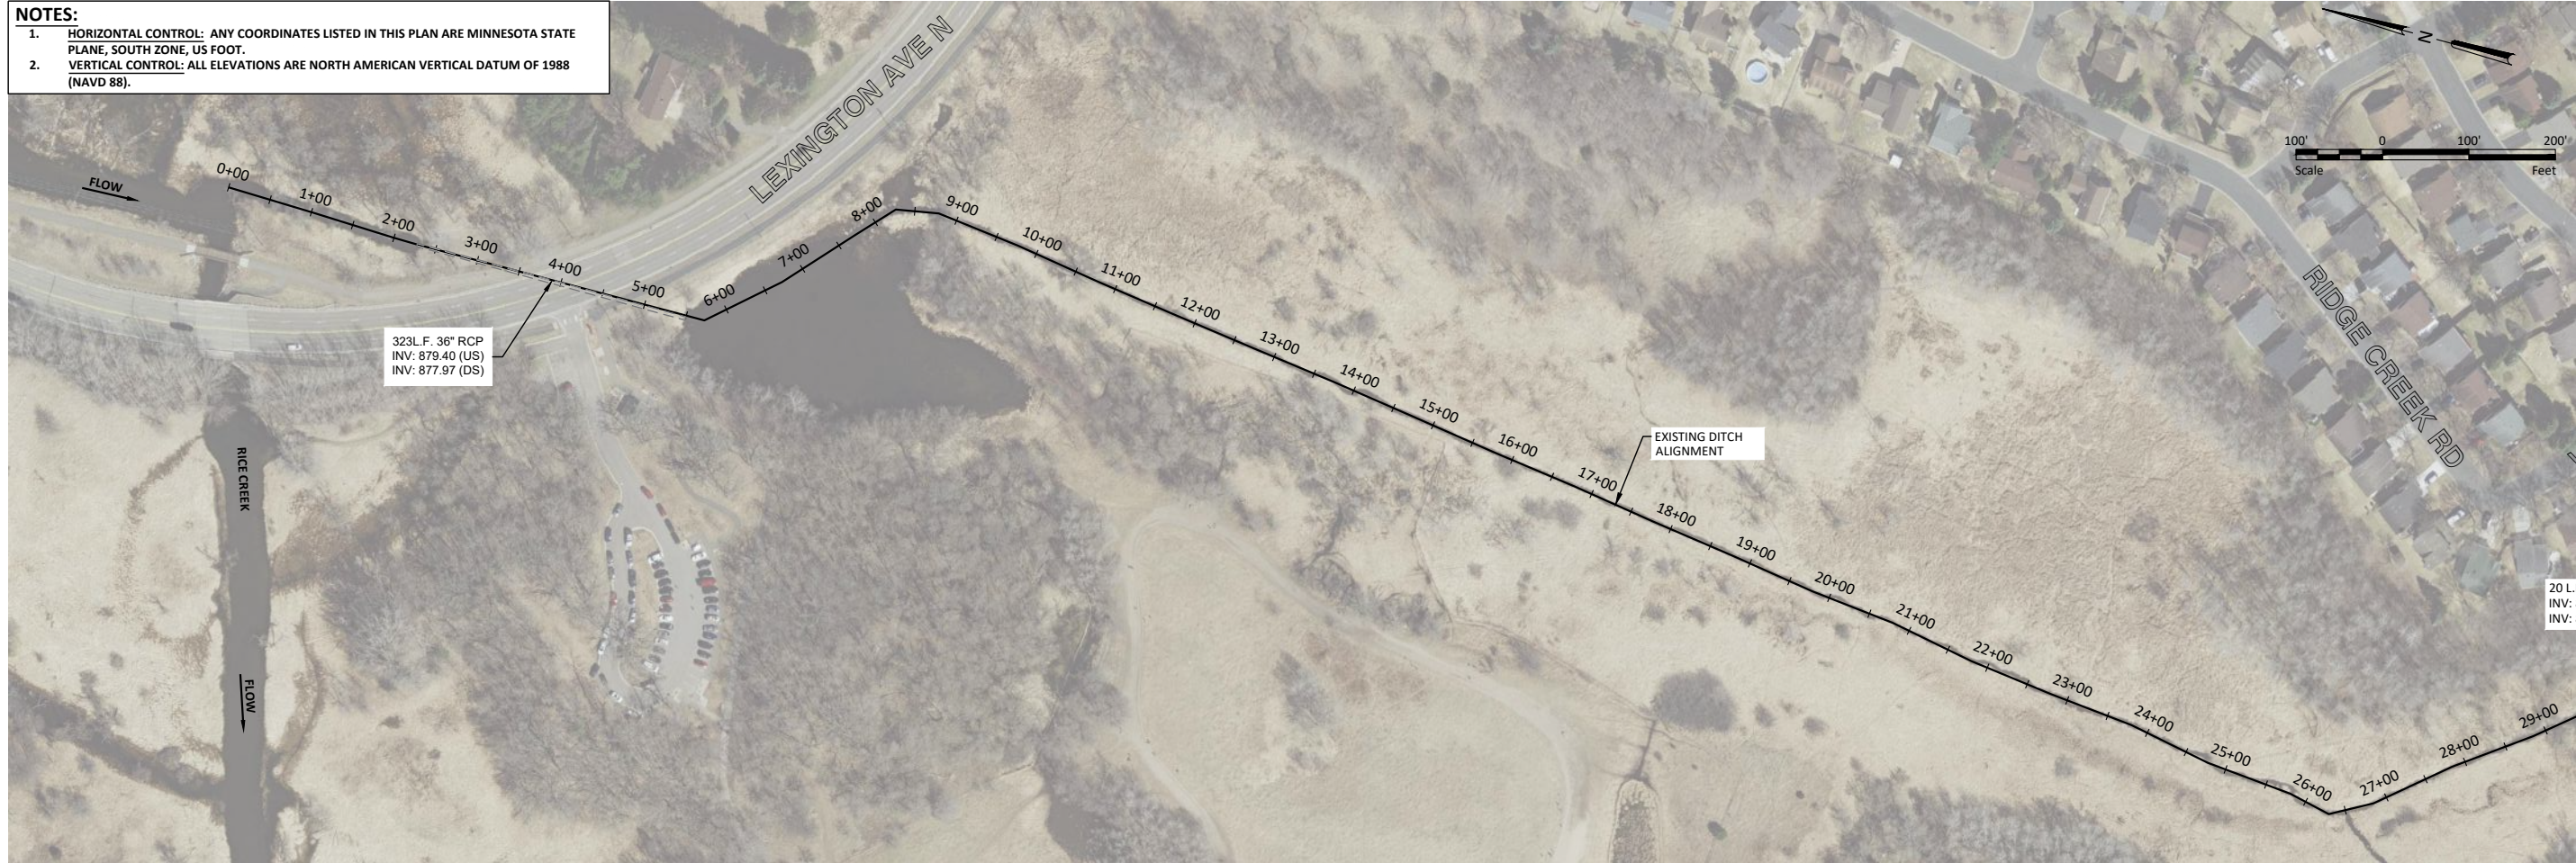
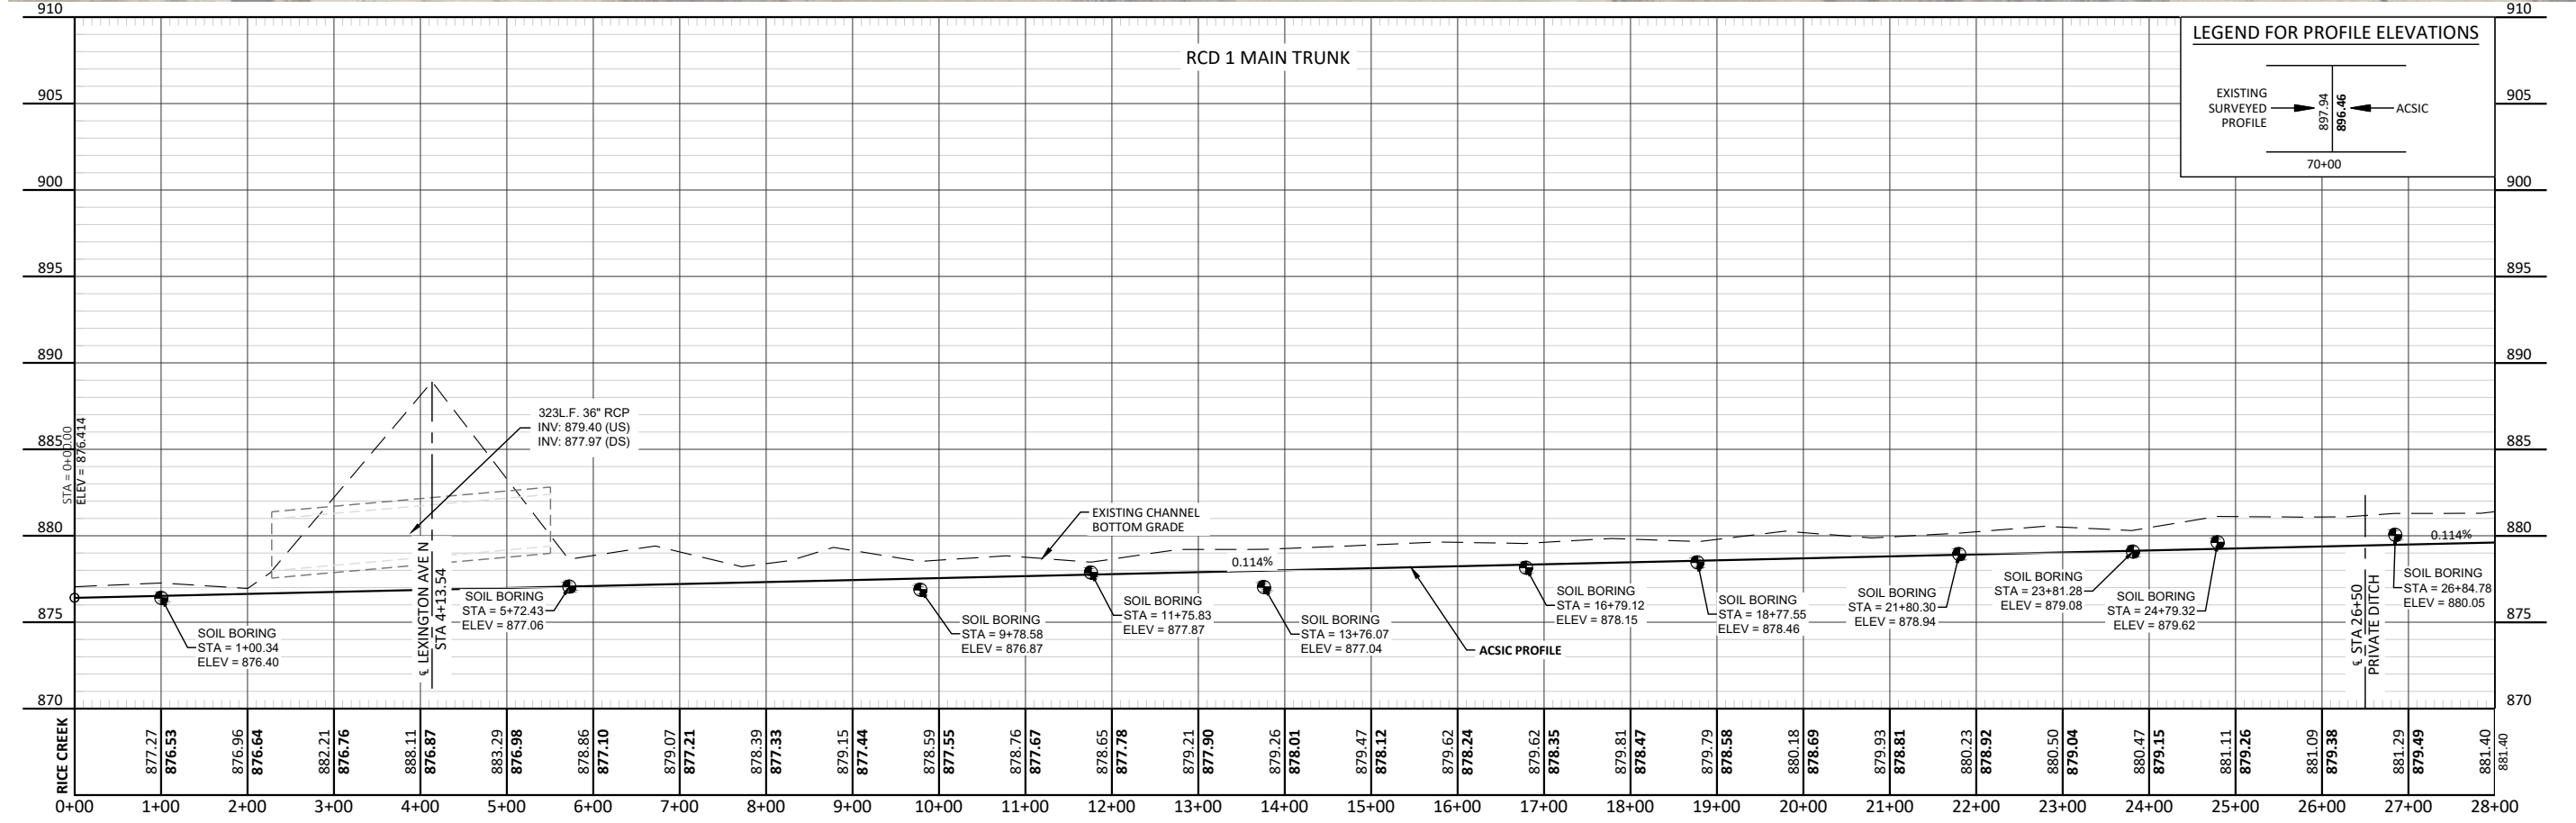
By	
Date	
Revision	
No.	
RAMSEY COUNTY DITCH 1 HISTORIC REVIEW RICE CREEK WATERSHED DISTRICT PLAN AND PROFILE (1 OF 2)	
Drawn By	APD
Checked By	ANN
Date	TBD
Scale	As Shown
Project No.	5555-0345
SHEET	1

LEGEND FOR PROFILE ELEVATIONS

EXISTING SURVEYED PROFILE: 897.94

ACSIC: 896.46

Within this historic review, field survey of the ditch and drainage structures are utilized to assist in the establishment of the ACSIC grade and cross section. The survey confirms the current conditions of the ditch cross section and profile, and confirms the as-constructed profile through the use of soil borings, which determine the “hard” clay elevation of the true ditch bottom. In the absence of design profiles, it is assumed that the elevation of bottom of organic sediments indicates the historical channel bottom. A “best-fit” line through the soil boring data is utilized to determine the as-constructed profile and has a slope of 0.114% and is the ACSIC determination of ditch grade for RCD 1 as displayed in **Appendix B**. Surveyed cross sections along the ditch are utilized to establish the ACSIC ditch cross section for RCD 1 with a 5-foot average bottom width, and 1.5:1 average ditch side slopes. This compares well with the cross section geometry listed in the 1985 inspection report.
