Prepared by:
Emmons & Olivier Resources, Inc.
for the Rice Creek Watershed District

Southwest Urban Lakes Study

April 2009

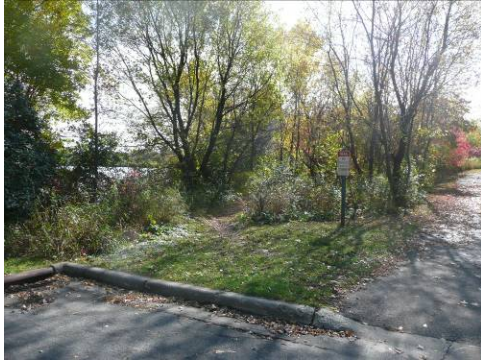
Island #1

Location: South end of Milton Street west of Island Lake

Description: Area at stormsewer outlet

Possible Improvements: Squeeze in feature to treat piped outlet at this location

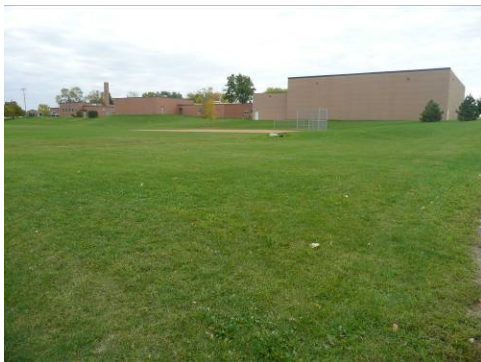
Island #2

Location: South of County Road E and east of Vivian Avenue

Description: Ditch / swale areas at corner

Possible Improvements: Rain gardens for roof outlet (seen in pic) or larger feature at corner also picking up adjacent street and parking (larger feature would need to be quite deep and may not be practical).

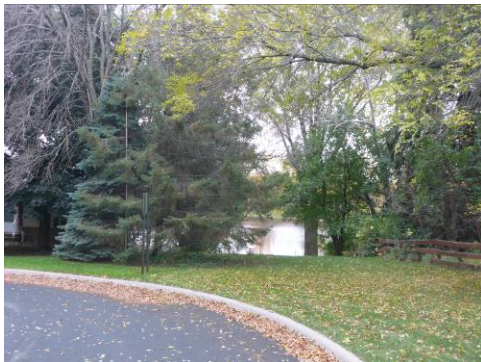
Island #3

Location: South side of Randy Avenue north of Island Lake

Description: Small green space areas

Possible Improvements: Incorporate small treatment areas for street runoff going directly to the lake

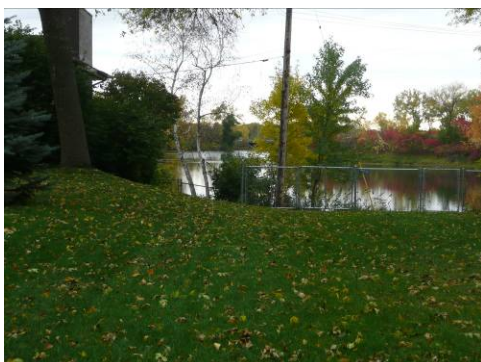
Island #4

Location: South side of Randy Avenue north of Island Lake

Possible Improvements: Incorporate small treatment areas for street runoff going directly to the lake

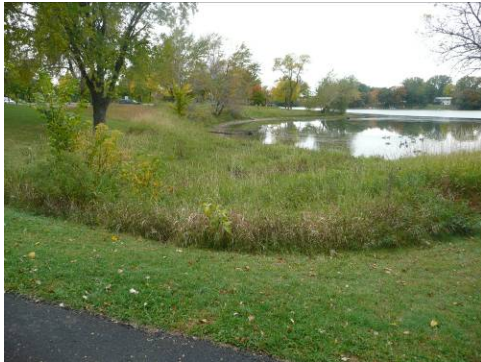
Island #5

Location: In park on east side of Island Lake

Description: Existing water quality pond

Possible Improvements: Excavation of second cell of pond downstream of bituminous trail; fix existing skimmer that has been heaved by ice and has been rendered ineffective.

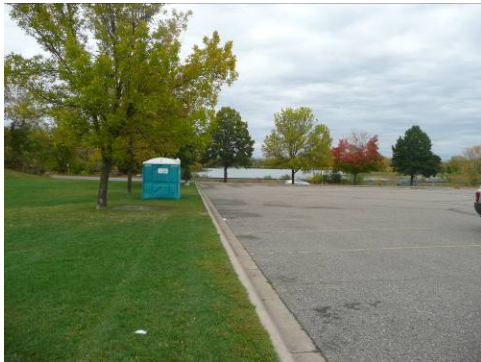
Island #6

Location: South of County Road E and west of Vivian Avenue

Description: Green space next to parking lot

Possible Improvements: Provide treatment for parking lot in open space

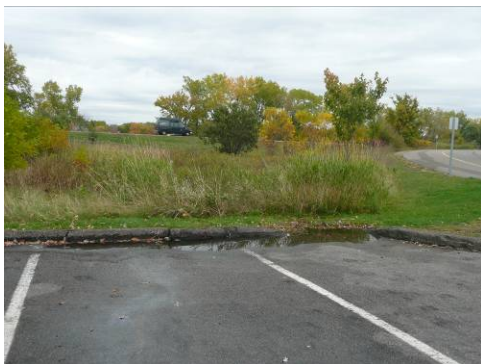
Island #7

Location: In park west side of Island Lake

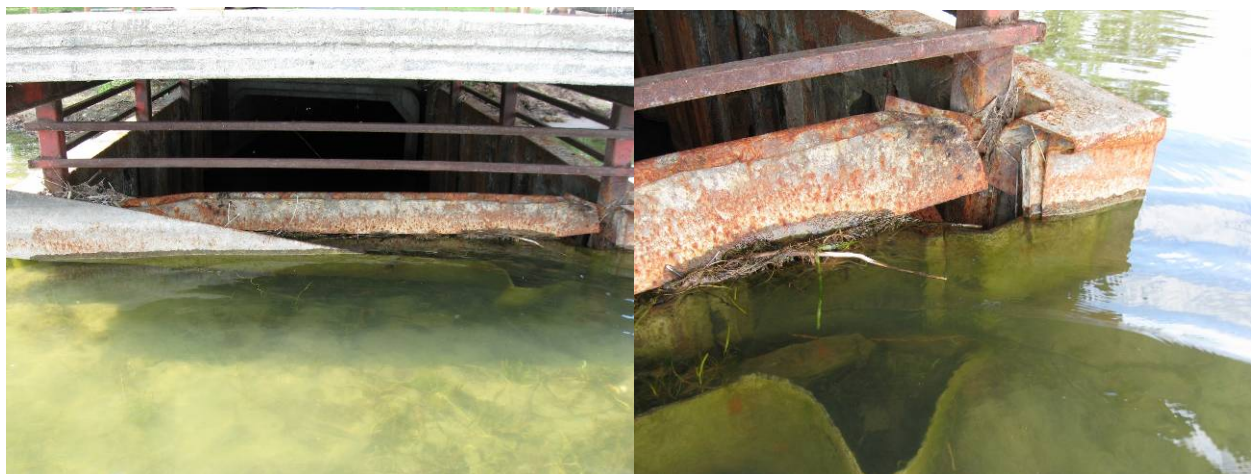
Figure 7. Photos of damaged outlet structure, Sept 9, 2008

In addition to the public input provided at the meeting held on June 5, 2008, members of both the Lake Johanna Improvement Society and the Arden Hills Beach Club expressed concern about the condition of Lake Johanna's outlet structure. Visits by RCWD staff revealed that the structure had been damaged, and was allowing water to pass approximately 0.02 feet lower than designed (Figure 7). RCWD engineers produced a technical memo recommending repair of the structure. Repair is slated for 2009.

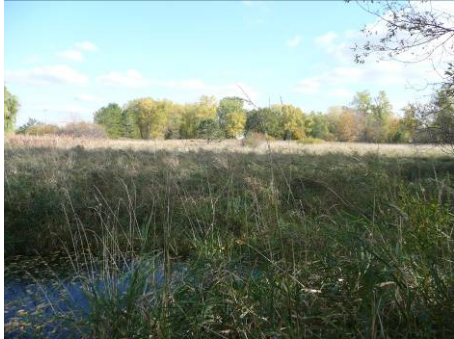
Johanna #1

Location: North of the intersection of Richmond Avenue and Richmond Court

Description: Wetland areas receiving upstream stormwater discharges.

Potential Improvements: Enhancements to the existing wetlands to provide more saturation and reduce ditched conditions that may exist in the complex. An assessment of the water quality leaving the wetland complex and the quality of the existing wetland vegetation should be assessed to determine the need for alterations.

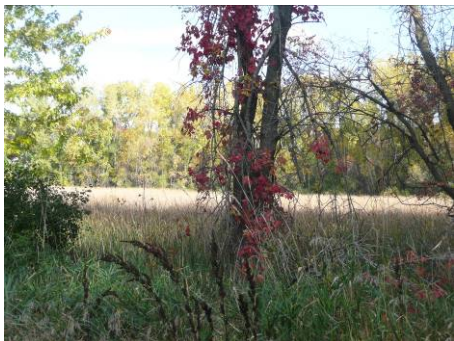
Johanna #2

Location: Northeast of the intersection of Edgewater Avenue and Ridgewood Road

Potential Improvements: Potential excavation/cattail removal. Assess the current water quality treatment being provided by the basin and assess options for improvement if warranted.

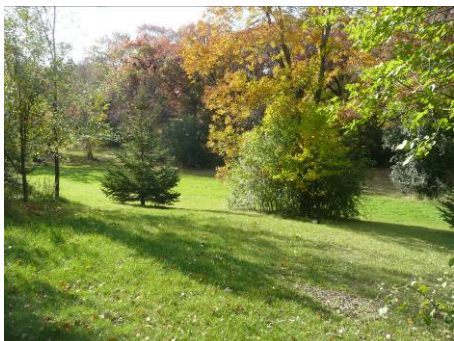
Johanna #3

Location: North of County Road E and west of Oak Avenue

Description: Low open area at the corner

Potential Improvements: Use for treatment of adjacent roadways.

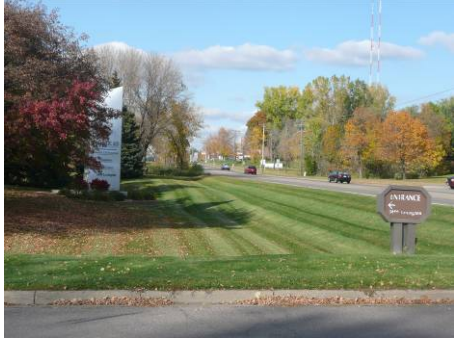
Johanna #4

Location: North of Harriet Avenue and west of Lexington Avenue

Description: Mowed swale area

Potential Improvements: Use and enhance to provide treatment for adjacent business and/or roadway.

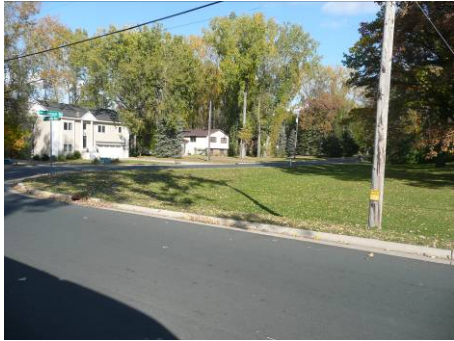
Johanna #5

Location: South of Ingerson Road and east of Hamline Avenue

Description: Open green space at the corner

Potential Improvements: Incorporate large raingarden to provide treatment for adjacent roadways.

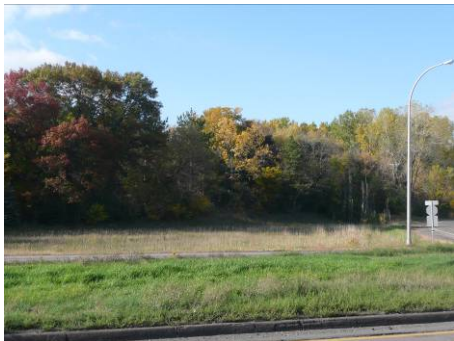
Johanna #6

Location: West of Snelling Avenue and north of Hamline Avenue

Potential Improvements: Use for wetland treatment or ponding for Snelling Avenue.

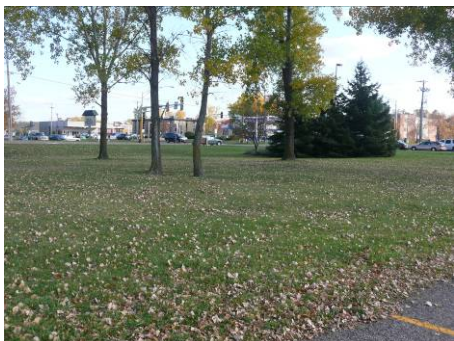
Johanna #7

Location: North of County Road E and west of Lexington Avenue

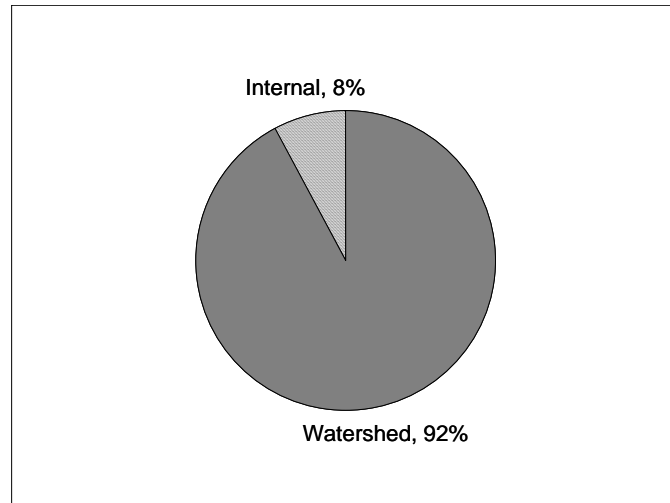
Figure 3. Jones Lake Phosphorus Load Distribution

In 2001, RCWD undertook a phosphorus budget study of Jones Lake, which concluded that Jones Lake was capturing approximately 13% of the TP entering it. The study noted the dense plant growth in the lake, with even the open water areas having almost complete coverage from the dense amount of submerged macrophytes.

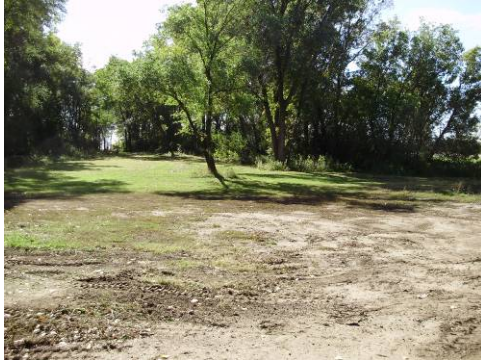
Jones Lake #1

Location: North of County Road D and west of Cleveland Avenue

Description: Large open area south of an apartment complex

Potential Improvements: Area could be used for a significantly sized feature depending on the drainage area that could be routed to this area.

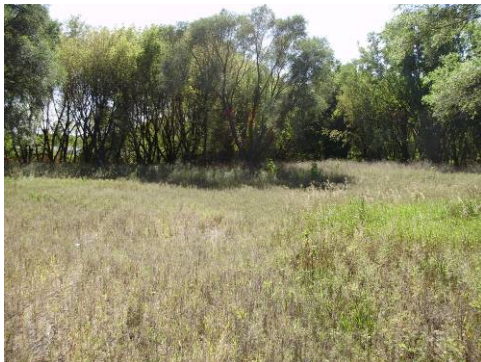
Jones Lake #2

Location: South of County Road D and west of New Brighton Blvd

Description: Large open/wooded area with drainage running southeast under New Brighton Blvd.

Potential Improvements: Create regional treatment feature for drainage area west of this location. An assessment of grades and routing would be required.

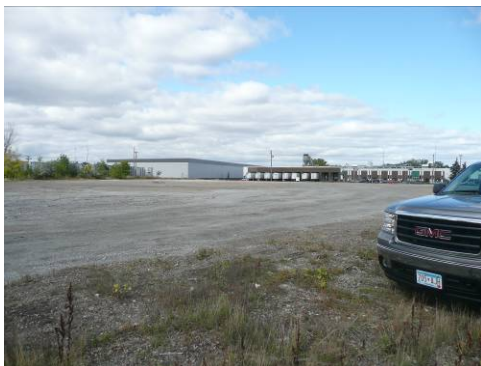
Jones Lake #3

Location: South of Terminal Road and west of railroad tracks

Potential Improvements: A large treatment area could be incorporated here to serve untreated industrial areas. Further assessment of the drainage area that could be routed to this location would be required.

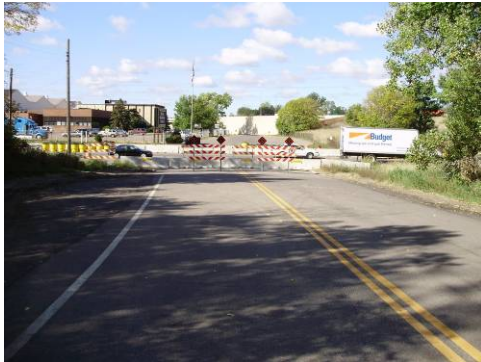
Jones Lake #4

Location: County Road B and TH 280

Description: Road closed off due to TH 280 expansion

Potential Improvements: If County Road B and TH 280 will no longer be connected, this area could be converted to a stormwater BMP

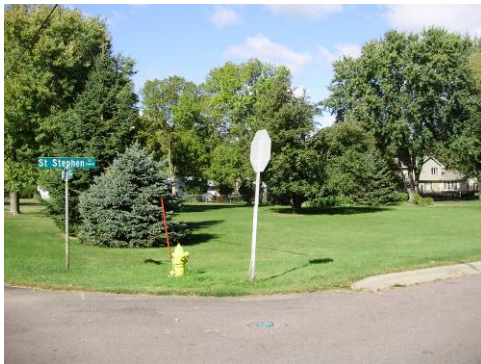
Jones Lake #5

Location: North of County Road B and west of Saint Stephen Street

Description: Open corner lot

Potential Improvements: Route road runoff to this area and provide treatment

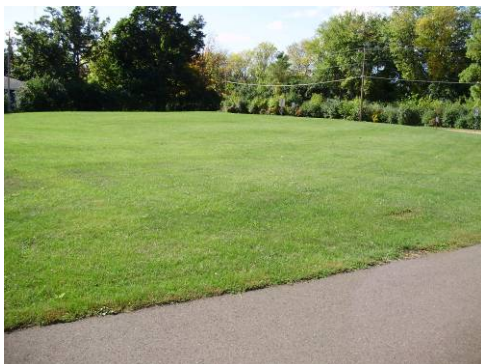
Jones Lake #6

Location: South of County Road B and east of Cleveland Avenue

Description: Large open green space with no apparent current use

Potential Improvements: Use this area to treat adjacent roads. The site sits higher than roads so additional excavation would be required if this site were to be used.

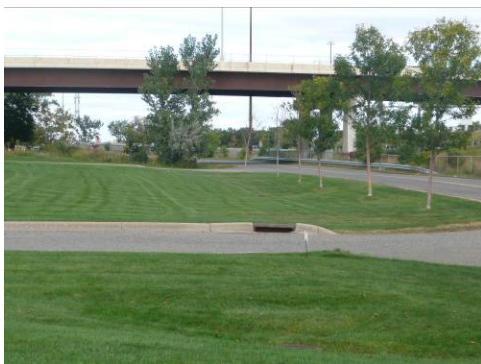
Jones Lake #7

Location: West side of Rosegate and south of County Road B2

Description: Large grass swales along Rosegate with catch basins at the bottom

Potential Improvements: Convert into treatment areas to provide storage/infiltration

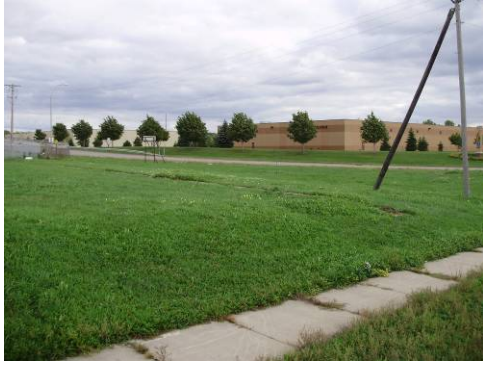
Jones Lake #8

Location: East of Long Lake Road and north of County Road B2

Description: Green space at the corner

Potential Improvements: Incorporate infiltration/water quality treatment BMP to treat roads or the adjacent business

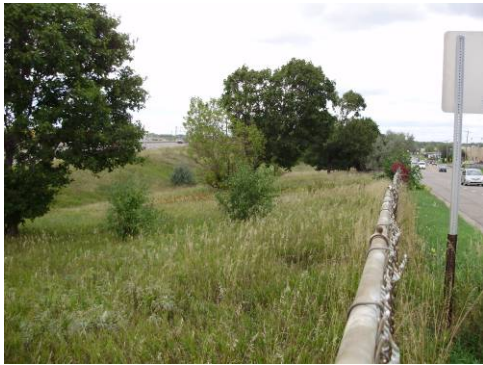
Jones Lake #9

Location: West of the intersection of Oakcrest Avenue and Cleveland Avenue

Description: Triangular open space between 35W and Cleveland Avenue

Potential Improvements: Potentially incorporate large treatment area. Would need to assess what areas could be routed to this area.

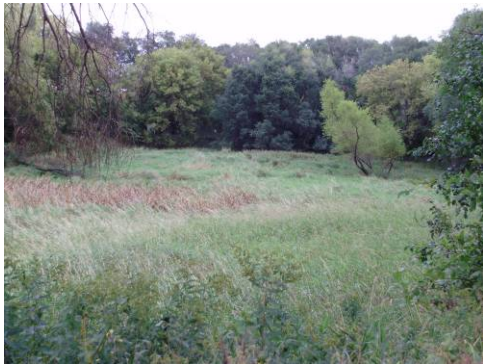
Jones Lake #10

Location: East of Cleveland Avenue and South of Brenner Avenue

Description: Low wetland area

Potential Improvements: Enhance wetland to provide additional water quality treatment. Would need assessment to evaluate need, the quality of the wetland, and what could be routed to it.

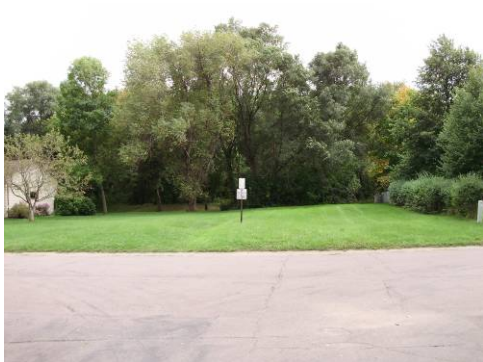
Jones Lake #11

Location: South of the intersection of Brenner Avenue and Mount Ridge Road

Description: Green space that could be used to treat adjacent roads

Potential Improvements: Infiltration or ponding feature.

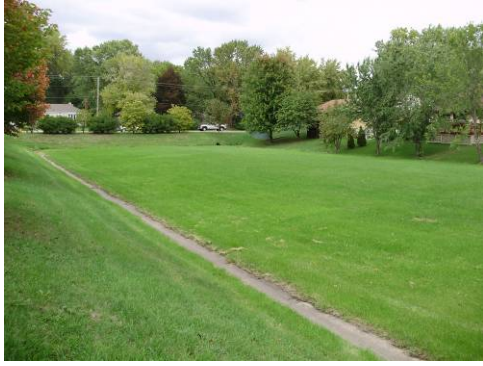
Jones Lake #12

Location: South of County Road D and east of Mount Ridge Road

Description: Large dry pond

Potential Improvements: Retrofit to provide infiltration or water quality storage.

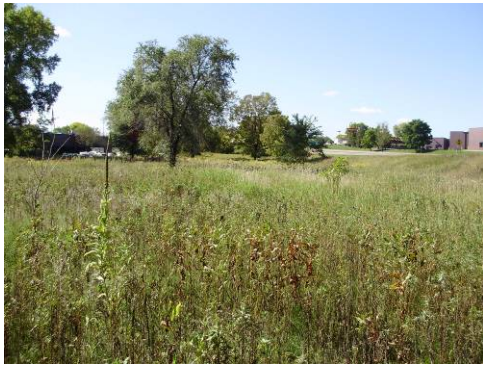
Jones Lake #13

Location: North of County Road D and west of New Brighton Blvd

Description: Large open area

Potential Improvements: Use area to treat New Brighton road and/or adjacent businesses.

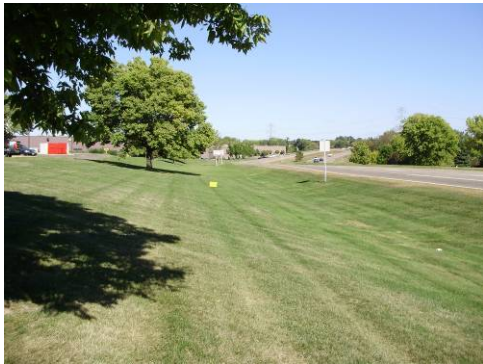
Jones Lake #14

Location: West side of New Brighton Blvd and north of County Road D

Description: Large grass swale areas

Potential Improvements: Could easily be enhanced to provide additional treatment and infiltration.

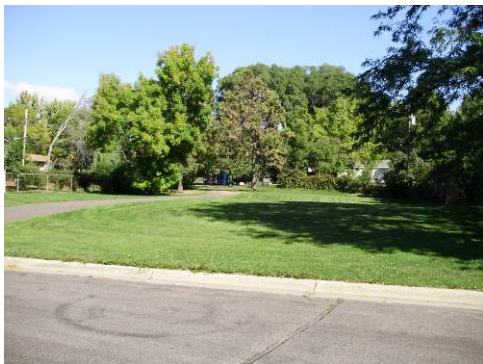
Jones Lake #15

Location: North of the intersection of Manson Street and Stanbridge Street

Description: Green space next to trail

Potential Improvements: Incorporate raingarden

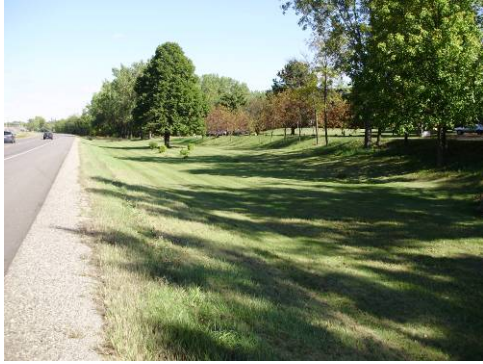
Jones Lake #16

Location: North of County Road C2 and east of New Brighton Blvd

Description: Large grass swale area

Potential Improvements: Could be enhanced to provide additional treatment.

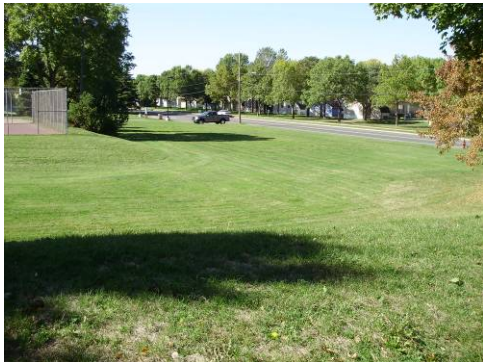
Jones Lake #17

Location: South of Foss Road and west of 9th Avenue

Description: Low green space

Potential Improvements: Retrofit to provide treatment for adjacent roads.

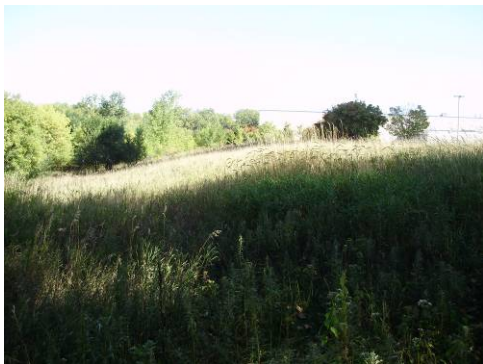
Jones Lake #18

Location: North of 5th Street and east of Old Highway 8

Description: Open space behind water tower

Potential Improvements: Use area to treat adjacent untreated industrial areas. Would need to assess adjacent drainage area to evaluate what could be routed here.

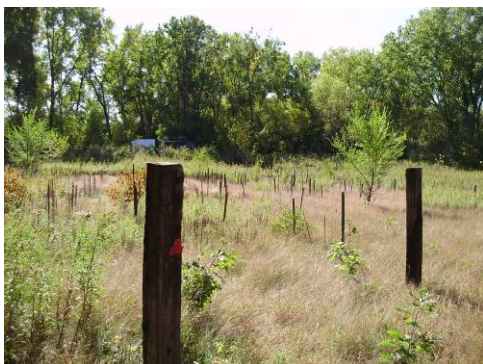
Jones Lake #19

Location: East side of Jones Lake

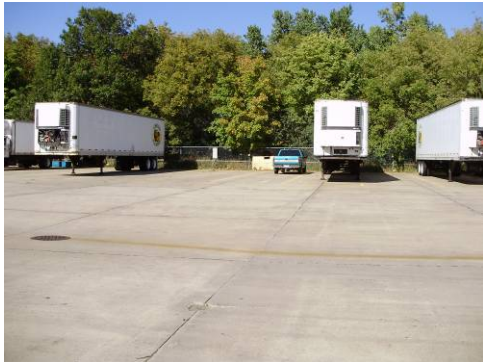
Jones Lake #20

Location: North of Lakeview Point Drive just south of Jones Lake

Description: Large amounts of impervious area routed directly to Jones Lake

Potential Improvements: Remove some impervious area and install treatment features or incorporate underground treatment devices.

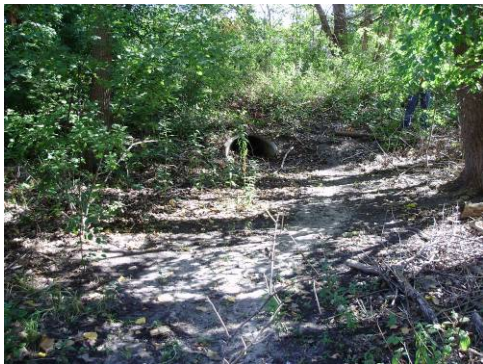
Jones Lake #21

Location: North of County Road D and west of New Brighton Blvd

Description: Large amounts of impervious areas from warehouse site routed through wooded area directly into culvert with no treatment.

Potential Improvements: Plenty of room to incorporate wetland treatment or an infiltration feature depending on site soils.

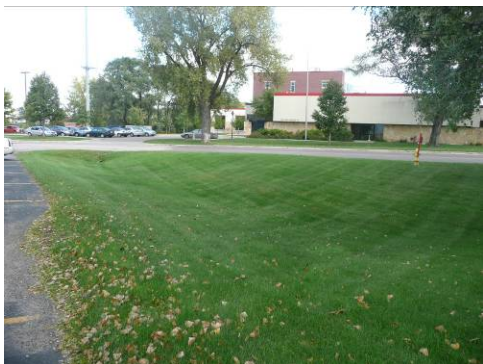
Jones Lake #22

Location: West of St. Croix Street and North of Frontage (north of I-35W)

Description: Grass swale to pipe outlet

Potential Improvements: Easy retrofit into raingarden area for adjacent business.

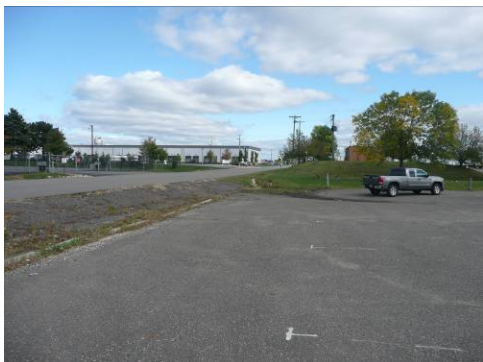
Jones Lake #23

Location: West of Walnut Street and south of Terminal Road

Description: Large parking lot routed directly to piped outlet. Area in front of pipe has been collecting sediment with vegetation growing.

Potential Improvements: Remove this corner of flood-prone parking and incorporate a ponding or infiltration feature.

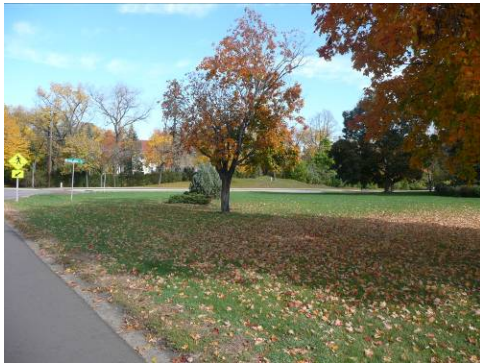
Josephine #1

Location: South of Josephine Road and east of Hamline Avenue

Description: Large openspace at church

Potential Improvements: Use area for treatment of church or adjacent roads.

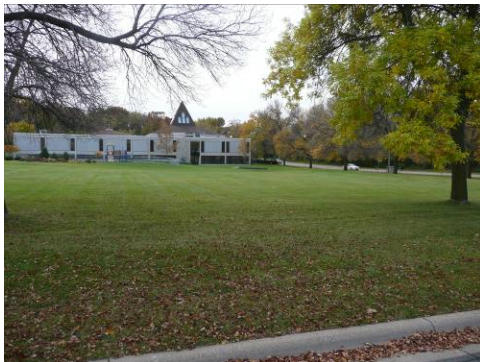
Josephine #3

Location: South of Cannon Avenue and east of Lexington Avenue

Description: Large dry pond on church lot

Potential Improvements: Retrofit to provide infiltration / water quality treatment.

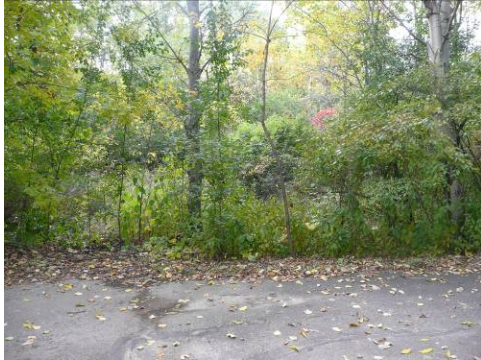
Karth #1

Location: South end of Karth Lake

Description: Low wooded area that could be used to treat the large manufacturing business south of lake. There is room to incorporate a good sized feature, which would be needed for that large amount of impervious draining to this location.

Potential Improvements: Incorporate ponding, infiltration, or wetland treatment depending on soils and water table.

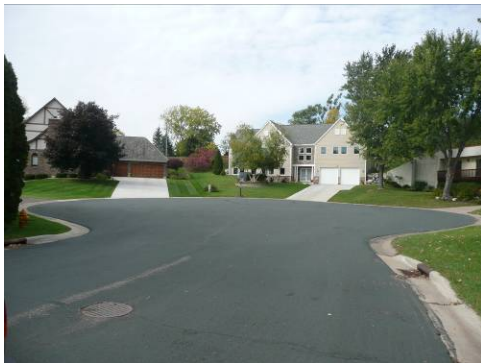
Karth #2

Location: Cul-de-sac at the end of Karth Lake Drive

Description: Catch basins drain directly to lake

Potential Improvements: Incorporate island with treatment in cul-de-sac to treat adjacent impervious.

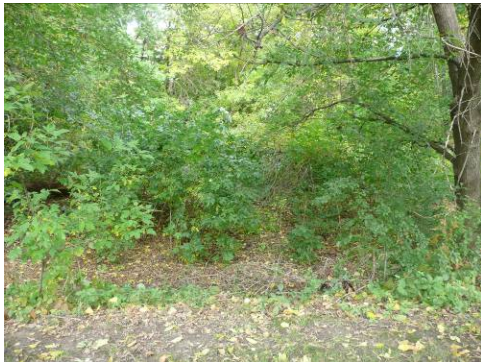
Karth #3

Location: North of Nursery Hill Court and west of Dellwood Street

Description: Low wooded wetland area

Potential Improvements: Incorporate treatment for adjacent roads (would need to assess current quality and function of the wetland)

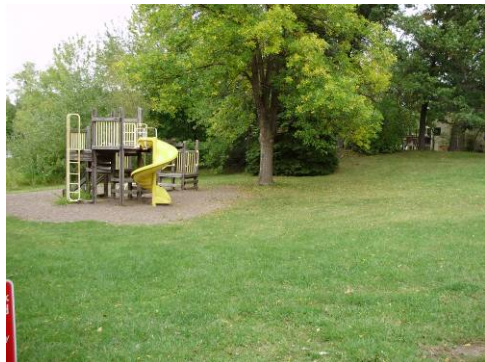
Langton #1

Location: West of Arthur Place and north of County Road C2

Description: Playground area on the east side of Langton Lake Park.

Potential Improvements: Coordinate with Roseville Parks & Rec to incorporate water quality BMP at the location of the playground equipment. Capture adjacent parking and street runoff. Move playground equipment to the east on higher ground.

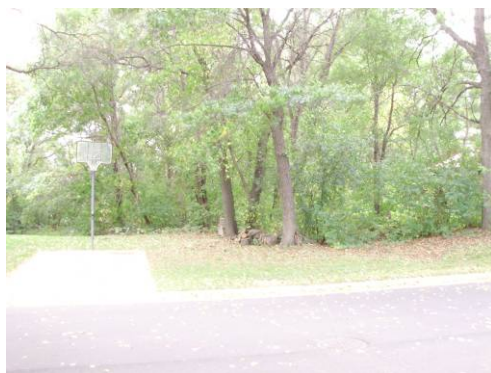
Langton #2

Location: Brenner Avenue just north of Langton Lake

Description: Open area currently being used as small basketball court.

Potential Improvements: Coordinate with Roseville Parks & Rec., consider this area for treatment of street runoff prior to discharge to lake. An assessment would need to be made with respect to how much drainage area could be routed to this location.

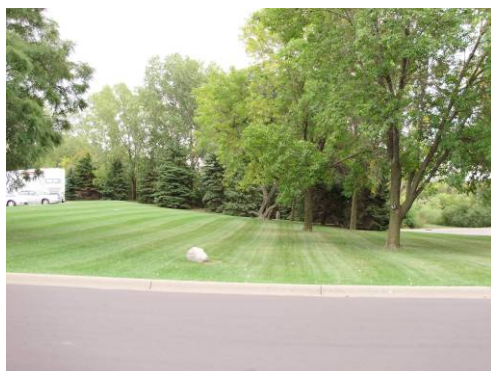
Langton #3

Location: Industrial area west of Langton Lake and north of County Road C2

Description: Open space with trees just north of County Road C2.

Potential Improvements: Coordinate with Roseville Parks & Rec and private landowner. Consider tree remove tree and excavation of large filtration or ponding. This location could potentially pick up a large amount of impervious area from the adjacent roads and industrial sites.

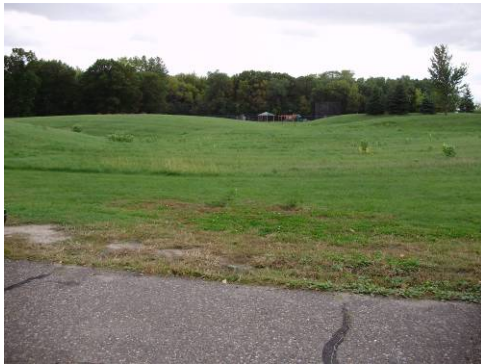
Langton #5

Location: Eagle Crest at the corner of Brenner Avenue and Arthur Street

Description: Open area with swale currently receiving parking runoff

Potential Improvements: Swale could be enhanced to provide more treatment / depressional storage prior to discharge to the lake.

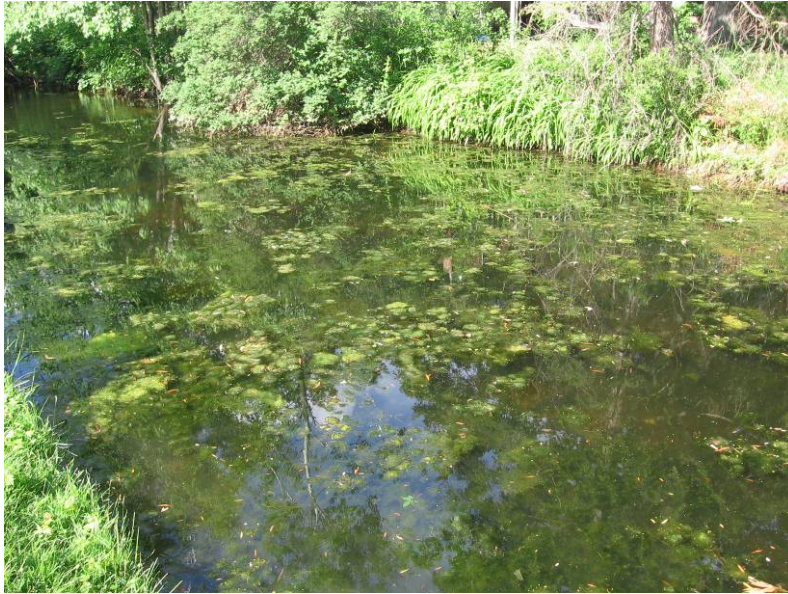
Figure 7. Dense algae mats in the Little Lake Johanna outlet on June 29, 2008.

- Finally, residents would like some attention placed on fish management. Nuisance rough fish are currently a problem.

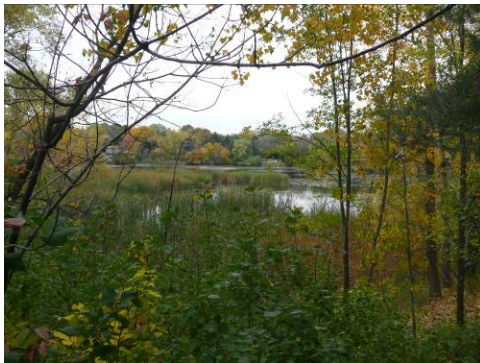
Little Johanna #2

Potential Improvements: Retrofit to provide additional infiltration/filtration for small storm events. Convert to native vegetation and get low flows out of the concrete flume.

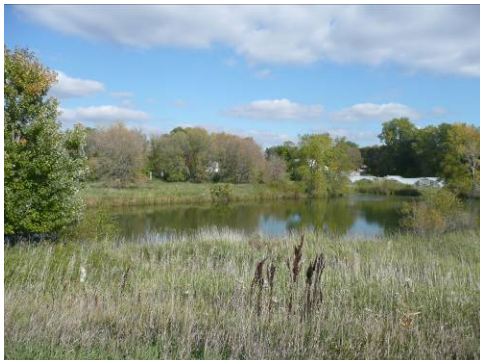
Little Johanna #3

Potential Improvements: Reroute inlet to reduce short circuiting; maintenance of sheetpile weir outlet. The sheet piling has some holes in it that were plugged but have rusted out, allowing water to pass at a lower-than-intended elevation.

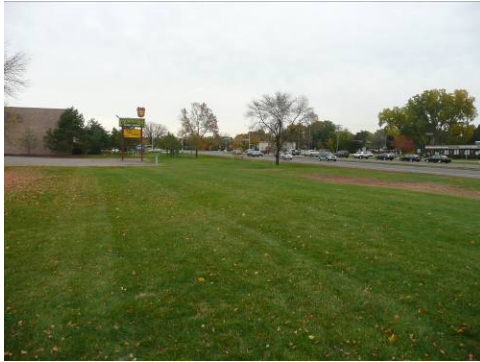
Little Johanna #4

Location: West of Snelling Avenue and south of County Road C2

Description: Green space

Potential Improvements: Use for infiltration/biofiltration features to treat adjacent drives/parking.

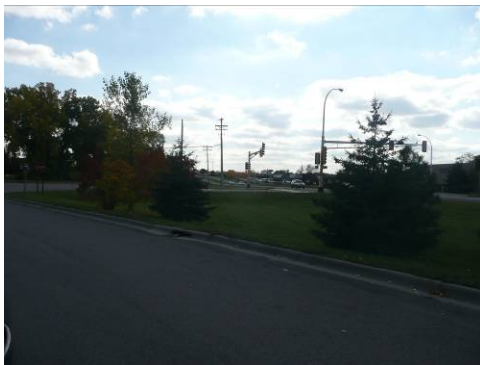
Little Johanna #5

Location: East of Snelling Avenue and north of County Road C2

Description: Green space

Potential Improvements: Use for treatment of Snelling Avenue. Note: There are several green space areas that appear to have the potential to be better used for treatment.

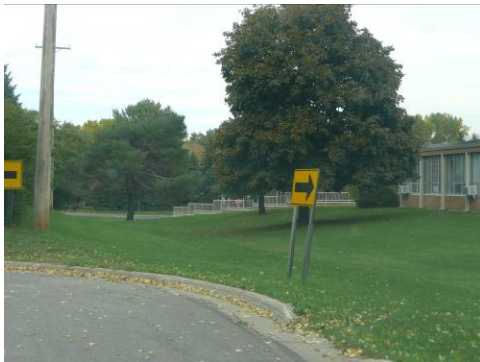
Little Johanna #6

Location: North of the intersection of Sharondale Avenue and Prior Avenue

Description: Swale area

Potential Improvements: Convert to raingarden.

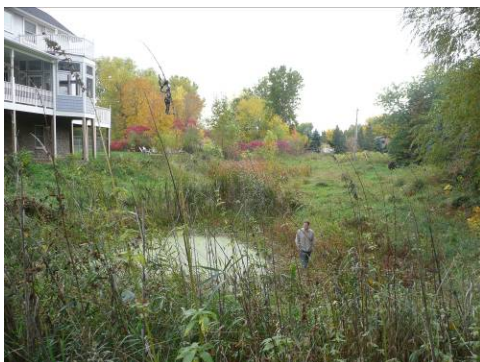
Little Johanna #7

Location: South of Gluek Lane N

Description: Low areas adjacent and behind homes in this neighborhood. Stormwater from Gluek Lane appears to be routed directly to stormsewer and does not use these low areas.

Potential Improvements: Consider retrofits to provide treatment for Gluek Lane.

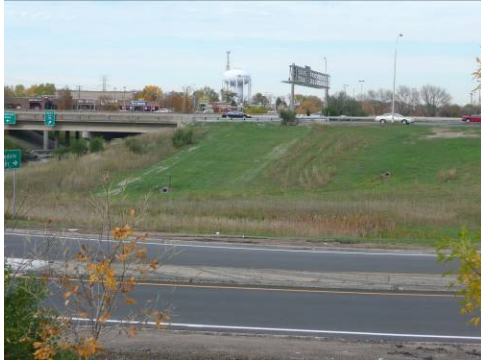
Little Johanna #8

Location: Intersection of Highway 36 and Fairview Avenue

Description: Green space in ramp loops

Potential Improvements: All three loops at this location could potentially be better used for treatment of adjacent roadways.

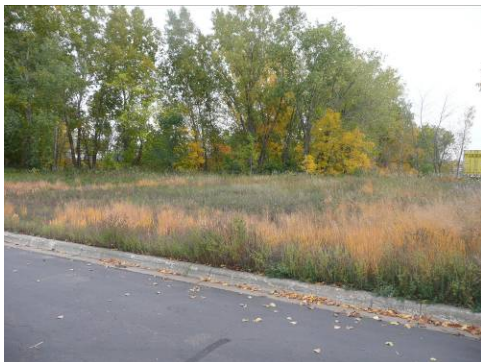
Little Johanna #10

Location: East of Fairview Avenue and south of Terrace Drive

Description: Open space adjacent to parking areas

Potential Improvements: Use for area infiltration or biofiltration feature to treat adjacent parking.

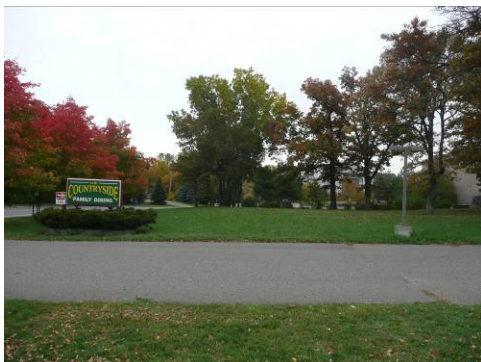
Little Johanna #11

Location: East of Lincoln Drive and south of County Road C2

Description: Green space

Potential Improvements: Use for infiltration/ biofiltration features to treat adjacent drives/parking.

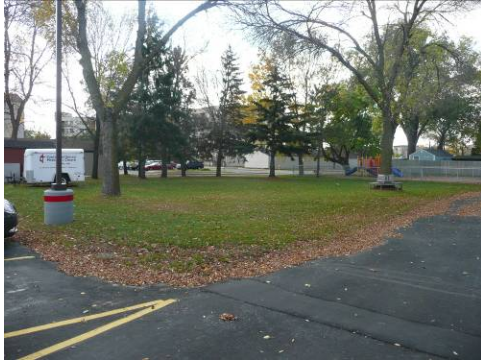
Little Johanna #12

Location: East of Snelling Avenue and south of County Road C2

Description: Green space adjacent to church parking lot

Potential Improvements: Incorporate infiltration or biofiltration feature for treatment of church parking lot.

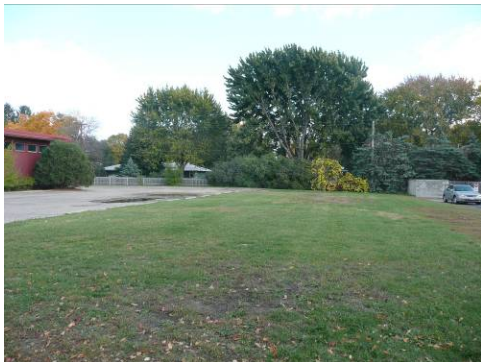
Little Johanna #13

Location: East of Snelling Drive and south of Lydia Avenue

Description: Green space adjacent to parking.

Potential Improvements: Incorporate raingarden areas to treat adjacent parking.

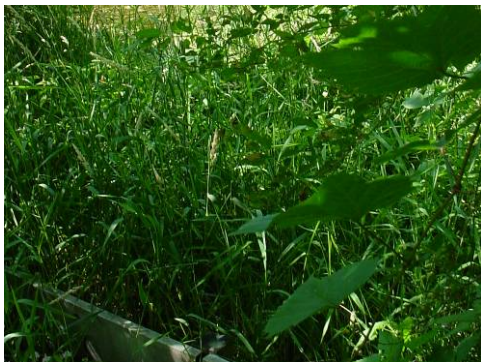
Little Johanna #14

Location: South of Lydia Avenue and west of Lincoln Drive on the Presbyterian Homes property.

Description: A small detention pond on the SW side of the Presbyterian Homes looks as though it drains a portion of the parking lot for the home and possibly the street.

Potential Improvements: Retrofit existing pond, but only a small amount of local storage would likely result.

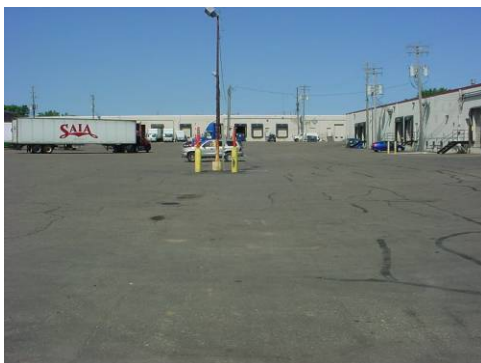
Little Johanna #15

Location: SALA truck/loading facility just south of Terrace Drive

Description: Runoff from the entire lot drains to some lot inlets and a surface pipe at the RCD 4 ditch bank.

Potential Improvements: Incorporation of a proprietary treatment device that both settles solids and adsorbs hydrocarbons.

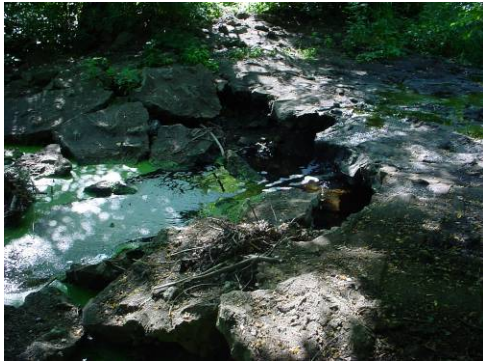
Little Johanna #18

Potential Improvements: Outfall stabilization with reinforcement (ex. rip-rap, concrete, blocks) between the outlet and the channel; also the pipe itself should be supported so that it does not collapse. Roseville noted it will address this stability issue.

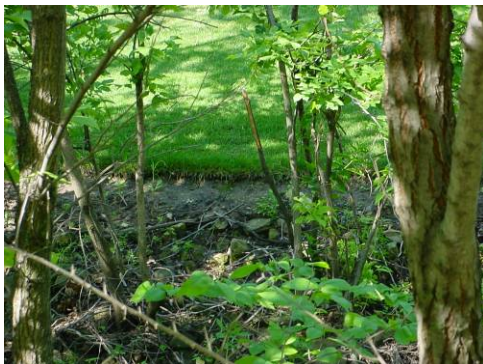
Little Johanna #19

Potential Improvements: Stabilize with additional rock and/or concrete repair to stop undercutting and movement upstream.

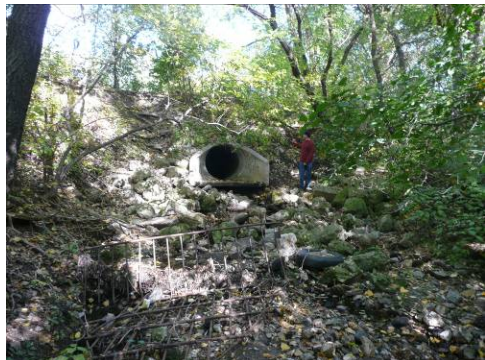
Little Josephine #1

Location: South of the intersection of Brenner Avenue and Churchill Street

Description: Large piped outlet that flows through woods and then into Little Josephine Lake.

Potential Improvements: Install wetland treatment ponding between outfall and Little Josephine Lake.

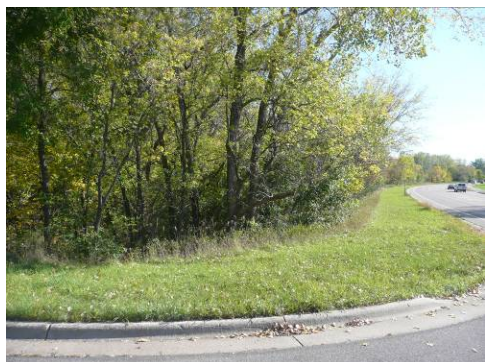
Little Josephine #2

Location: South of County Road C2 and east of Lexington Avenue

Description: Low wooded area

Potential Improvements: Use for treatment of the neighborhood to the west and County Road C2.

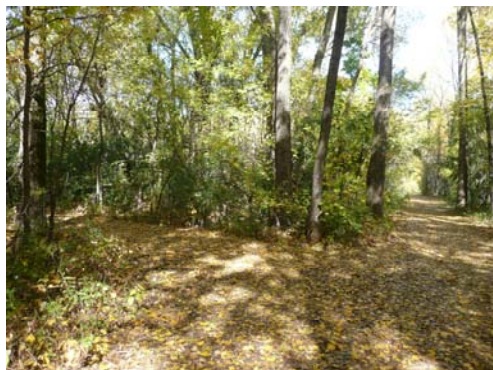
Little Josephine #3

Location: Cottontail Park

Potential Improvements: Daylight and provide treatment within Cottontail park or open space east of the park. The depth of this trunk line has not been investigated and will have significant effects on the feasibility and cost of this potential project.

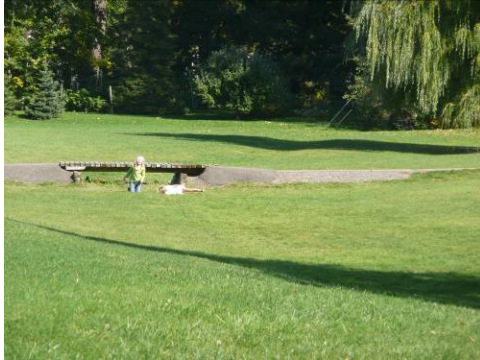
Little Josephine #4

Location: North of County Road D and east of Richmond Avenue

Description: Swale running through school property. Swale receives runoff from adjacent neighborhood.

Potential Improvements: Convert swale into a series of raingardens.

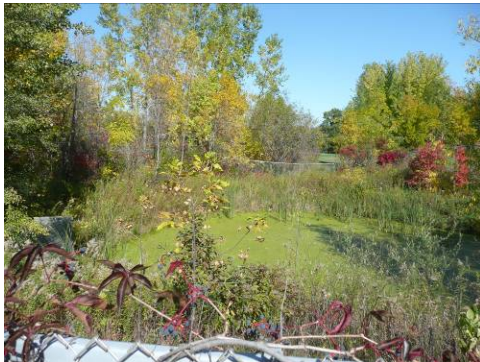
Little Josephine #5

Location: North of County Road D and east of Richmond Avenue

Description: Pond at the end of the swale (#4) appears to be undersized.

Potential Improvements: Expand pond (however it would seem to make sense to explore Little Josephine #4 first).

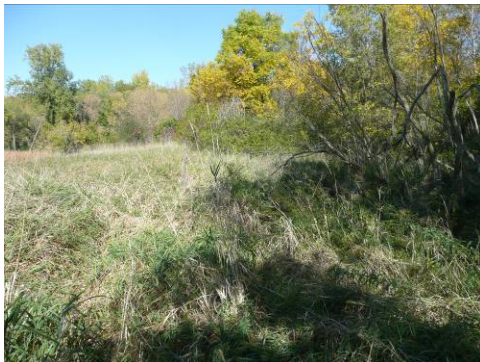
Little Josephine #6

Location: West of the intersection of Chatsworth Street North and Millwood Avenue

Description: Stormsewer outflow swaled to lake

Potential Improvements: Incorporate wetland treatment feature at outlet

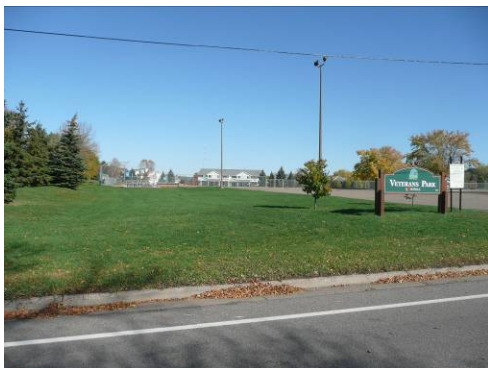
Little Josephine #7

Location: North of Woodhill Drive and east of Griggs Street

Description: Open green space adjacent to Veterans Park parking lot and VFW

Potential Improvements: Use area for volume control/infiltration BMP. (This area is routed to a treatment pond.)

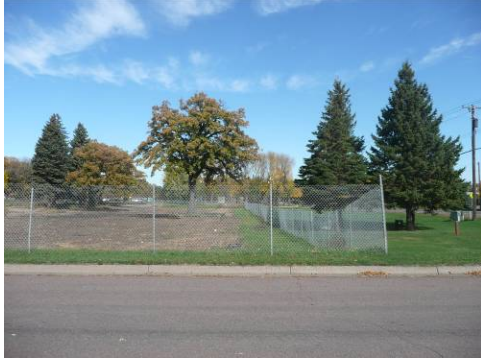
Little Josephine #8

Location: North of Millwood Avenue and west of Hamline Avenue

Description: Vacant Lot (redeveloping)

Potential Improvements: Use part of lot to provide treatment for adjacent roads / neighbor hood areas.

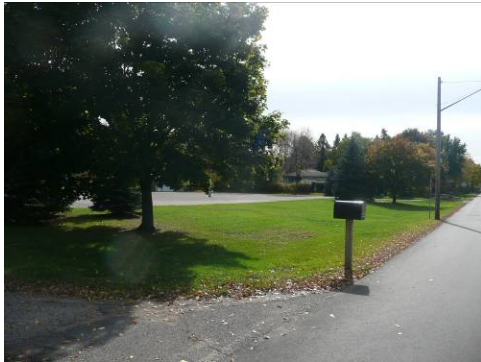
Little Josephine #9

Location: East of Hamline Avenue and south of Lydia Avenue

Description: Catch basin at the bottom of green space area

Potential Improvements: Retrofit to provide infiltration and better treatment.

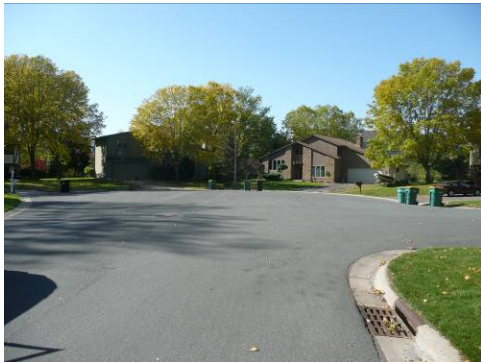
Little Josephine #10

Location: Intersection of Glen Paul Court and Churchill Street

Potential Improvements: Incorporate center island and provide infiltration/treatment for adjacent impervious.

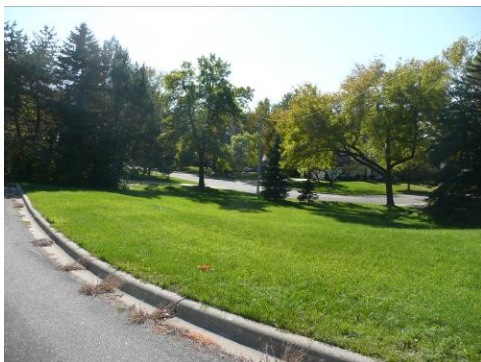
Little Josephine #11

Location: North of Woodlynn Avenue and east of Milton Street

Description: Open green space adjacent to parking lot

Potential Improvements: Use area for treatment of parking lot.

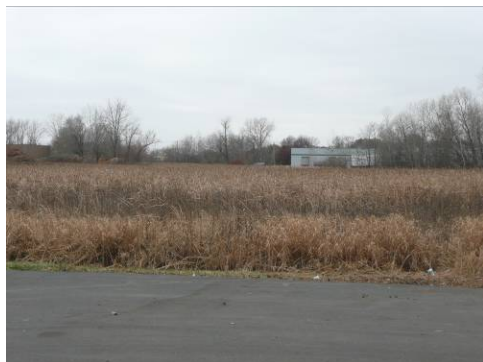
Locke 1

Location: East of Old Central Avenue and north of 81st Avenue

Potential Improvements: Create wetland treatment/ponding area to provide treatment for stormsewer flows.

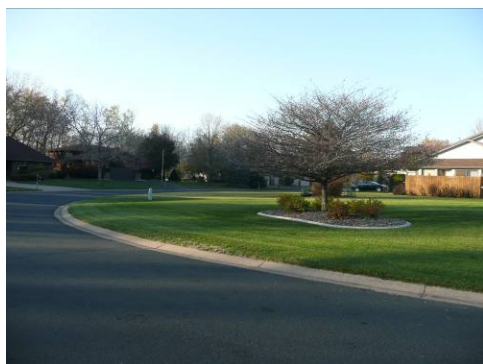
Locke 3

Location: West of Hayes Street and north of 80th Avenue

Description: Green space on corner

Potential Improvements: Incorporation of a large raingarden for treatment of adjacent roadways.

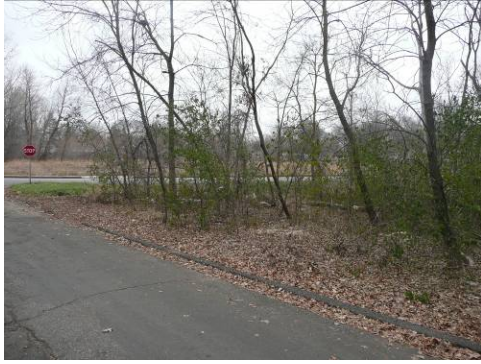
Locke 4

Location: West of Silver Lake Road and south of Woodcrest Drive

Description: Open space/small trees on corner

Potential Improvements: Incorporation of a large raingarden to treat street runoff.

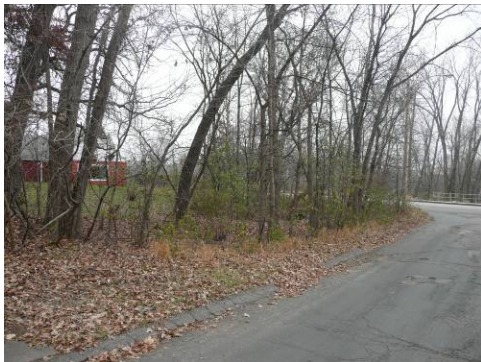
Locke 5

Location: West of Silver Lake Road and north of Woodcrest Drive

Description: Open space/small trees on corner

Potential Improvements: Incorporation of a large raingarden to treat street runoff.

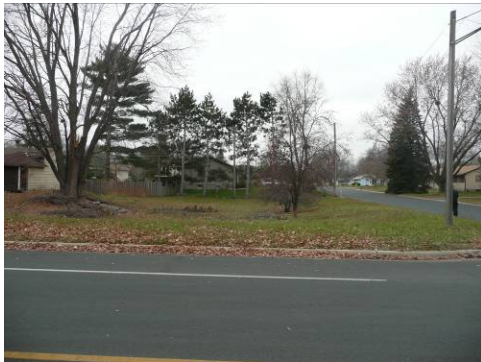
Locke 6

Location: West of Stinson Boulevard and south of Onondaga Street

Description: Open low area at the corner.

Potential Improvements: Incorporation of infiltration basin or ponding area for treatment of adjacent roadways.

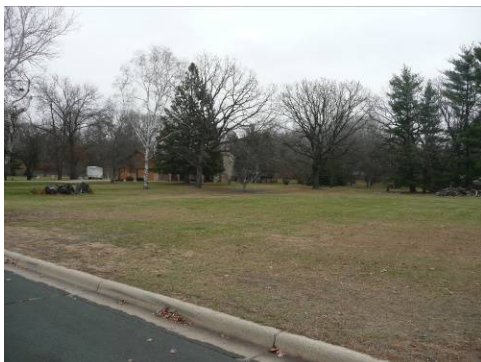
Locke 7

Location: East of the intersection of Arthur Street and 76th Avenue

Description: Large vacant lot.

Potential Improvements: Utilize area for treatment of adjacent roadways.

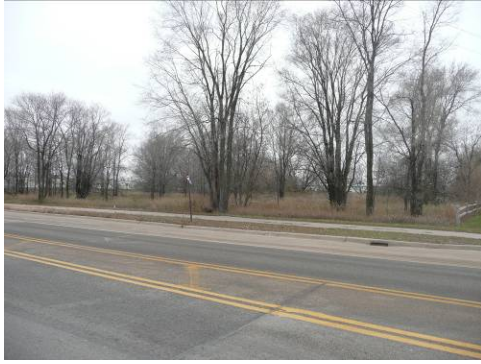
Locke 8

Location: West of Old Central Avenue and south of 76th Avenue

Description: Large vacant lot adjacent to industrial areas.

Potential Improvements: Utilize for a large treatment basin for Old Central Avenue and or adjacent industrial sites.

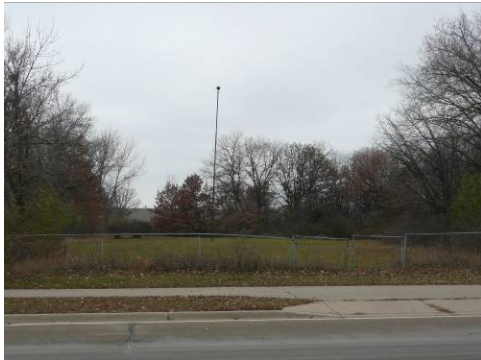
Locke 9

Location: West of Old Central Avenue and north of Lakeview Lane

Description: Large vacant lot adjacent to industrial and residential areas.

Potential Improvements: Utilize for a large treatment basin for Old Central Avenue and or adjacent impervious areas.

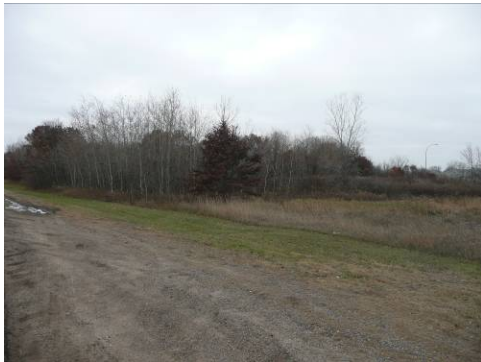
Locke 10

Location: East of Old Central Avenue and north of 81st Avenue

Description: Large open and wooded areas (current use unknown)

Potential Improvements: Utilize for treatment of adjacent highway and/or adjacent industrial park.

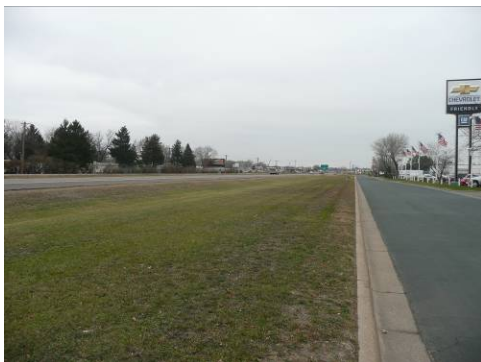
Locke 11

Location: North of Fireside Drive and east of Highway 65

Description: Example of large swales along Highway 65 providing treatment.

Potential Improvements: Maintain and or enhance rural section drainage.

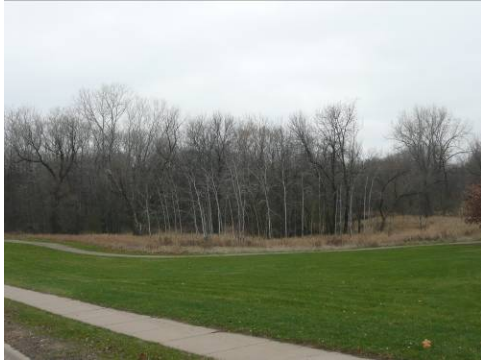
Locke 12

Location: North of the intersection of Mississippi Street and Mississippi Circle

Description: Green space between Mississippi Street and existing trail.

Potential Improvements: Incorporate raingarden area for treatment of a portion of Mississippi Street.

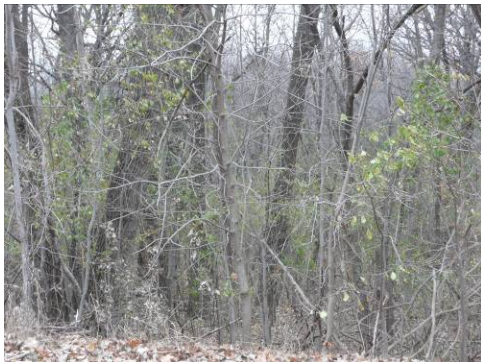
Locke 13

Location: North of Mississippi Street and east of Violet Lane

Description: Wooded area west of the creek.

Potential Improvements: Route stormsewer to this area and construct a wetland treatment area.

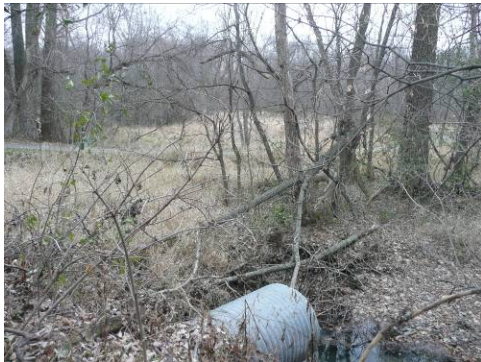
Locke 14

Location: South of the intersection of Anoka Street and Timber Ridge South

Description: Stormsewer discharge from Timber Ridge Condos and Rice Creek Condos routed directly into Rice Creek.

Potential Improvements: Reroute outlet into existing wetland area and eliminate direct connection to creek. The quality of the existing wetland and potential impacts from stormsewer discharges would need to be assessed before rerouting/reconfiguring the system.

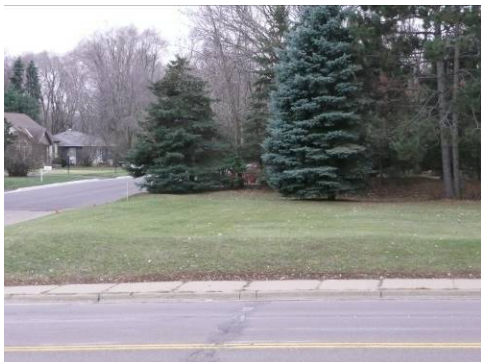
Locke 15

Location: South of Mississippi Street and west of Ashton Avenue

Description: Open green space at the corner.

Potential Improvements: Utilize for treatment of adjacent roadways with a large raingarden.

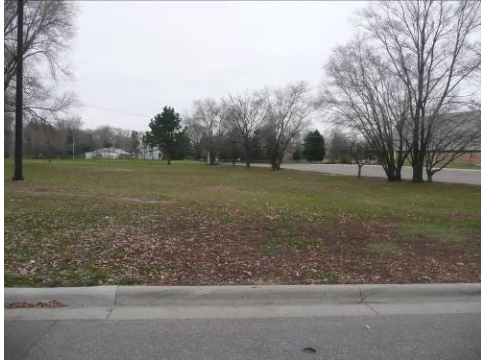
Locke 16

Location: South of 66 ½ Way and west of Ashton Avenue

Description: Open space adjacent to an existing church.

Potential Improvements: Utilize area for treatment of the church parking lot or the adjacent roadways.
