Prepared by:
Emmons & Olivier Resources, Inc.
for the Rice Creek Watershed District

Southwest Urban Lakes Study

April 2009

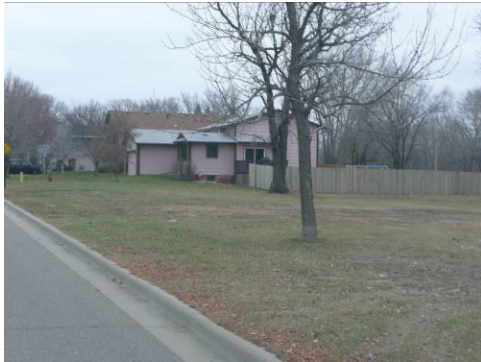
Locke 17

Location: East of Ashton Avenue and north of 66th Way

Description: Open space within Edgewater Gardens Park

Potential Improvements: Incorporate raingardens along right-of-way to treat Ashton Avenue.

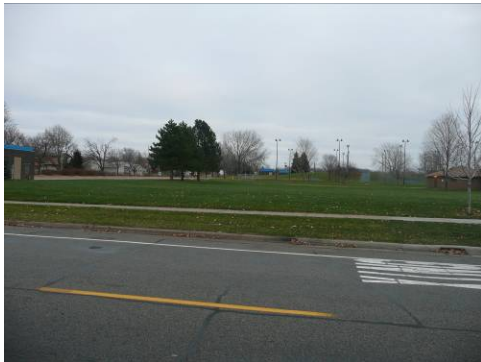
Locke 18

Location: East of 7th Street and south of 63rd Avenue

Description: Large open space located within Commons Park

Potential Improvements: Incorporate treatment features for adjacent parking lot and/or 7th Avenue.

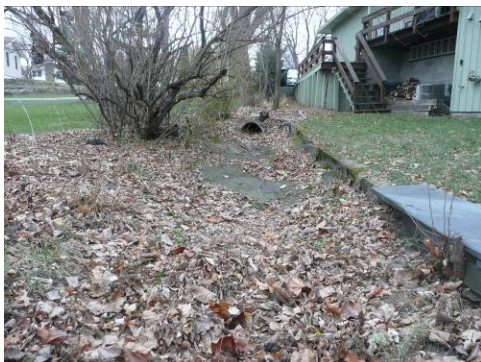
Locke 19

Location: North of the cul-de-sac at the end of Thorndale Avenue

Description: Stormsewer outlet discharging through swale along lot line into Rice Creek

Potential Improvements: Create a linear treatment feature along the lot line prior to discharge to Rice Creek.

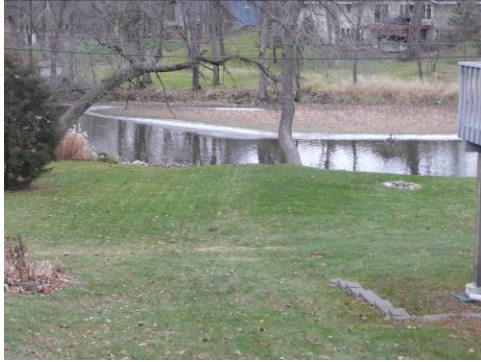
Locke 20

Location: North of Mound Avenue and west of Thorndale Avenue

Description: Stormsewer pipe running along lot line and discharging into Rice Creek

Potential Improvements: Daylight stormsewer discharge and create a raingarden providing treatment prior to discharge to Rice Creek.

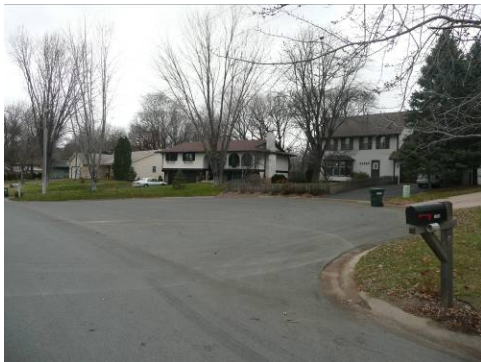
Locke 21

Location: North of Rice Creek Terrace and east of Pleasant View Drive

Description: Unnecessary impervious area

Potential Improvements: Extend driveways to road and use remaining area for creation of raingardens to treat adjacent roadway.

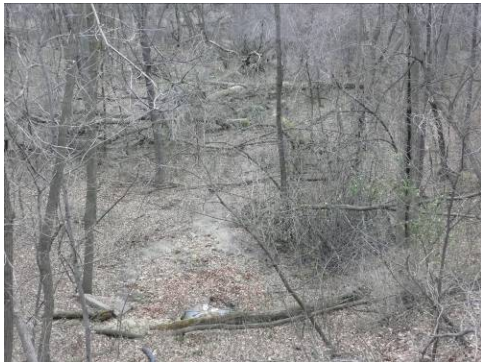
Locke 22

Location: North of the intersection of Stinson Boulevard and 66 1/2 Avenue

Description: Stormsewer outfall discharging in woods flowing into Rice Creek

Potential Improvements: Create wetland treatment/ponding areas at stormsewer outfall.

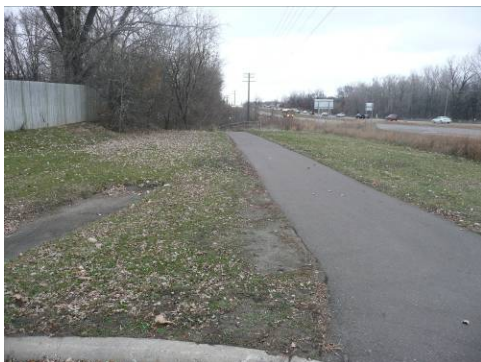
Locke 23

Location: North of the intersection of Brookview Drive Rice Creek Terrace

Potential Improvements: Convert area into a raingarden.

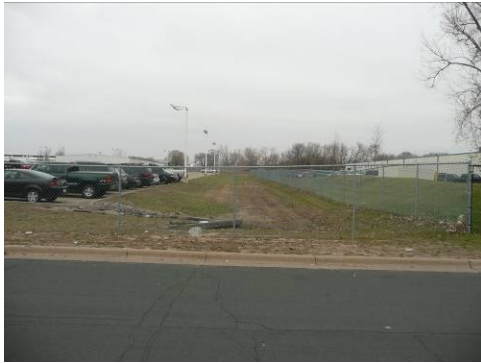
Locke 24

Location: North of Fireside Drive and west of Old Central Avenue

Description: Existing treatment facility adjacent to Fridley Chevrolet parking lot. Appears that the feature may provide rate control but limited water quality benefit.

Potential Improvements: Feature could be enhanced to provide additional infiltration and water quality treatment.

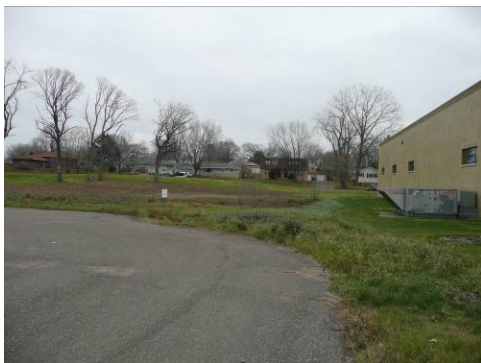
Locke 25

Location: West of Main Street and south of Rice Creek Terrace

Potential Improvements: Enhance/retrofit low area and utilize for treatment of adjacent building.

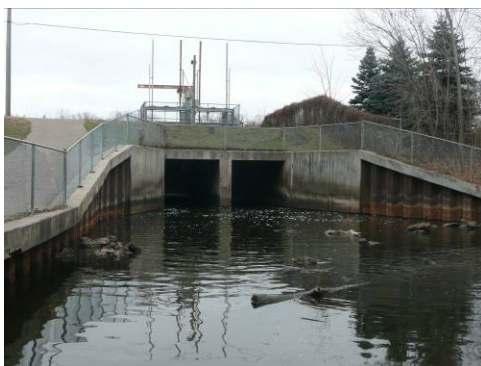
Locke 26

Location: Locke Lake Outlet

Description: Dam controlling water levels in Locke Lake. The dam is an obstruction to natural fish migration upstream.

Potential Improvements: Consider reestablishment of fish passage from the Mississippi into Locke Lake and Rice Creek. Establish a smallmouth fishery in the lower stretch of Rice Creek. The pros and cons of allowing Mississippi River fish (game and rough) to migrate upstream would need to be considered before proceeding with any studies/assessments.

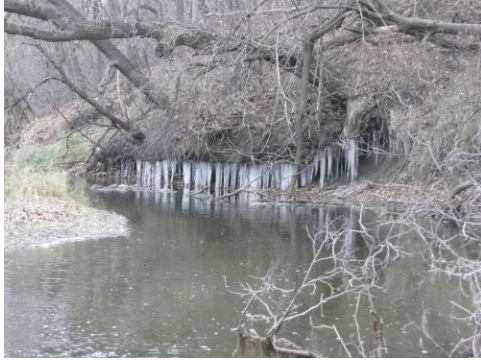
Locke 27

Location: Rice Creek South of Timber Ridge South

Description: Ground water seepage beneath an undercut bank. Just one example of a failing bank along Rice Creek.

Potential Improvements: Incorporate bank stabilization for areas along Rice Creek with severe bank erosion. Continue to reduce rates and flows from upstream sources that are the cause accelerated bank erosion.

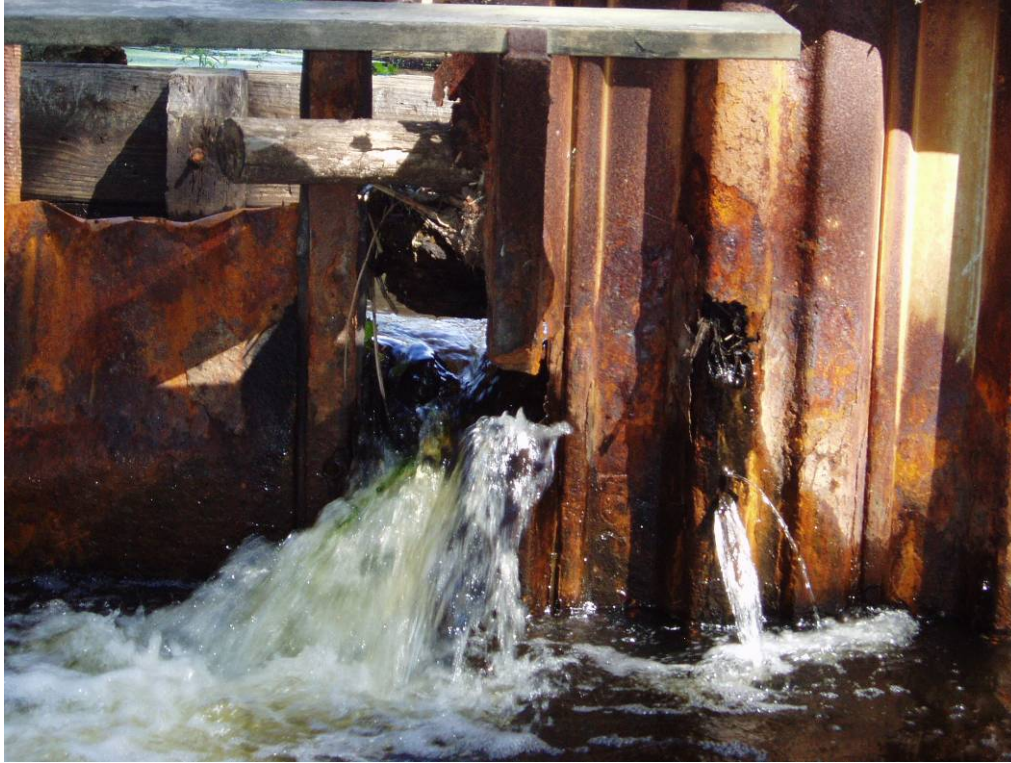
Figure 11. Outlet Weir Corrosion at Farrel's (E-2) Wetland.

- Follow-up inspection, operation and maintenance of all Long Lake Chain of Lakes Clean Lakes Partnership (CLP) BMPs.
- Notice/letter to potential site-specific BMP landowners educating them of potential grant funding through the District's Urban Stormwater Remediation Cost-Share Program.

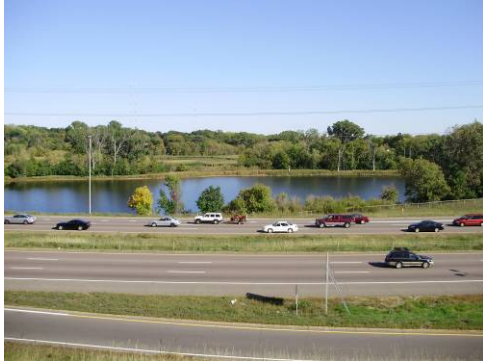
Long 1

Location: E2 wetland looking from the east

Potential Improvements: Enhancements or improvements throughout the E2 wetland complex. An assessment of current effectiveness of the upstream wetland systems should be completed and outlet structure should be replaced.

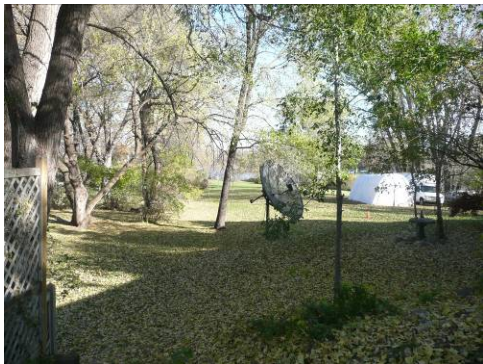
Long 3

Location: East of Long Lake Road and south of 17th Street

Potential Improvements: Daylight pipe and create wetland treatment/ponding area.

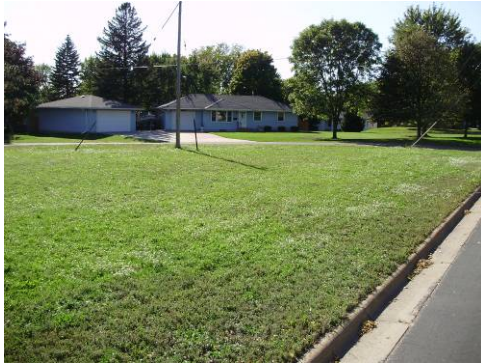
Long 4

Description: Open green space

Potential Improvements: Pick up street runoff and incorporate a large raingarden.

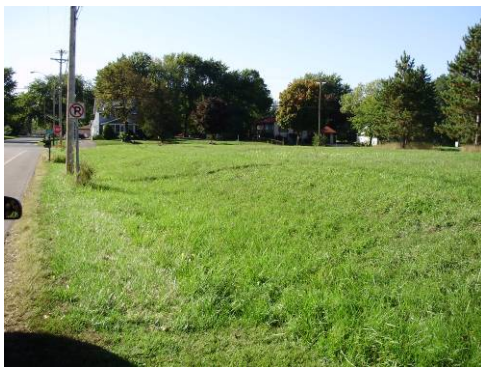
Long 5

Description: Large open green space (appears to be park property)

Potential Improvements: Incorporate ponding or infiltration areas, however appears slightly high and may not be able to route much drainage area to this site.

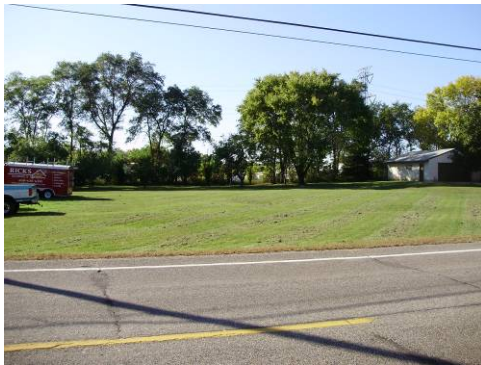
Long 6

Description: Large open green space

Potential Improvements: Incorporate ponding or infiltration areas for treatment of adjacent roads.

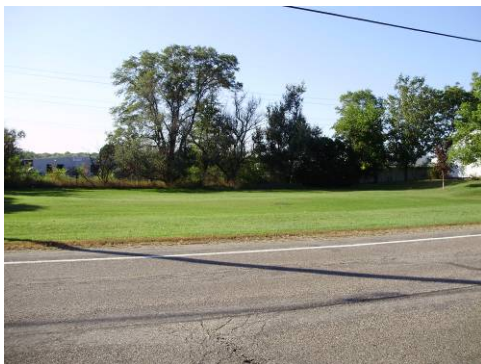
Long 7

Description: Large open green space

Potential Improvements: Incorporate ponding or infiltration areas for treatment of adjacent roads.

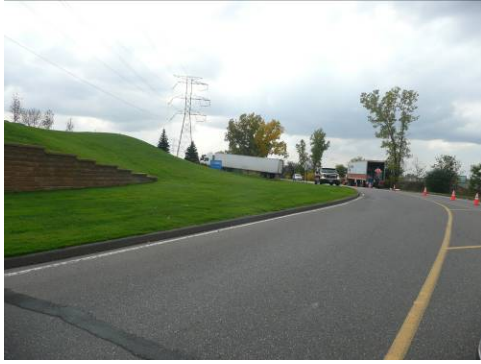
Long 8

Description: Green space along Round Lake Road

Potential Improvements: Incorporate raingardens for treatment of adjacent roadway.

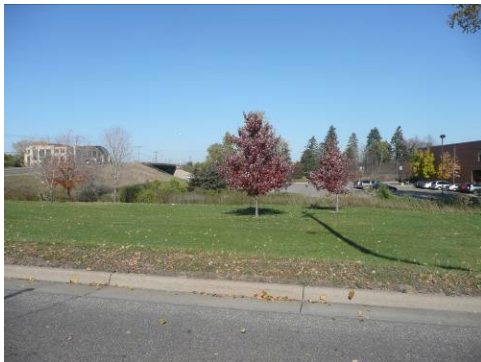
Long 9

Description: Green space at the corner.

Potential Improvements: Use area for treatment of adjacent roadways.

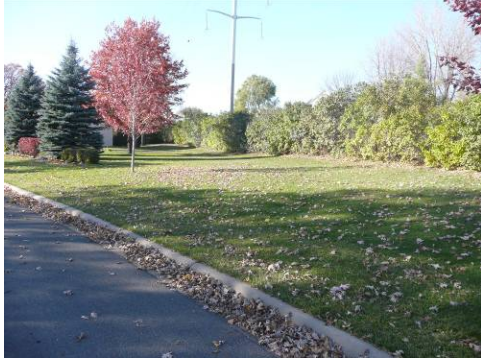
Long 12

Description: Open space adjacent to roadway

Potential Improvements: Install raingarden to treat a portion of Mississippi Street.

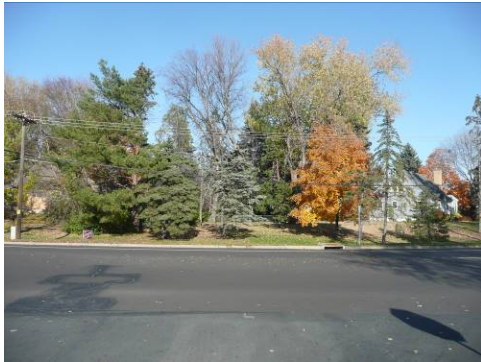
Long 13

Location: East of the intersection of Long Lake Road and 14th Street

Potential Improvements: Incorporate raingarden areas for treatment of a portion of Long Lake Road (note: this would require the removal of some trees).

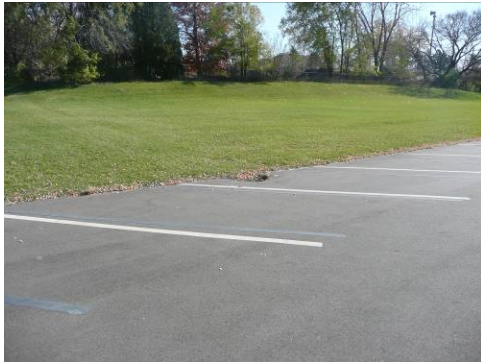
Long 14

Description: Catch basin located at the edge of the parking lot.

Potential Improvements: Use green space behind catch basin to provide treatment. Numerous areas are available onsite for treatment of impervious area.

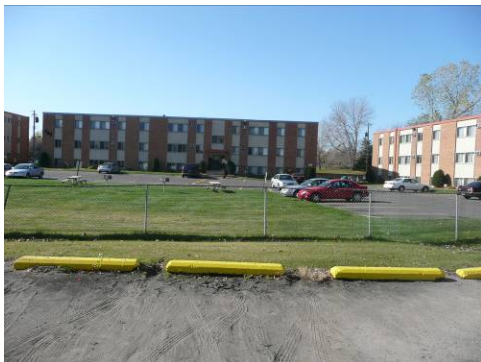
Long 15

Description: Green space adjacent to apartment parking lots.

Potential Improvements: Create raingarden or sand filter area for treatment of adjacent parking lots.

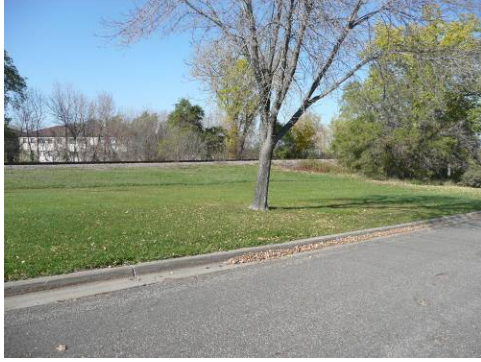
Long 16

Description: Green space adjacent to parking lot.

Potential Improvements: Use green space for a raingarden to treat a portion of the adjacent parking lot (note: this maybe within railroad ROW).

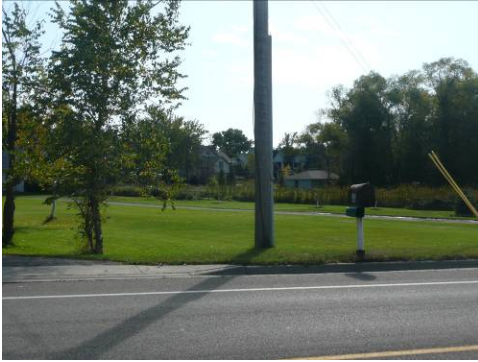
Marsden #1

Description: Large open area in front yard along County Road I.

Potential Improvements: Incorporate infiltration/biofiltration feature for treatment of County Road I (note: treatment may already be occurring in downstream wetlands and ponds)

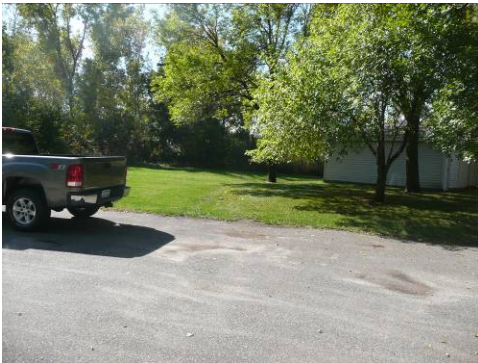
Marsden #2

Description: Shallow swale flowing from pavement area back to wetland.

Potential Improvements: Create raingarden for local drainage or pick up stormsewer from Carmel Court and incorporate a slightly larger treatment feature.

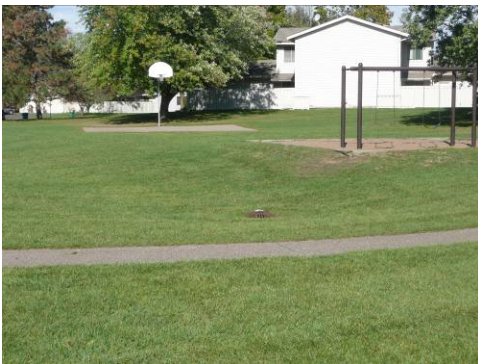
Marsden #3

Location: Inside Carmel Court loop

Potential Improvements: Retrofit to provide infiltration/water quality treatment.

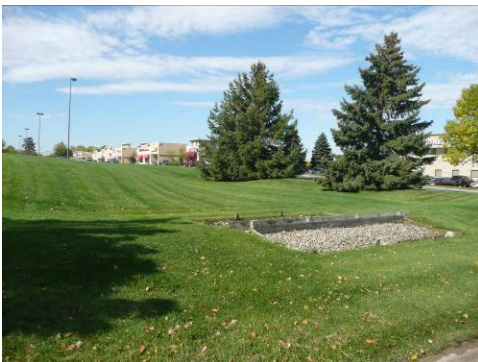
Marsden #4

Description: Appears to be an existing infiltration feature, which outlets to the road.

Potential Improvements: Might be working as is, however the vegetation and storage of features onsite could likely be enhanced to provide more infiltration and treatment.

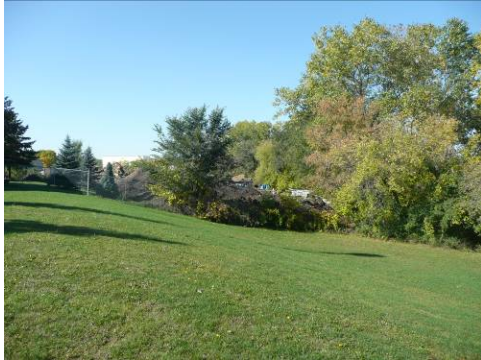
Martha #1

Description: Backside of Shoreview Public Works / Maintenance building. The yard area is immediately adjacent to the lake and appears to be draining to the lake untreated.

Potential Improvements: Assess runoff reaching lake and install BMPs prior to discharge to the lake as needed.

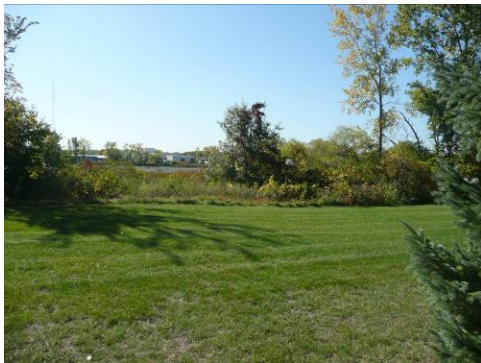
Martha #2

Description: Stormsewer from Monterey Drive outlets directly to Martha Lake.

Potential Improvements: Incorporate water quality BMP in green space.

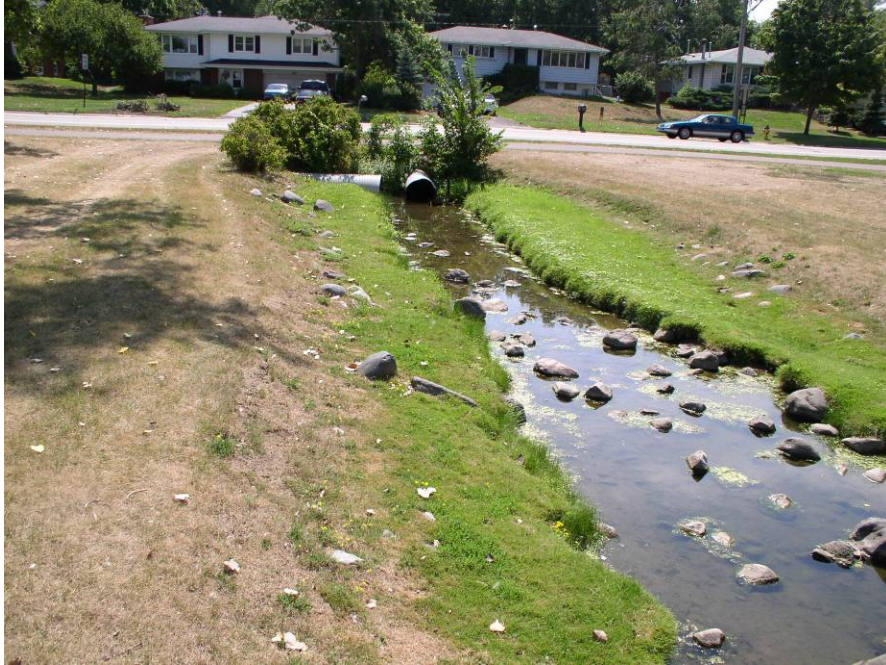
Figure 11. Drainage Channel through Moore Lake Park

- The City of Fridley manages the park near Moore Lake. BMPs could be implemented at the park to manage stormwater as well as serve as an example for homeowners within the watershed to institute positive changes. An example of a BMP would be conversion of the channel that drains to the lake through the south-central part of the park (Figure 11 & Field Recon Supplement BMP #7). This channel currently accommodates runoff with very little, if any, water quality treatment. Converting this to a water quality BMP, such as a bioretention swale, could yield some movement toward the 25% TP reduction needed for the lake to meet its goal.

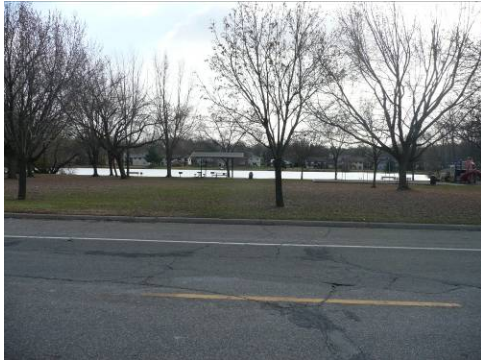
Moore 1

Description: Green space in Harris Lake Park

Potential Improvements: Incorporate raingardens to provide treatment of Mississippi Street.

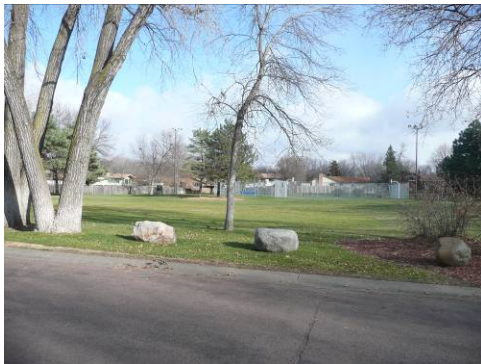
Moore 2

Description: Green space in Briardale Park

Potential Improvements: Use open space for treatment of adjacent roadways.

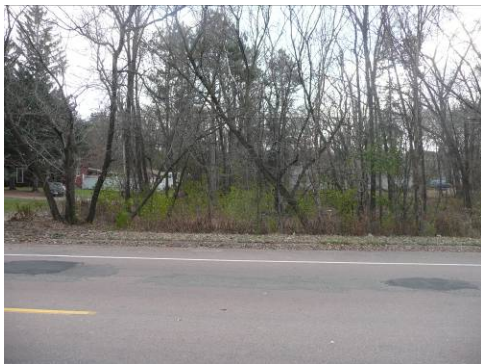
Moore 3

Description: Open wooded lot adjacent to Rice Creek Road.

Potential Improvements: Use to provide treatment for Rice Creek Road.

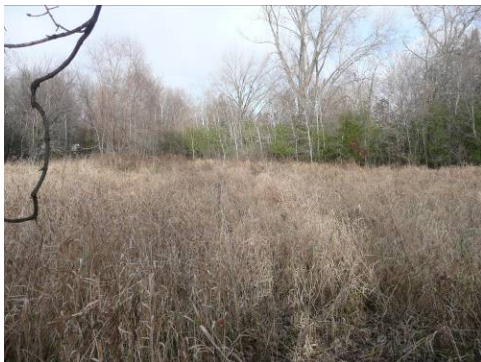
Moore 4

Description: Wetland area adjacent to Rice Creek Road

Potential Improvements: Enhance and use for treatment of adjacent roadways.

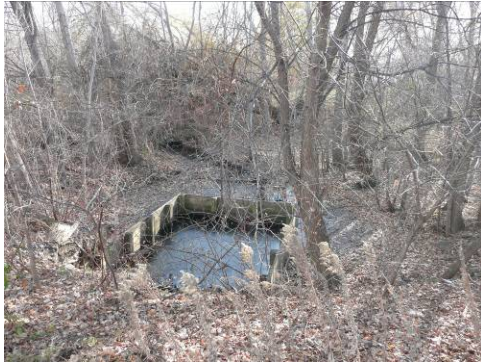
Moore 5

Description: Existing basin providing minimal treatment.

Potential Improvements: Enhance to provide additional water quality treatment.

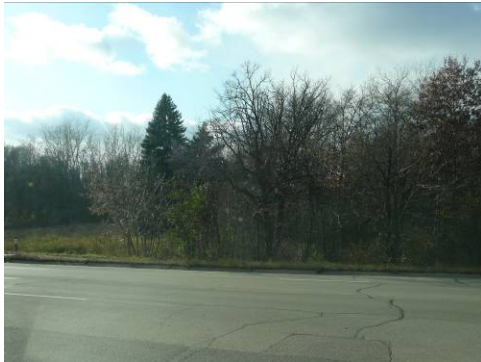
Moore 6

Description: Large open space adjacent to Old Central Avenue

Potential Improvements: Use for treatment of adjacent roadways.

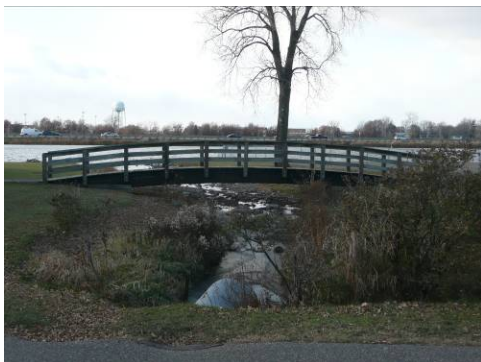
Moore 7

Description: Stormsewer discharge through park into Moore Lake

Potential Improvements: Enhance area to provide additional treatment (note: current configuration of bridge could limit treatment capacity). If dissolved phosphorus is an issue a permeable limestone weir could potentially be considered as an option.

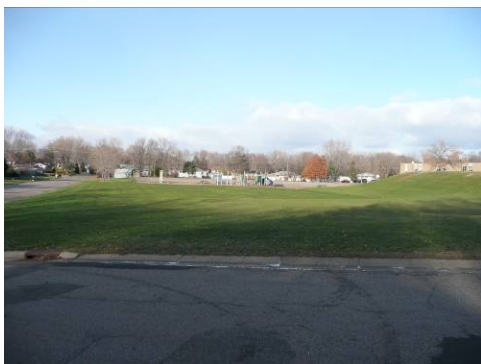
Moore 8

Description: Green space on school property

Potential Improvements: Use area for infiltration and/or ponding for adjacent roads and school parking lot.

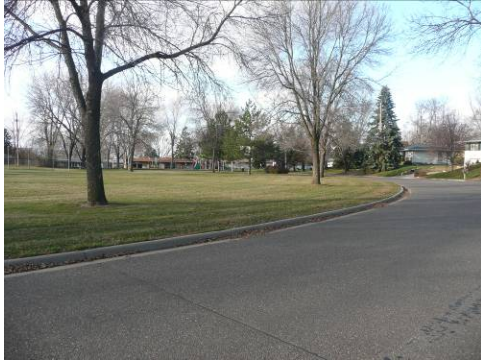
Moore 9

Location: East of Hackman Avenue and west of Hackman Circle

Potential Improvements: Incorporate infiltration areas for treatment of Hackman Circle.

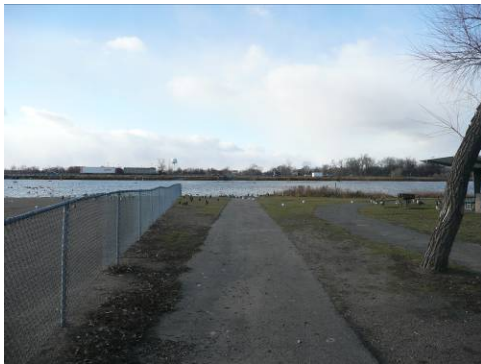
Moore 11

Location: Moore Lake

Description: Looking west from park

Potential Improvements: Remove bituminous flume and incorporate treatment.

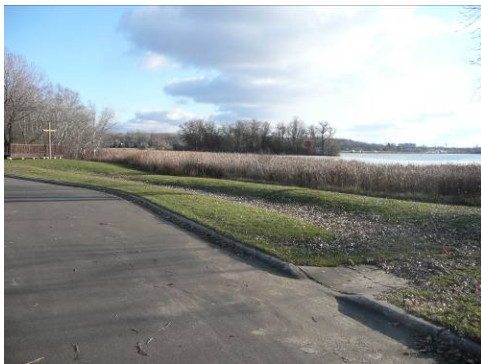
Moore 12

Location: South of Moore Lake Drive and west of Highway 65

Description: Treatment swale south of Saint Phillips Lutheran Church parking lot

Potential Improvements: Enhance vegetation and treatment storage prior to discharge to Moore Lake.

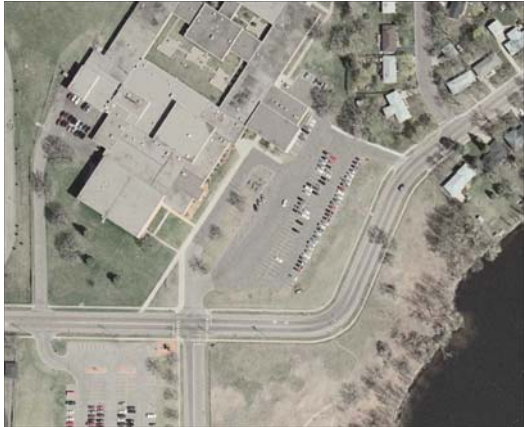
Moore 13

Location: Fridley Middle School and surrounding property

Potential Improvements: Infiltrate stormwater from Fridley Middle school rooftop and parking lot, as well as West Moore Lake Drive. Would divert water that current is discharged to West Moore Lake without treatment

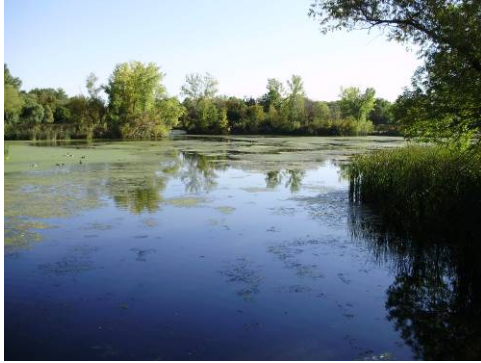
Pike Lake #1

Location: Hanson Park

Description: Large wetland/pond treatment area previously enhanced by RCWD

Potential Improvements: An assessment of the current storage capacity versus the original design and the need for maintenance/excavation of accumulated material could be done. Other vegetation enhancements or management strategies could also be evaluated. Carp management/eradication options for small ponds should be reviewed.

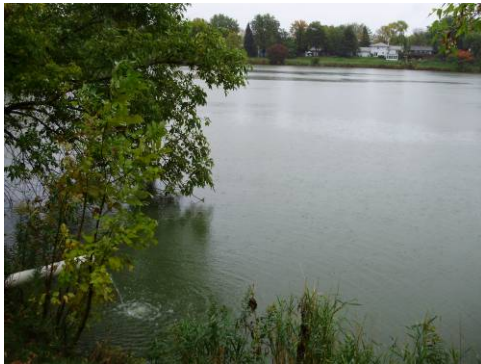
Pike Lake #2

Location: North of County Road D and east of Oakwood Drive

Description: Mirror Pond – the water was very green the day of the site visit. This could potentially be a contributing source of the poor water quality at the outlet of RCD 3.

Potential Improvements: Assessment of Mirror Pond should be done. Options could be to chemically treat the outlet or seal sediments to reduce downstream loading.

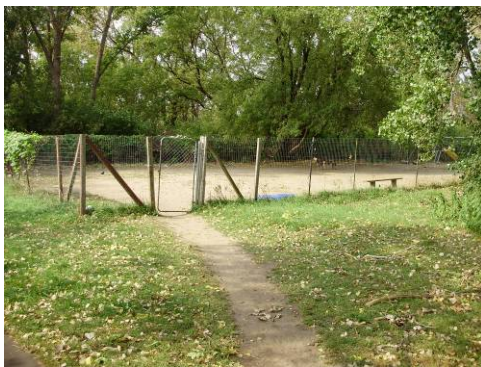
Pike Lake #3

Location: Immediately southeast of Pike Lake

Potential Improvements: This area could potentially be used as a regional treatment facility.

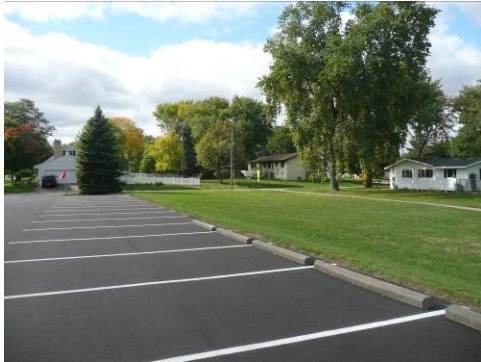
Pike Lake #4

Location: North of Wendhurst Ave and east of Chelmsford Road

Description: Open grass area next to recently repaved church parking lot

Potential Improvements: Raingarden/water quality BMPs could be installed for runoff from the church parking area or adjacent road. The sloped nature of the area would limit the opportunities to utilize the space.

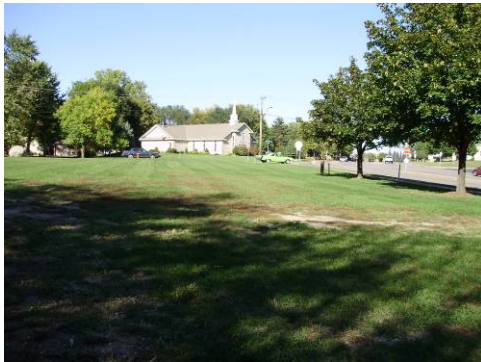
Pike Lake #5

Location: South of 1st Street and west of Old Highway 8

Description: Large grass area on corner.

Potential Improvements: This site could be used for infiltration or ponding for runoff from adjacent road ways.

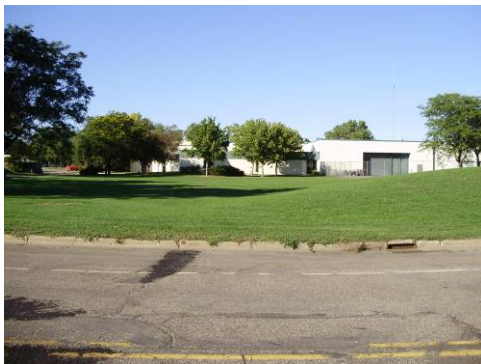
Pike Lake #6

Location: North of 5th Street and east of 8th Avenue

Description: Open grass area at New Brighton Public works building.

Potential Improvements: Raingarden/water quality BMPs could be installed for runoff from adjacent roads/buildings.

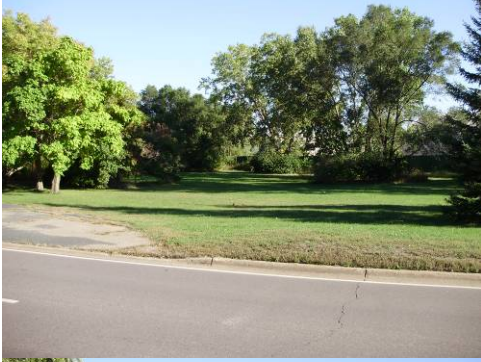
Pike Lake #7

Location: East of 8th Avenue and north of 6th Street

Description: Large open areas

Potential Improvements: Install ponding or infiltration areas for runoff from adjacent roads

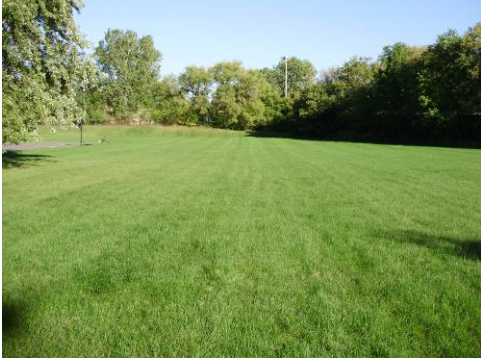
Pike Lake #8

Location: East of 8th Avenue and north of 6th Street

Description: Large open areas.

Potential Improvements: Install ponding or infiltration areas for runoff from adjacent roads.

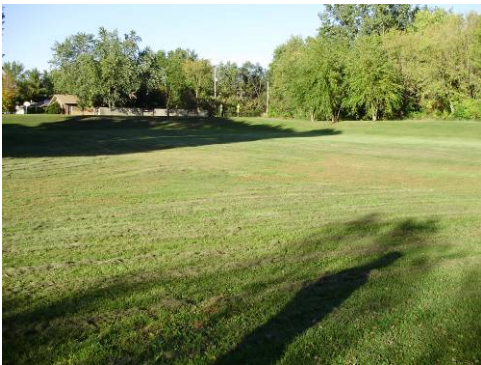
Pike Lake #9

Location: South of 7th Street and east of 17th Avenue

Description: Open grass area (current use is unclear).

Potential Improvements: Pick up pipe inlet from southwest and provide additional treatment prior to discharge to the regional pond. This area could also be used to treat 7th Street runoff.

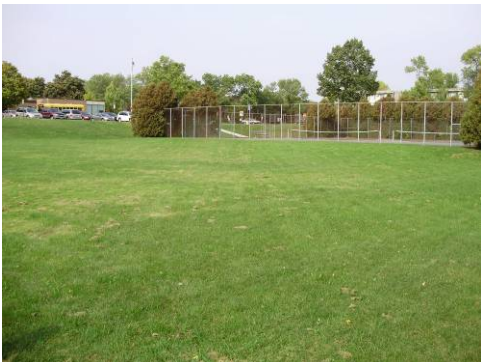
Pike Lake #10

Location: South of 14th Street and west of 20th Avenue

Description: Open grass area on school grounds.

Potential Improvements: Utilize this area to treat school runoff or adjacent roads.

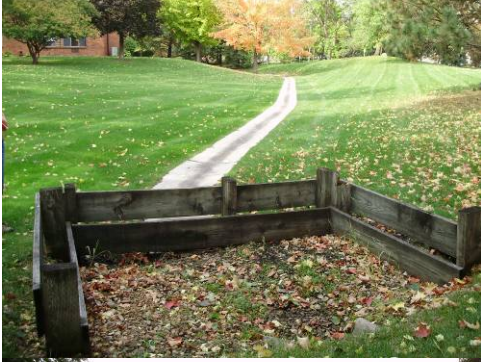
Pike Lake #11

Location: Northwest of intersection of Robin Lane and 12th Street

Description: Dry ponding area along with additional swales/green space onsite.

Potential Improvements: Incorporate water quality treatment prior to discharge (e.g. infiltration and/or ponding).

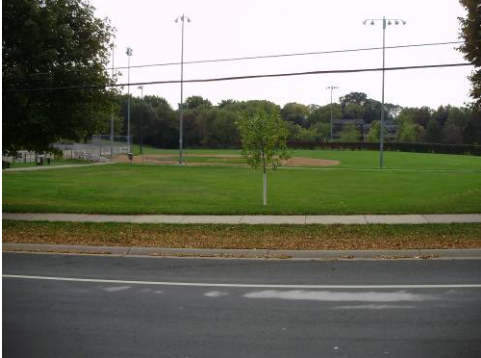
Pike Lake #12

Location: South of 14th Street and east of Silver Lake Road

Description: Greenspace on school property behind baseball field.

Potential Improvements: Use this area to treat runoff from school or adjacent streets.

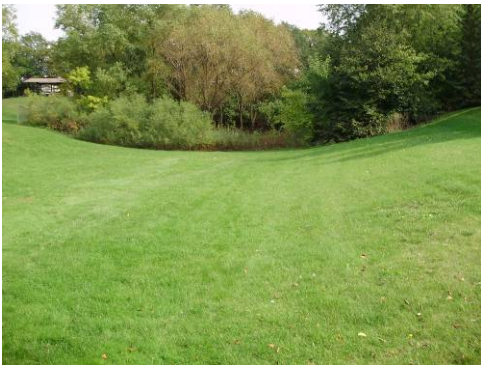
Pike Lake #13

Location: West of the intersection of Robin Lane and 13th Street

Description: Large dry pond.

Potential Improvements: Retrofit this site to include water quality treatment and infiltration.

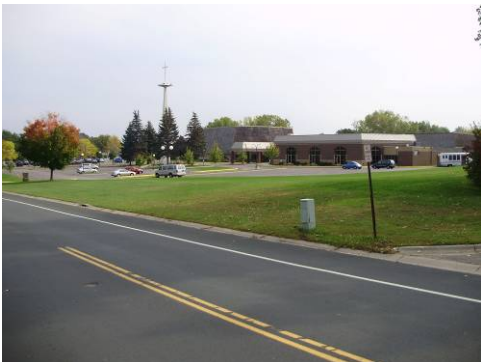
Pike Lake #14

Location: South of the intersection of 5th Street and Driftwood Road

Description: Large open green space.

Potential Improvements: Incorporate a large infiltration area for adjacent road runoff (area is likely already treated by water quality ponds).

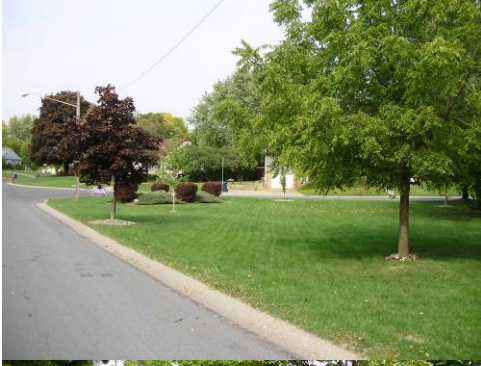
Pike Lake #15

Location: East of Heights Drive and south of Maiden Lane

Description: Open green space.

Potential Improvements: Utilize to treat runoff from the adjacent roadway.

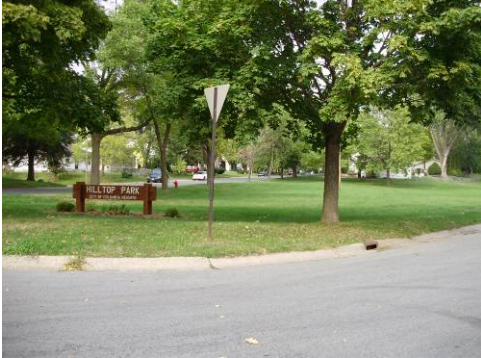
Pike Lake #16

Location: East of the intersection of Heights Drive and Golf Place

Description: Open green space.

Potential Improvements: Utilize to treat runoff from the adjacent roadway.

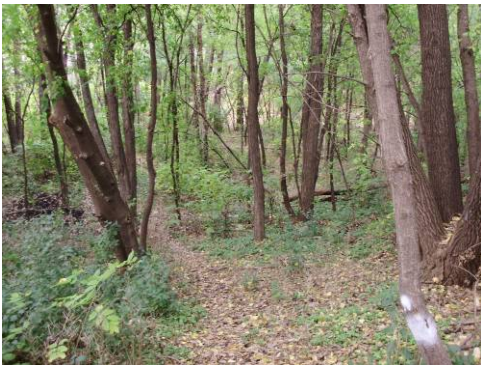
Pike Lake #17

Location: South of 3rd Street and west of 23rd Avenue

Description: Wooded lot

Potential Improvements: Utilize to treat runoff from the adjacent roadways or impervious areas from the south and west (note: the lot has significant grade change from south to north).

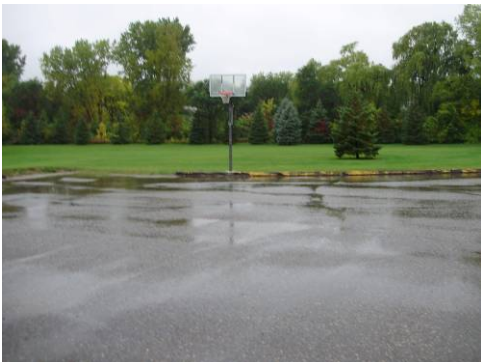
Pike Lake #18

Location: South of 1st Street and east of 13th Avenue

Description: Large unused green space.

Potential Improvements: Possibly use the area to treat runoff from the adjacent neighborhood to the west.

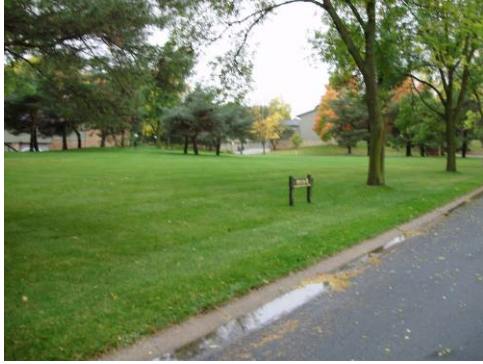
Pike Lake #19

Location: South of Windsor Way and west of 20th Avenue

Description: Large grass area at Winsor Park (private common area)

Potential Improvements: Incorporate a large infiltration/filtration feature for treatment of runoff from adjacent roadways.

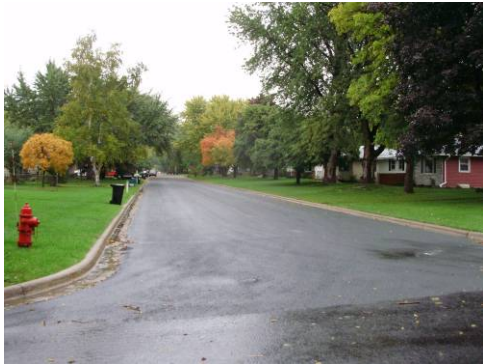
Pike Lake #20

Location: 11th Avenue looking north from 4th Street

Potential Improvements: Incorporate raingardens throughout the area during road reconstruction projects.

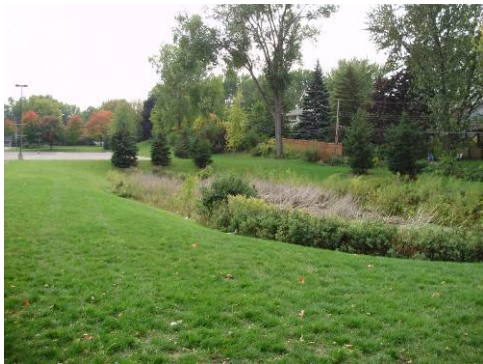
Pike Lake #21

Location: North of 7th Street and east of 22nd Avenue

Description: Existing ponding area on church site.

Potential Improvements: Clean out and expand the pond for additional treatment.

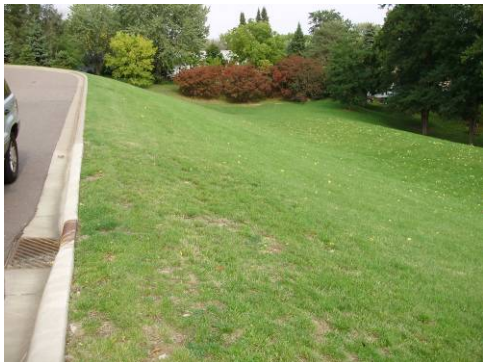
Pike Lake #22

Location: North of 7th Street and west of Oakwood Drive

Description: Grass swale on church site.

Potential Improvements: Retrofit the swale to an infiltration area treating runoff from the adjacent drive.

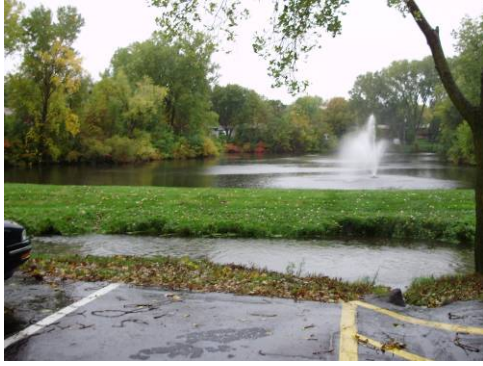
Pike Lake #23

Location: North of 7th Street and east of Patton Road

Description: Ramsey County Ditch #2 and offline pond (in the background), parking lot flumes straight to ditch (in the foreground). The adjacent Venetian Village apartment complex and parking drains directly to RCD-2 and receives no treatment prior to reaching Pike Lake

Potential Improvements: Assess options that would, at a minimum, remove debris before entering the ditch.

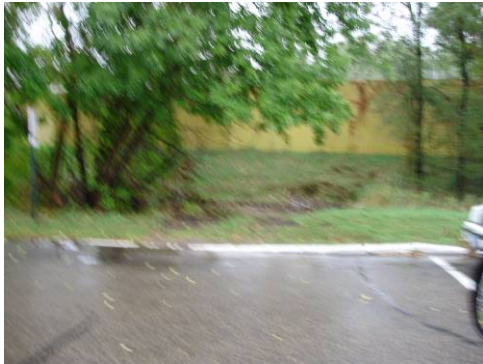
Pike Lake #24

Location: South of 694 and east of Patton Road

Description: Swale adjacent to apartment drive with exposed soils.

Potential Improvements: Improve/enhance the swale to provide treatment for runoff from the adjacent drive.

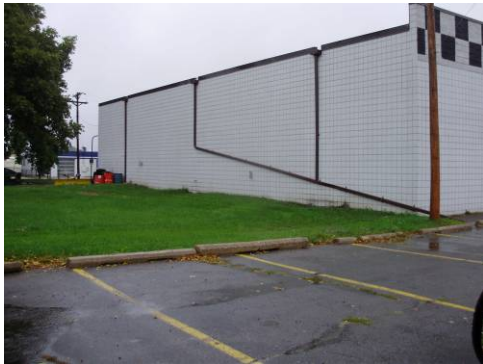
Pike Lake #25

Location: West of 8th Avenue and south of 5th Street

Description: Roof drainage directed to parking area @ J & B Auto Repair

Potential Improvements: Green space could easily be converted into a raingarden area that could treat the roof top and possibly some of the parking area.

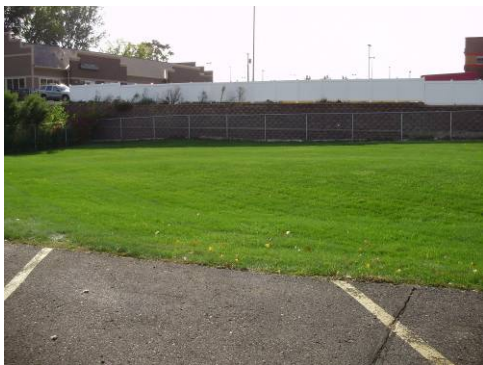
Pike Lake #26

Location: West of Macalaster Drive and south of 39th Avenue

Potential Improvements: This location along with other areas onsite could be converted to raingarden areas for treatment of the adjacent apartments and associated parking.

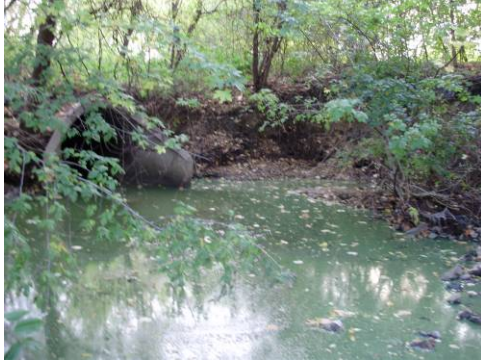
Pike Lake #27

Location: West of Old Highway 8 and south of 1st Street

Potential Improvements: Bank Stabilization is needed at the outlet of Ramsey County Ditch #3.

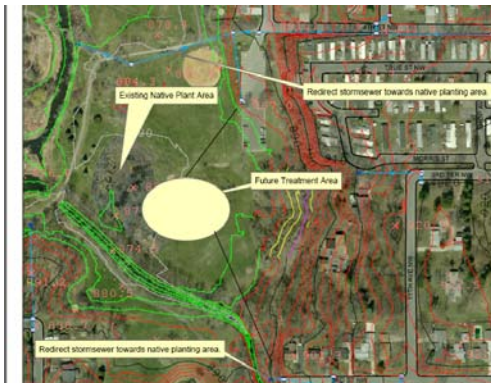
Pike Lake #28

Location: West of 3rd Terrace NW

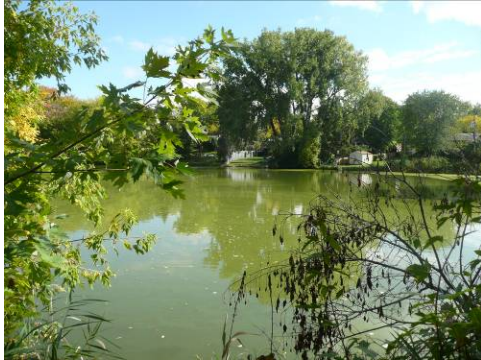
Poplar Lake #1

Location: South of Foss Road and west of Imperial Lane

Potential Improvements: Assess the effectiveness and perform maintenance or other improvements as needed to ensure that the pond is providing the treatment needed before discharging to Poplar Lake.

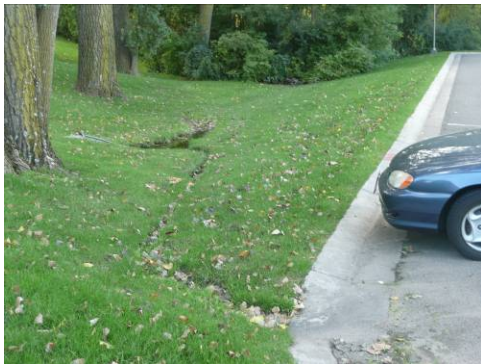
Poplar Lake #2

Location: Near parking area north of Mooney Drive and just east of Poplar Lake

Description: Curb cut from parking area and an additional piped discharge enter a grassed swale that then flows through a small patch of woods before reaching Poplar Lake.

Potential Improvements: A raingarden could be incorporated in the available green space. Removal of some trees would allow for a larger feature. Appropriate sizing would be dependent on a determination of the drainage area from the piped discharge.

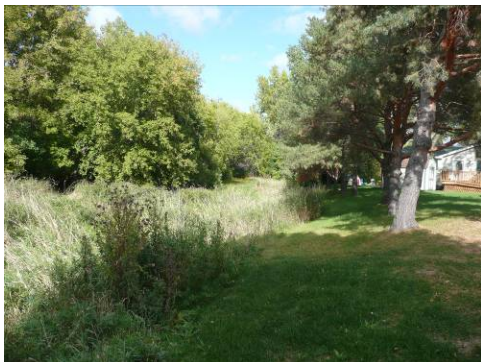
Poplar Lake #3

Location: Intersection of Champion Drive and West Road

Possible Improvements: Swale could easily be expanded into a treatment feature providing storage or infiltration as needed.

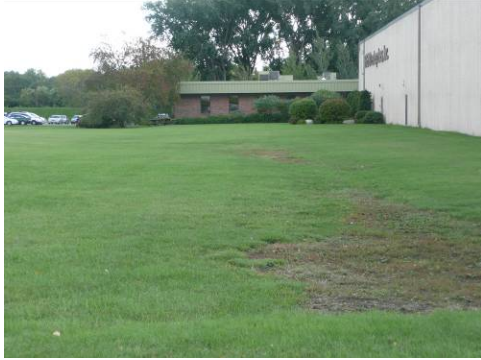
Poplar Lake #4

Location: Trend Enterprises west of 9th Avenue SW

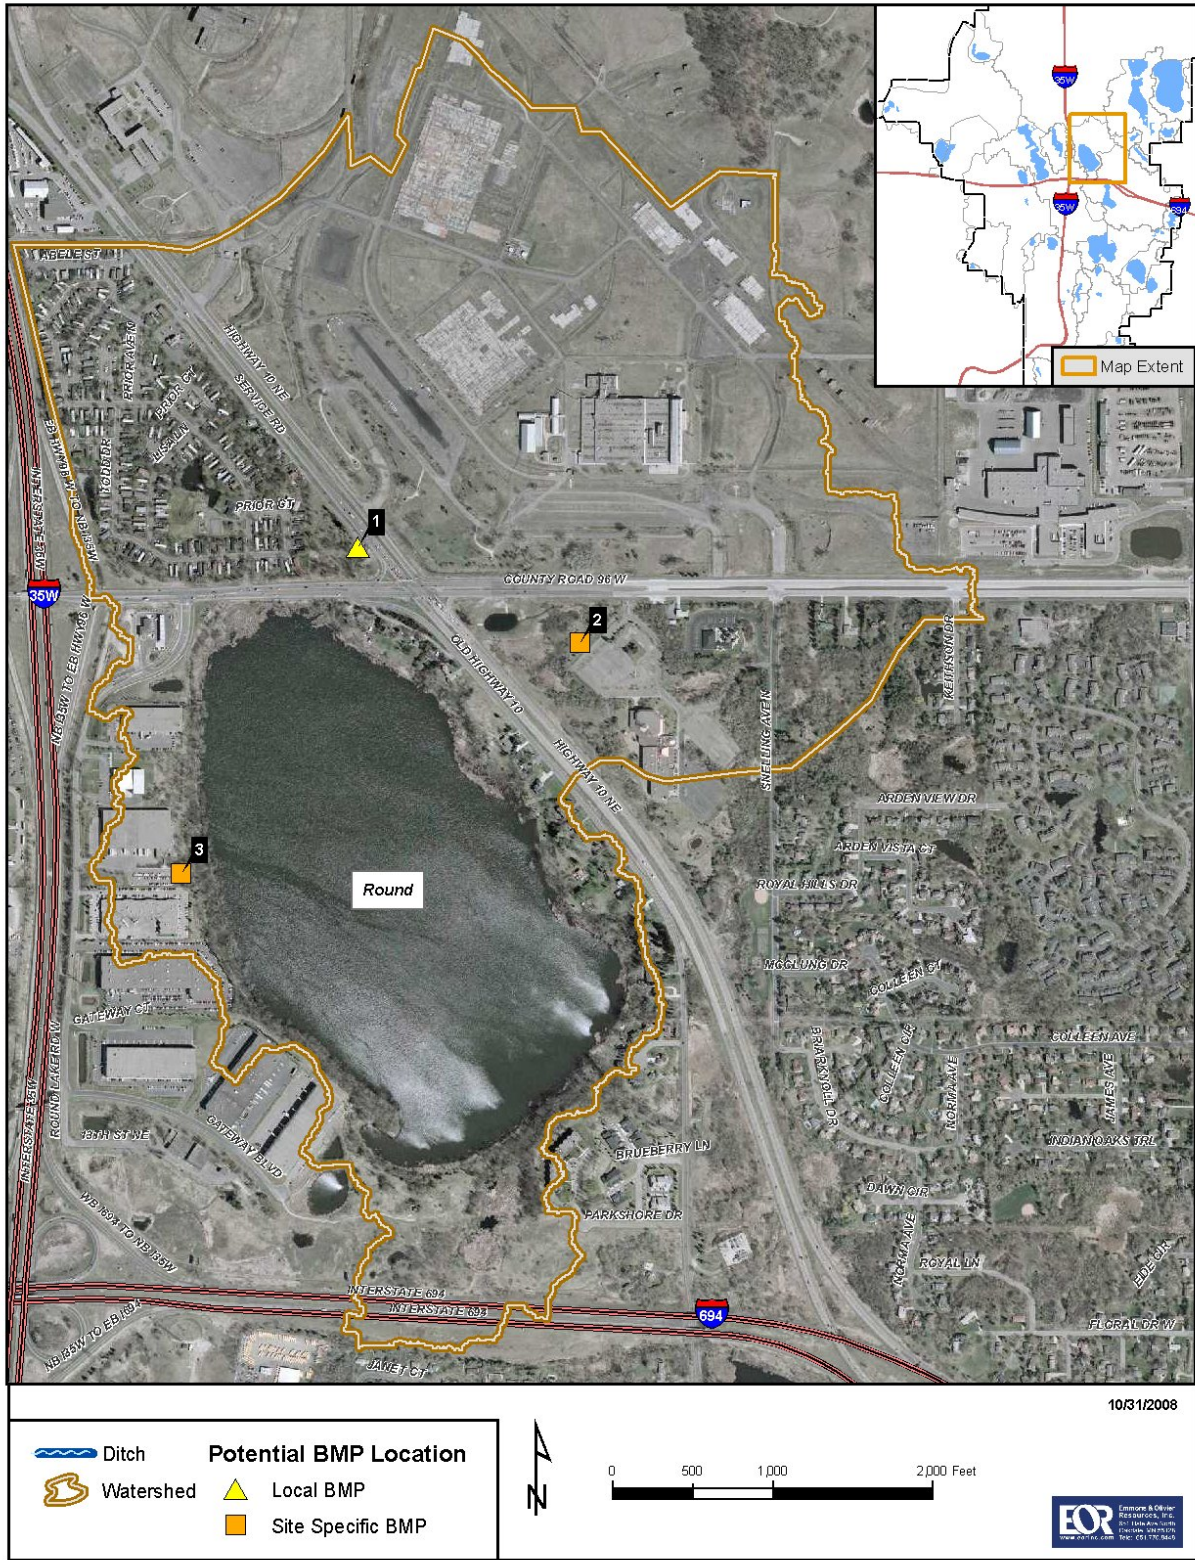
Figure 1. Round Lake and Potential BMP Locations

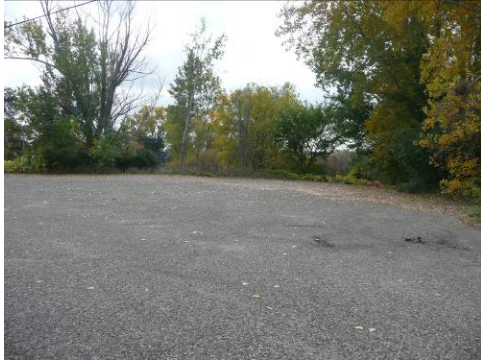
Round 1

Location: North of County Road 96 and west of Highway 10

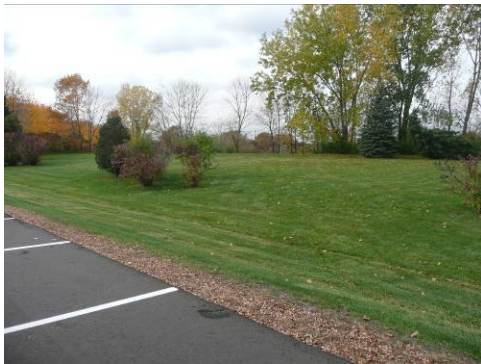
Round 2

Location: South of County Road 96 and west of Snelling Avenue

Description: Open space adjacent to church parking lot.

Possible Improvements: Incorporate raingardens (likely filtration) to treat sheet flow runoff from the northern North Heights Lutheran Church parking lot.

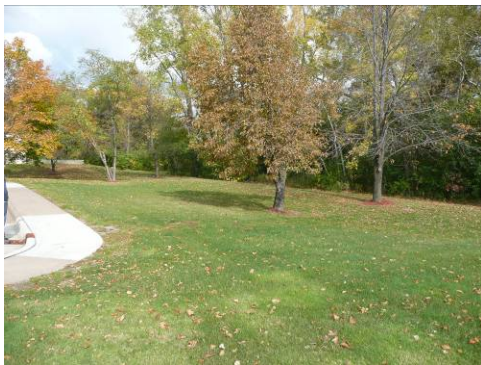
Round 3

Location: East of Round Lake Road and north of Gateway Court

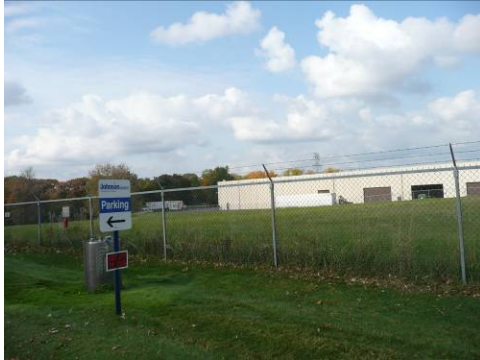
Rush 1

Location: West of the intersection of Old Highway 8 and Mound Street

Description: Large open space behind an existing home.

Possible Improvements: Use for treatment of adjacent businesses or Old Highway 8.

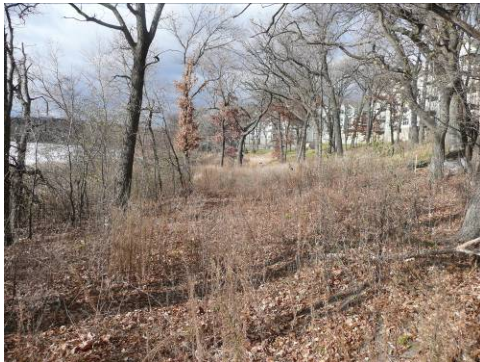
Rush 2

Location: West of the intersection of Old Highway 8 and County Road 96

Description: Open space near outlet of stormsewer from Old Highway 8

Possible Improvements: Incorporate wetland treatment/ponding area.

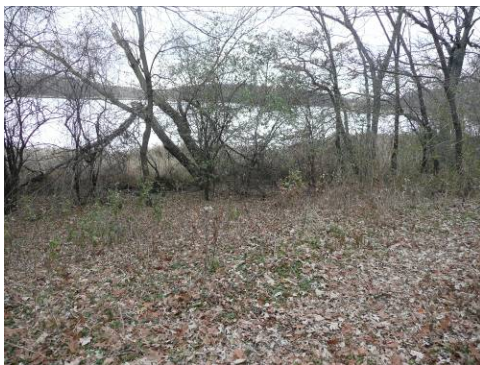
Rush 3

Location: West of Old Highway 8 and south of County Road 96

Description: Open space near outlet of stormsewer from Old Highway 8

Possible Improvements: Incorporate wetland treatment/ponding area.

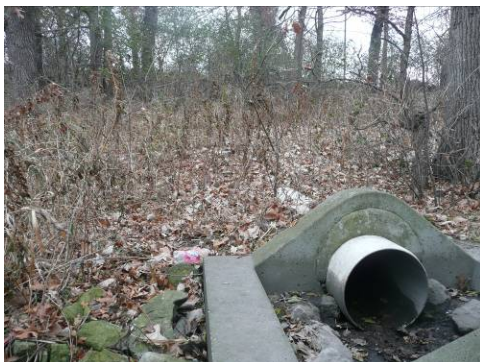
Rush 4

Location: West of Old Highway 8 and north of 1st Avenue
