Prepared by:
Emmons & Olivier Resources, Inc.
for the Rice Creek Watershed District

Southwest Urban Lakes Study

April 2009

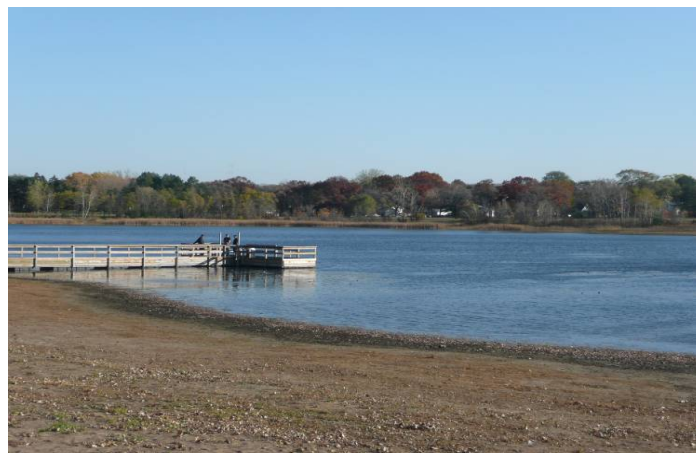
Water level in Spring Lake has fluctuated dramatically over the years (Figure 3). Most of the periods of low water level are preceded by periods of low precipitation, suggesting that the lake is fed by surficial groundwater and that water levels are tied to long-term precipitation patterns. Historical records show that water levels in the lake used to be maintained by the county through groundwater pumping. However, after this practice contributed to the spread of several non-native plant and animal species in other water bodies, the DNR restricted pumping of groundwater for the maintenance of surface water levels in the late 1980s. Currently, other than encouraging practices that infiltrate water in the watershed, there are few (if any) options for augmenting surface water levels.

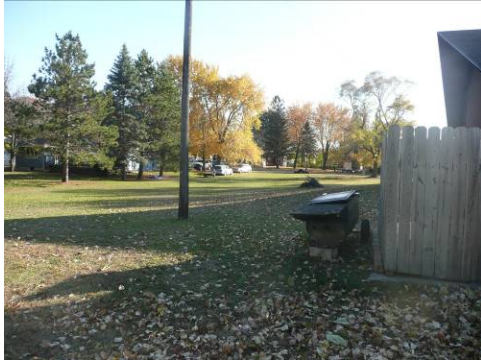
Spring 1

Location: North of Hill View Road and east of Pleasant View Drive

Description: Open space adjacent to church.

Possible Improvements: Incorporate raingarden area for treatment of church and/or adjacent roadways.

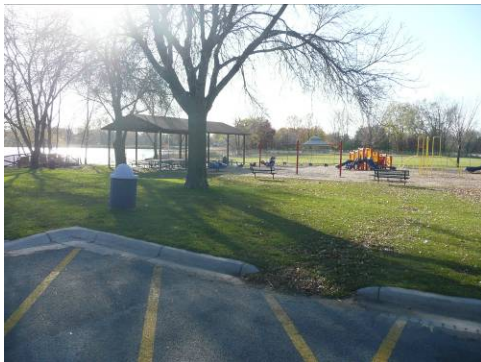
Spring 2

Location: South of the intersection of Pleasant View Drive and 79th Avenue

Description: Swale receiving runoff from the Lakeside Park parking lot located within the park north of Spring Lake.

Possible Improvements: Incorporate raingarden prior to discharge to Spring Lake.

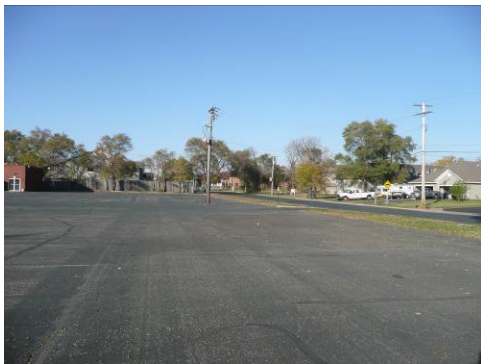
Spring 3

Location: West of Pleasant View Drive and south of 81st Avenue

Description: Large bituminous parking lot at VFW

Possible Improvements: Remove east stalls or southeast corner of parking and incorporate treatment feature.

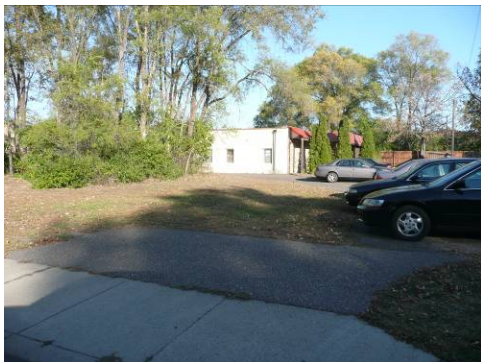
Spring 4

Location: East of Spring Lake Road and south of County Road 10

Description: Green space adjacent to parking lot

Possible Improvements: Incorporate raingarden area for treatment of adjacent parking lot.

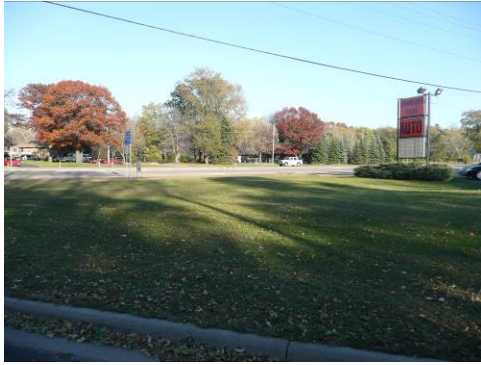
Spring 5

Location: East of Spring Lake Road and south of County Road 10

Description: Green space adjacent to parking lot at Spring Lake Park Auto

Possible Improvements: Incorporate raingarden area for treatment of adjacent parking lot.

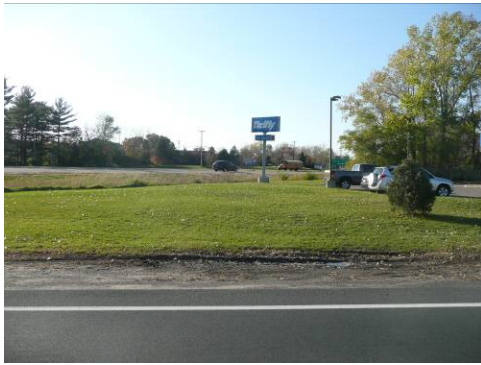
Spring 6

Location: West of Spring Lake Road and north of County Road 10

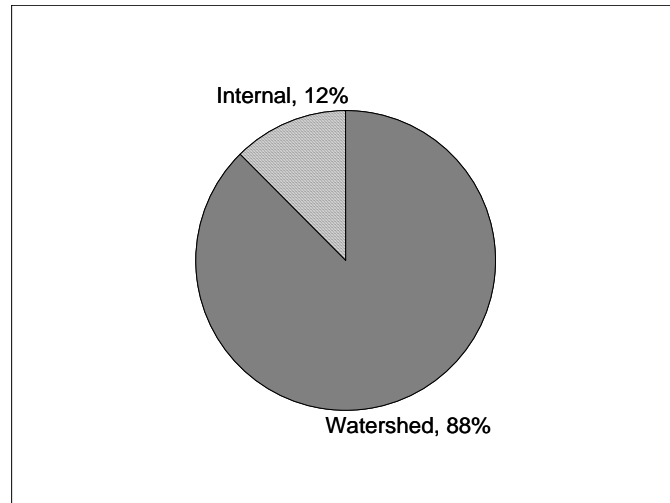
Figure 3. Jones Lake Phosphorus Load Distribution

A watershed model (P8) was used to estimate the watershed phosphorus load to the lake, and an in-lake model (Bathtub) was used to predict the response of the lake to phosphorus loading. There were no in-lake monitoring data available to calibrate the lake model. Water quality modeling indicates that watershed inputs account for approximately 88% of the nutrient load, with internal loading accounting for the remaining 12% (Figure 3). Without any in-lake nutrient data for the lake for model calibration, the modeling results should be considered preliminary.

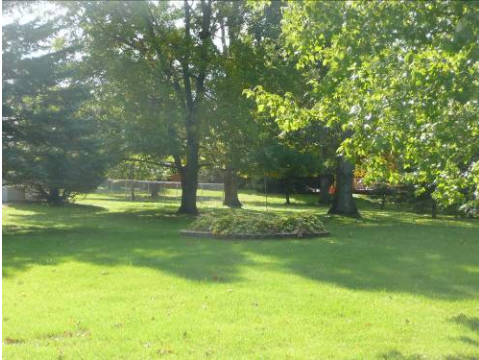
Turtle #1

Location: West of Saint Albans Street and north of Taylor Avenue

Description: Open area in front/side yard

Potential Improvements: Incorporate large raingarden to treat adjacent roadways.

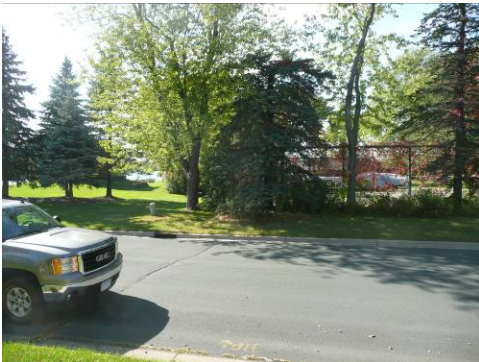
Turtle #2

Location: West of Carlson Street and south of County Road I

Description: Stormwater discharge into Turtle Lake from adjacent neighborhood.

Potential Improvements: Incorporate infiltration/biofiltration BMPs at this location. This site would require using areas that already appear to have uses (e.g. tennis court or garden areas).

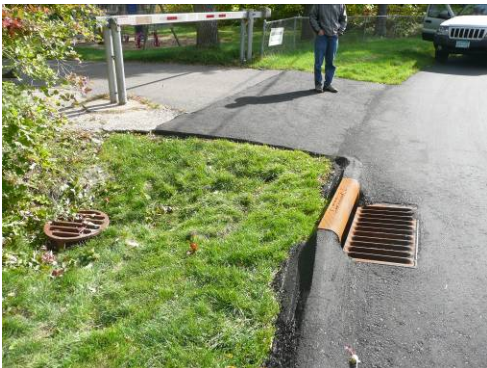
Turtle #3

Location: North end of Turtle Lane Loop

Description: Catch basin intended to route water across the street to an underground infiltration feature. It appears that some of the runoff may bypass to the inlet behind the catch basin that flow directly to Turtle Lake.

- The Turtle Lake Pre-treatment Facility Project (Local BMP #3) was recently constructed by the City of Shoreview for the southwest side of the lake, through the RCWD Urban Remediation Grant Program. This project on Turtle Lane treats stormwater from an 11-acre area via an underground infiltration system. The RCWD predicts that about 65% of the TP from this area would be eliminated. Survey of the pavement elevations is warranted to ensure that runoff is not bypassing the infiltration system.

Potential Improvements: Assess whether flows are bypassing the treatment feature, and if so, modify grades to ensure that runoff is directed to the treatment feature prior to discharge to Turtle Lake.

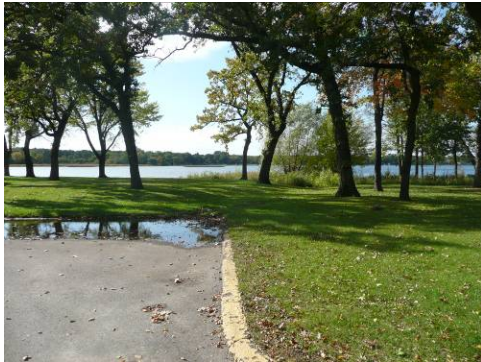
Turtle #4

Location: West of Hodgson Road and north of Schifsky Road

Description: Existing small treatment feature (4-6 inches of storage with a skimming structure) treating a large amount of the park's drives and parking lots

Potential Improvements: Increase treatment capacity. The onsite oak trees are an issue; however, with some creativity another cell could be added to the south of the existing feature.

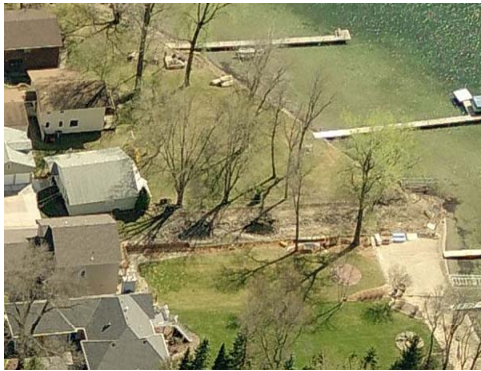
Turtle #5

Location: Western terminus of Birch Lane South

- Another possibility is in the Birch St. neighborhood on the east side of the lake (BMP#5). Although some infiltration tubes exist in this neighborhood, residual stormwater enters the lake via a rip-rap channel. Retrofit of this rip-rap channel to incorporate biofiltration could improve the runoff from this sub-watershed and help to further improve the lake.

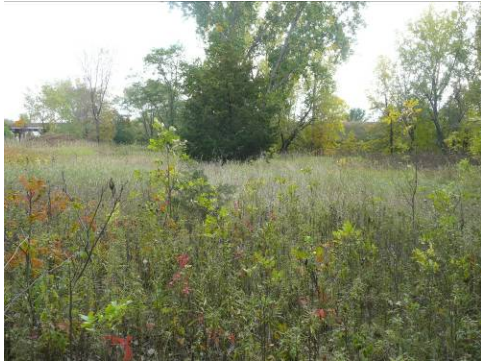
Valentine #1

Location: North of I-694 and west of Highway 10

Potential Improvements: Use space for large regional facility to treat the highways and upstream discharges. An assessment should first be done to assess the effectiveness of the upstream treatment features and determine if this ditch is a significant source of phosphorous to the Lake. Additional treatment may not be needed for upstream discharges because portions of the drainage area are already routed through wetland treatment features, however the area should at a minimum be considered for treatment of the adjacent highways when this area is reconstructed.

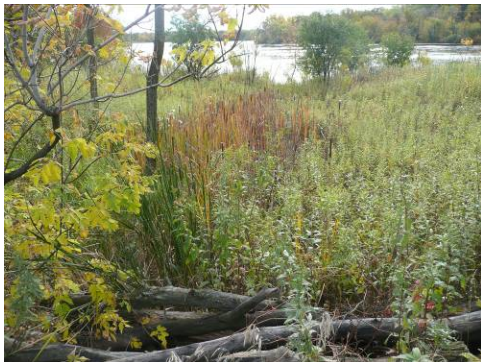
Valentine #2

Location: North end of Valentine Lake

Description: Area receiving stormwater from I-694.

Potential Improvements: Enhance area to provide better treatment prior to discharge to Valentine Lake

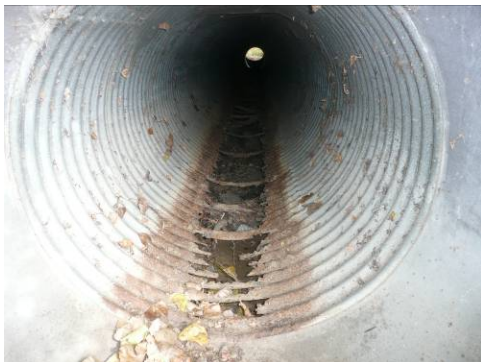
Valentine #3

Location: North end of Valentine Lake

Description: Rusted out pipe delivering runoff from Mn/DOT right-of-way

Potential Improvements: Repair pipe and look into upstream BMPs to reduce sediment transport from I-694 to Valentine Lake.

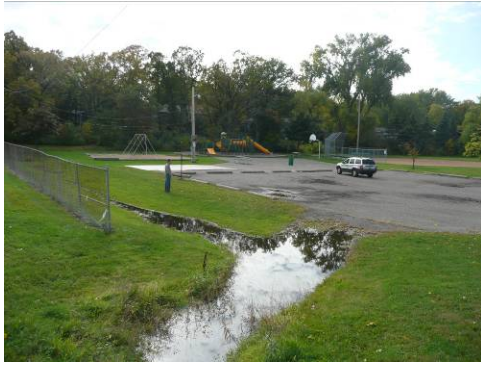
Valentine #4

Location: West of Snelling Avenue and south of Valentine Road

Description: Swale/ditch draining neighborhood from the west and draining under Snelling Avenue to Valentine Lake. Parking lot is in poor shape and not much higher than Valentine Lake. Water in photo is backwater from Valentine Lake.

Potential Improvements: Enhance/expand swale or remove parking and incorporate larger wetland treatment feature. Parking could be potentially moved out along Valentine Road.

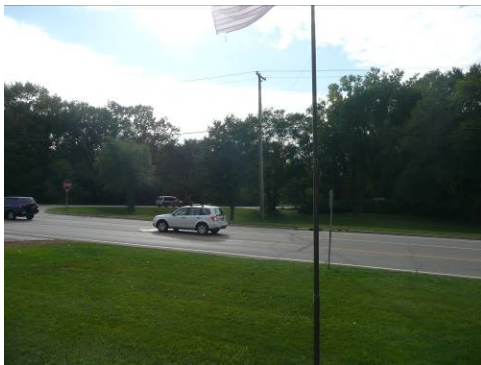
Valentine #5

Location: West of Snelling Avenue and north of Lake Johanna Boulevard

Description: Low open space northwest of the intersection of Snelling Avenue and Lake Johanna Boulevard

Potential Improvements: Use for infiltration/treatment of adjacent roadway

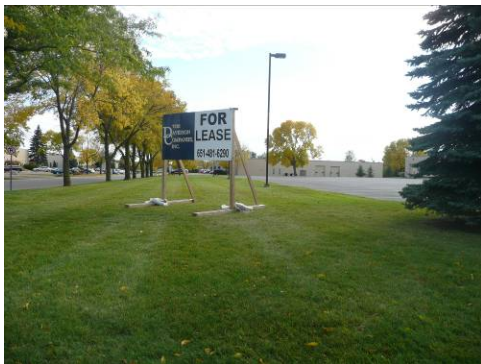
Valentine #6

Location: Dunlap street between Grey Fox Road and Red Fox Road

Description: Large green spaces between road and adjacent businesses

Potential Improvements: Use green spaces to treat impervious from adjacent businesses.

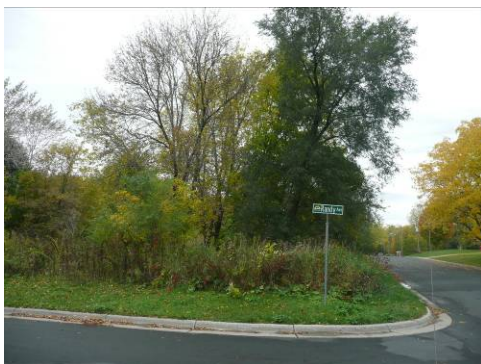
Valentine #7

Location: South of Gramsie Road and west of Randy Avenue

Description: Open space

Potential Improvements: Use to provide treatment for Gramsie Road

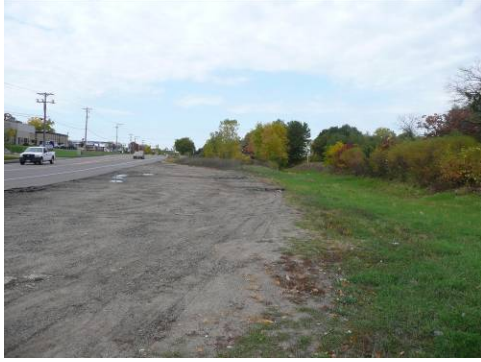
Valentine #8

Location: North of County Road E

Description: Large gravel area adjacent to County Road E

Potential Improvements: Use area for a new treatment feature when County Road E is repaired or upgraded.

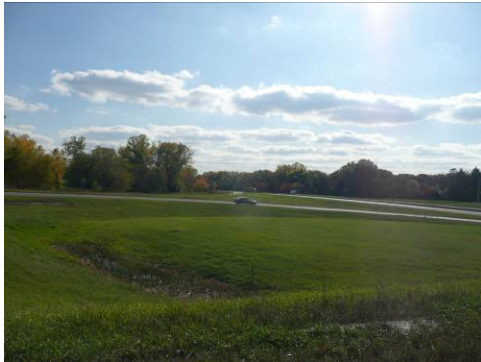
Valentine #9

Location: SE Loop at Snelling and County Road E

Potential Improvements: Provide additional treatment within loops (e.g. infiltration or ponding)

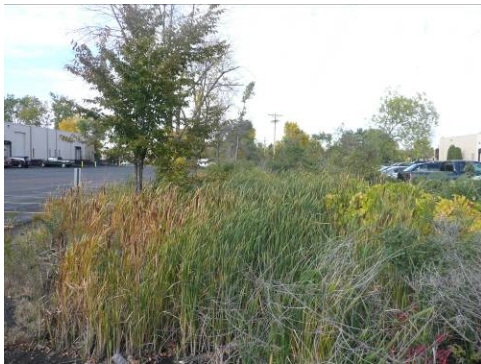
Valentine #10

Location: South of Grey Fox Road and east of Dunlap Street

Description: Treatment swale receiving runoff from adjacent parking areas.

Potential Improvements: Maintain/enhance to provide additional treatment.

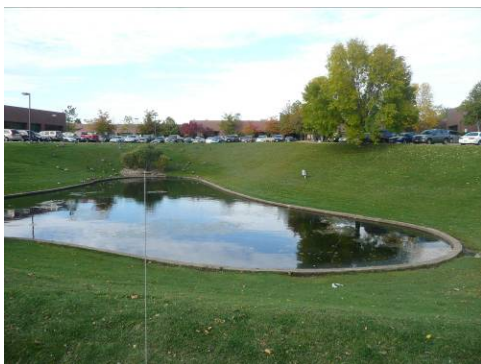
Valentine #11

Location: North of Grey Fox Road and west of Dunlap Street

Description: Existing treatment pond

Potential Improvements: Maintain and retrofit to provide additional treatment. Remove concrete, add native vegetation, and get rid of geese.

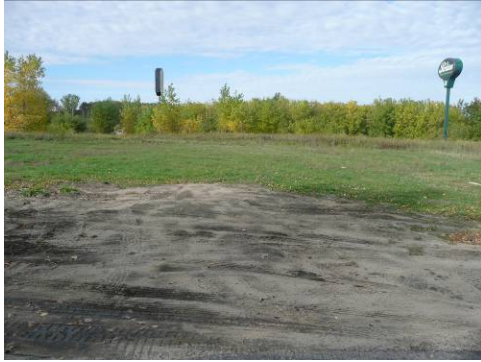
Valentine #12

Location: North of Red Fox Road and east of Northwoods Drive

Description: Open areas adjacent parking lot.

Potential Improvements: Incorporate infiltration/ water quality treatment BMPs

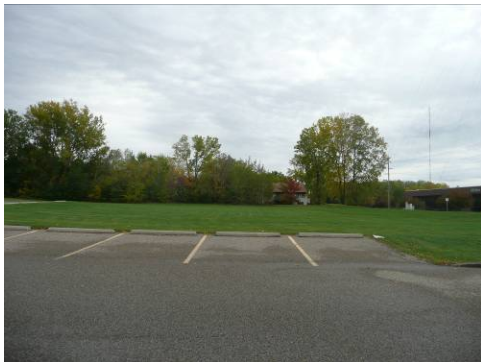
Valentine #13

Location: North of County Road F and east of Lexington Avenue

Description: Apartment complex, no onsite treatment. This area is treated by a downstream pond; however, infiltration/biofiltration could be incorporated in the onsite green spaces to provide volume control and additional water quality treatment for a large amount of impervious area routed directly to stormsewer.

Potential Improvements: Incorporate infiltration/ biofiltration BMPs.

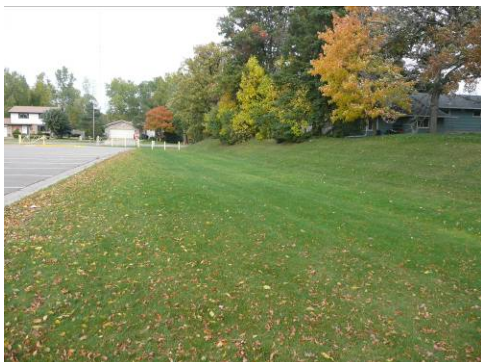
Valentine #14

Location: Mounds View High School

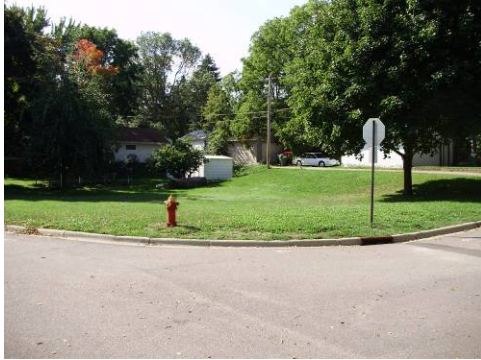
Walsh Lake #1

Location: South of Summer Street and east of Carl Street

Description: Private corner lot

Potential Improvements: Create stormwater treatment feature for adjacent street runoff.

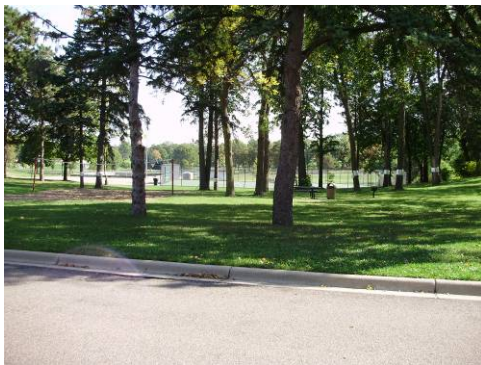
Walsh Lake #2

Location: West side of Lauderdale Community Park off of Pleasant Street

Description: Open park space

Potential Improvements: Create stormwater treatment feature for adjacent street runoff.

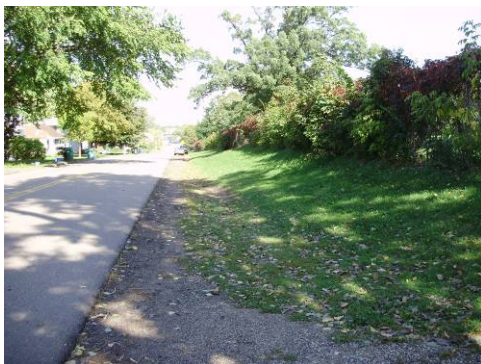
Walsh Lake #3

Location: Fulham Street-between Ione St. and Roselawn Avenue

Description: Swales/green space in right-of-way

Potential Improvements: Maintain/improve routing of runoff through green space or convert to raingarden areas.

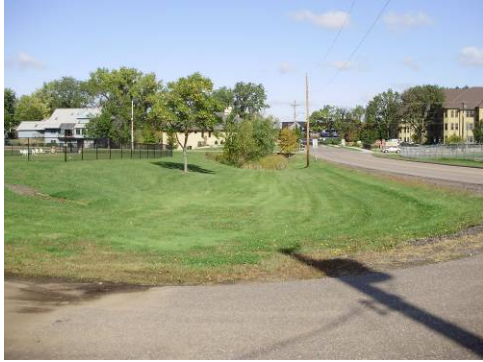
Walsh Lake #4

Location: East side of Lauderdale Community Park off of Fulham Street

Description: Large grass swale areas both north and south of parking lot drive. The swale north of the entrance is supposed to be filled with sandy soils and a large raingarden was to be created in northeast corner to promote infiltration per RCWD Permit 00-001.

Potential Improvements: Verify presence of sandy soils in swale, and improve treatment via excavation of depressional storage and vegetation enhancement in northeast corner.

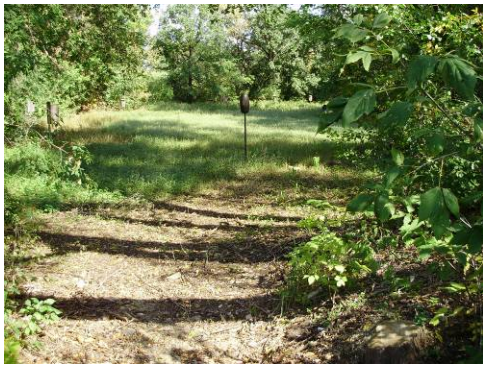
Walsh Lake #5

Location: East of Midland Hills Road and North of Rosewood Lane North

Description: Wetland area

Potential Improvements: Looks fairly good as is, however an assessment could be made to determine the benefit of increasing storage or other modifications that could be made to provide additional treatment. (Note: there may have low floor issues with 2211 Rosewood Lane.) Roseville has identified this area for implementation of an expansion project in 2009.

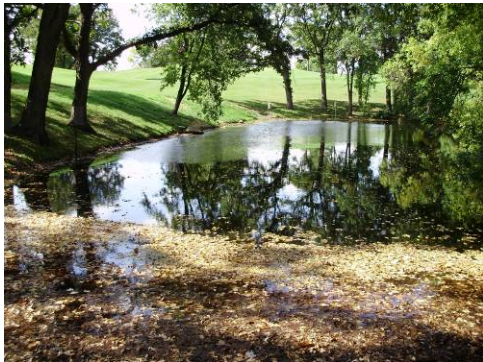
Walsh Lake #6

Location: Midland Hills Golf course, north of Walsh Lake

Potential Improvements: Excavation/maintenance to increase storage, native vegetation around pond perimeter, and the addition of a skimming structure at the outlet.

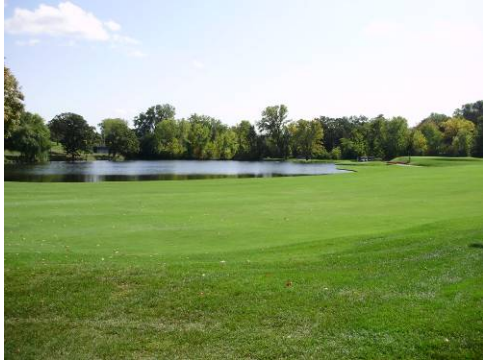
Walsh Lake #7

Location: West side of Walsh Lake

Description: Golf course area immediately adjacent to Walsh Lake

Potential Improvements: Replace turf with native vegetation buffer along western shore of the lake.

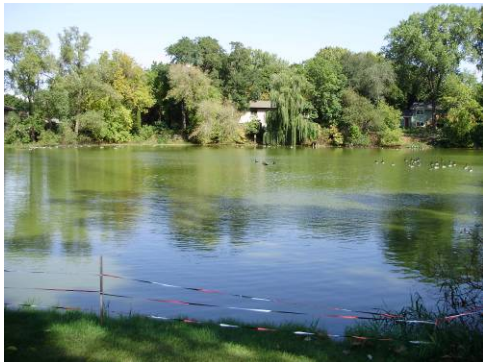
Walsh Lake #8

Location: Pond at the corner of Roselawn Avenue and Cleveland Avenue

Potential Improvements: Replace grass with native vegetation along the shoreline on the adjacent church property.

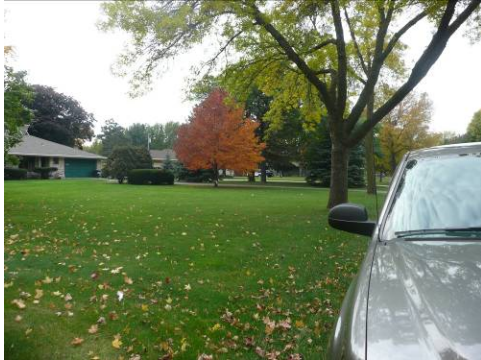
Zimmerman #1

Location: South side of Ryan Avenue W and west of Hamline Avenue N

Description: Example of large open areas in front yards

Potential Improvements: Install raingardens along road corridors; many opportunities in this area will exist when streets are reconstructed. (Note: there are also large boulevard trees limiting some areas.)

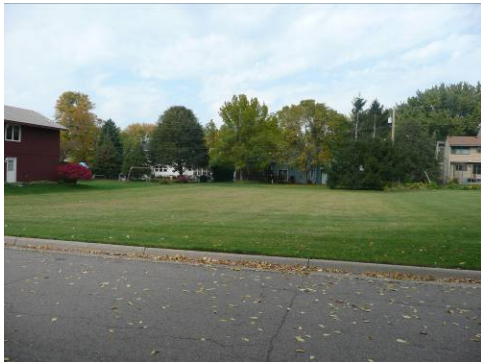
Zimmerman #2

Location: North of Eldridge Avenue W and west of Hamline Avenue N

Description: Large open lot

Potential Improvements: Room for good-sized infiltration or water quality feature (might not be able to get enough drainage area to the location to necessitate using the entire lot).

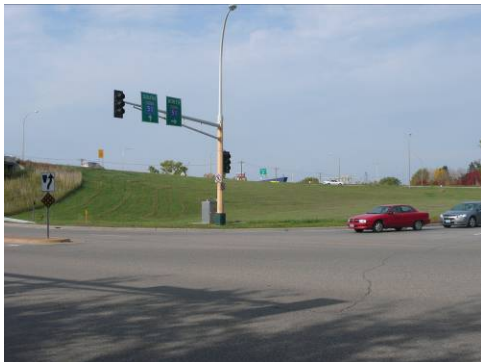
Zimmerman #3

Location: North of County Road B2 W and east of Snelling Avenue

Description: Southeast exit ramp loop

Potential Improvements: It appears that the loop areas adjacent to Snelling Ave. could be better used for treatment. These areas should be assessed for opportunities during road improvement projects.

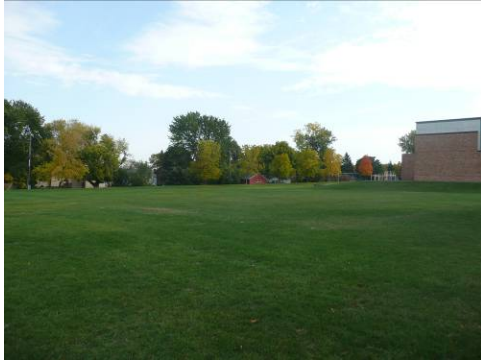
Zimmerman #4

Location: South of County Road B and west of Midlothian Road

Potential Improvements: Incorporate feature for school and or adjacent roads. Note there are lots of opportunities on the school site to provide treatment (as needed). It appears that a raingarden was recently incorporated for a small paving project on site.

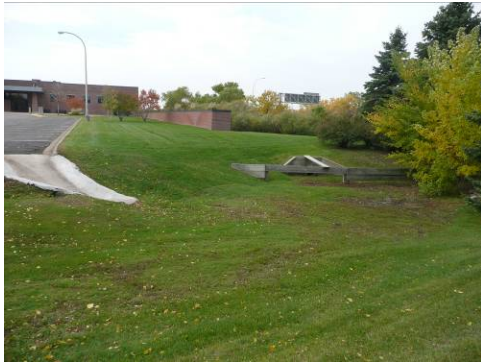
Zimmerman #5

Location: North of Commerce Street and west of Albert Street (or commerce Street to EB Hwy 36)

Description: Swale and dry pond picking up large parking area

Potential Improvements: Improve feature to include infiltration and/or water quality improvement.

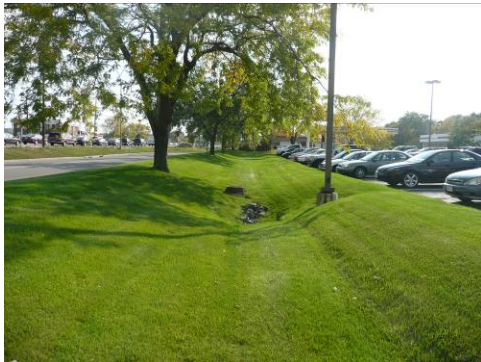
Zimmerman #6

Location: West of Snelling Avenue and South of Hwy 36

Description: Swale picking up parking via curb cuts. No storage currently provided and curb cuts not draining properly.

Potential Improvements: Enhance area to provide depressional storage / create raingardens or bio-filtration areas.

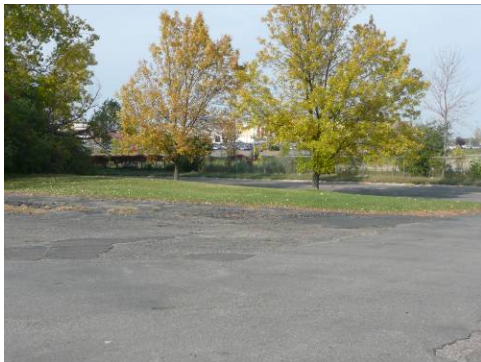
Zimmerman #7

Location: West of Snelling Avenue and south of Hwy 36

Description: Green space area in apartment complex

Potential Improvements: Green space areas in apartment ground could be better used to provide treatment.

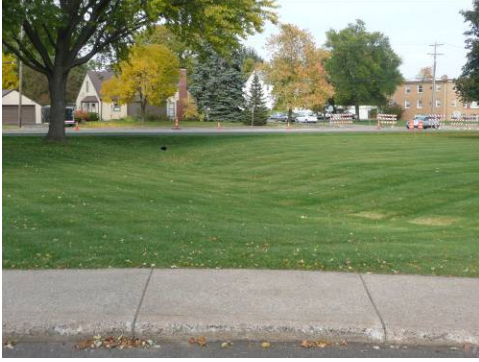
Zimmerman #8

Location: South of County Road B and east of Midlothian Road
